A Vexing Problem of Air Trapping in the Trima Accel During Plateletpheresis Procedure: Reflecting Our Experience in Troubleshooting

Suman S. Routray¹, Sukanta Tripathy¹, Gopal Ray²

Keywords: troubleshooting, fishbone analysis, apheresis, air block, access pressure

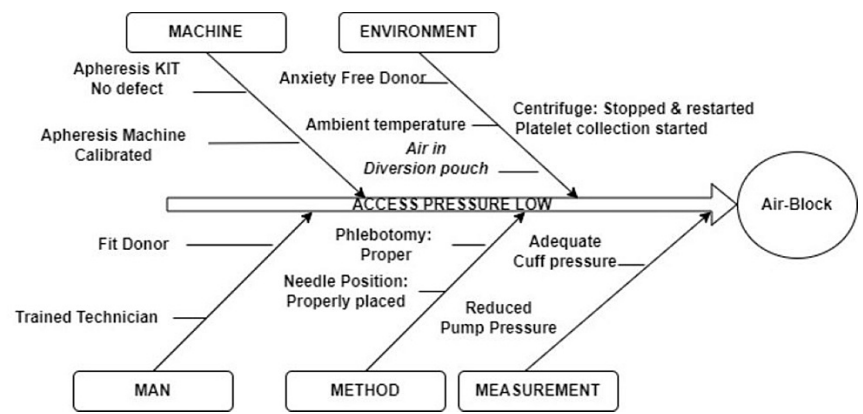
The root cause analysis (RCA) for these events was carried out in consultation with the apheresis technical expert (Terumo Penpol Pvt Ltd.). The details of the fishbone diagram used to identify many possible causes for the specific problem are depicted in Figure 1. The "air block" was detected as the root cause of the above events.

FIGURE 1: Fishbone analysis for the "Low access pressure"

The root cause analysis of "access pressure low" using the fishbone tool by the Authors depicts that air block is due to the presence of air in the diversion pouch (first and second events) and in the inner channel (third event).
