Pacemaker Failure to Capture Caused by Electrocautery: A Rare Pacemaker Pulse Generator Change Complication

Aman Qureshi 1, Intisar Ahmed 2, Aamir H. Khan 2

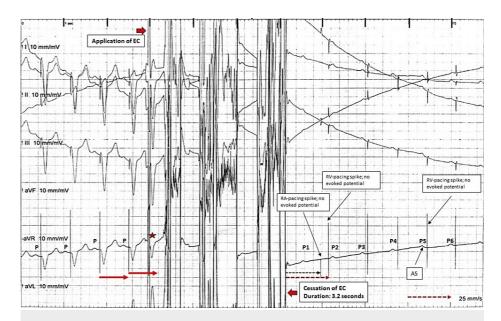
FIGURE 1: Electrocardiogram During Electrocautery

On the day of the procedure, the patient was hemodynamically stable with preliminary laboratory workup all within the normal range. Manually operated transcutaneous pacemaker (TCP) pads were applied that are used for both cardioversion/defibrillation and pacing. The return patch for the EC was placed on the right leg. Although the patient was pacemaker-dependent, we did not put a temporary pacemaker as it increases the risk of infection. After preparing the left infraclavicular area, midazolam 1 mg aliquots to a total of 3 mg were administered to establish conscious sedation. The old scar was removed using an ellipsoid wedge incision. To stop bleeding in the scar, unipolar EC was used in a short burst. The EC was set at 45 watts, and only coagulation was used. This resulted in a sudden and unexpected loss of ventricular capture (Figure 1 and Figure 2).

Six-lead rhythm strip that shows atrial sensing, followed by a unipolar pacing spike and appropriate ventricular pacing. There is an application of electrocautery (EC) for a period of 3.2 seconds and then an abrupt failure to pace. The first beat after the application of EC (star) is possibly a tracked-paced beat. After EC cessation, the first two P waves (P1 and P2) are not sensed. There are atrial and ventricular pacing spikes without evoked potentials (failure to pace). Onward from P4, there is appropriate atrial sensing then the programmed AV delay and unipolar ventricular pacing spikes, but no ventricular evoked potential (failure to pace), which remains for the duration of the trace.

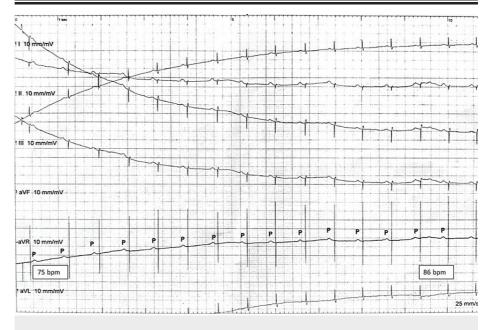
FIGURE 2: Six-Lead Electrocardiogram

The figure shows the continuation of the six leads from Figure 1, showing atrial sensing and ventricular pacing spike with failure to capture. The device outputs after the programmed AV delay but does not capture the myocardium. The sinus rate goes from 75 to 86 bpm in 10 seconds.

The loss of capture (LOC) remained for 30 seconds, and before the TCP could kick in, the ventricular capture through the permanent pacemaker spontaneously resumed. The further procedure was done using blunt dissection. When the device was removed from the pocket, a few beats were missed because of unipolar pacing, necessitating the generator to be repositioned in the pocket. The device was replaced into the pocket, and pacing resumed. The device ventricular lead was then carefully shifted to the analyzer cable, and subsequent pacing was done through it. The leads were rechecked for thresholds and impedance and were
