# Metallosis After Oxinium Total Knee Arthroplasty in a Patient With Rheumatoid Arthritis: A Case Report

Cañizares S, Carrera Barriga G, Valencia Jarrín F, et al. (February 02, 2023) Metallosis After Oxinium Total Knee Arthroplasty in a Patient With Rheumatoid Arthritis: A Case Report. Cureus 15(2): e34541. DOI 10.7759/cureus.34541

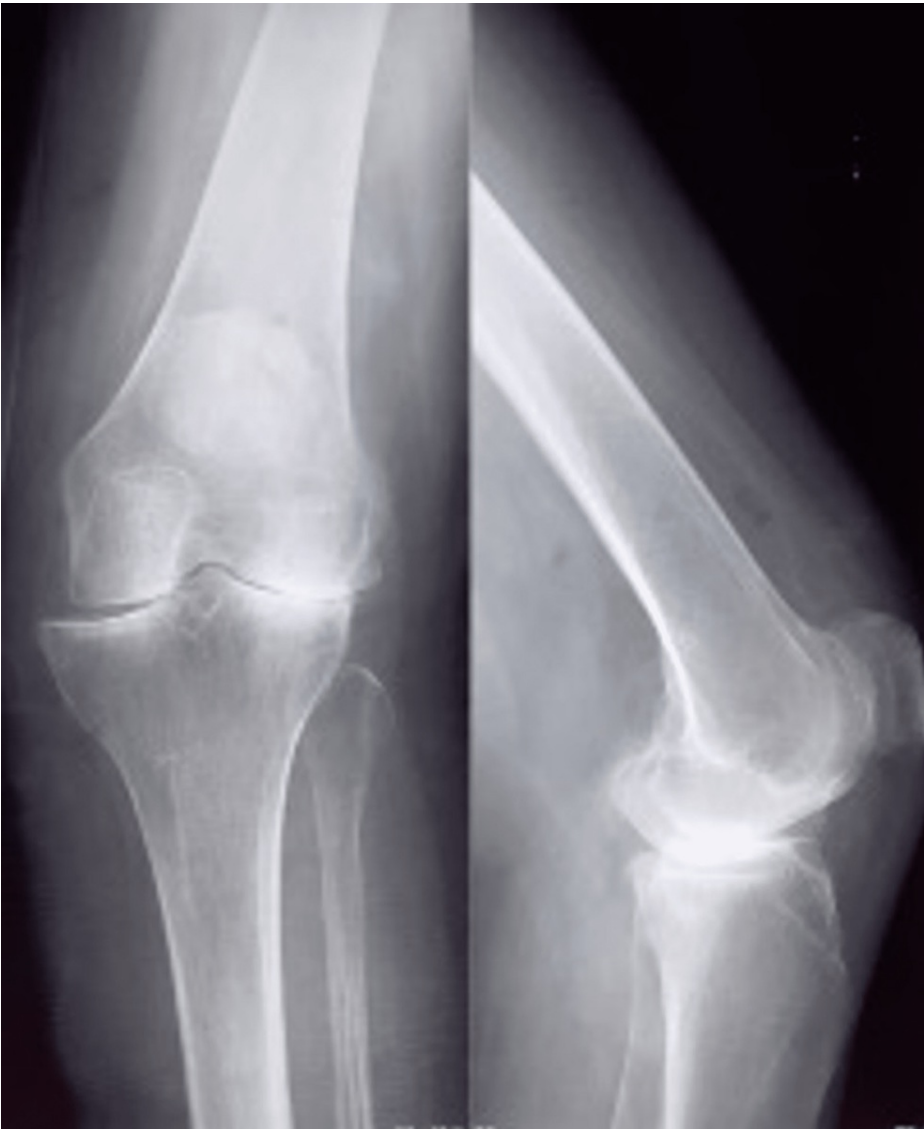
**FIGURE 1: X-ray images of the affected knee**

Stage IV left gonarthrosis (Kellgren and Lawrence classification) previous to the Total Knee Arthroplasty

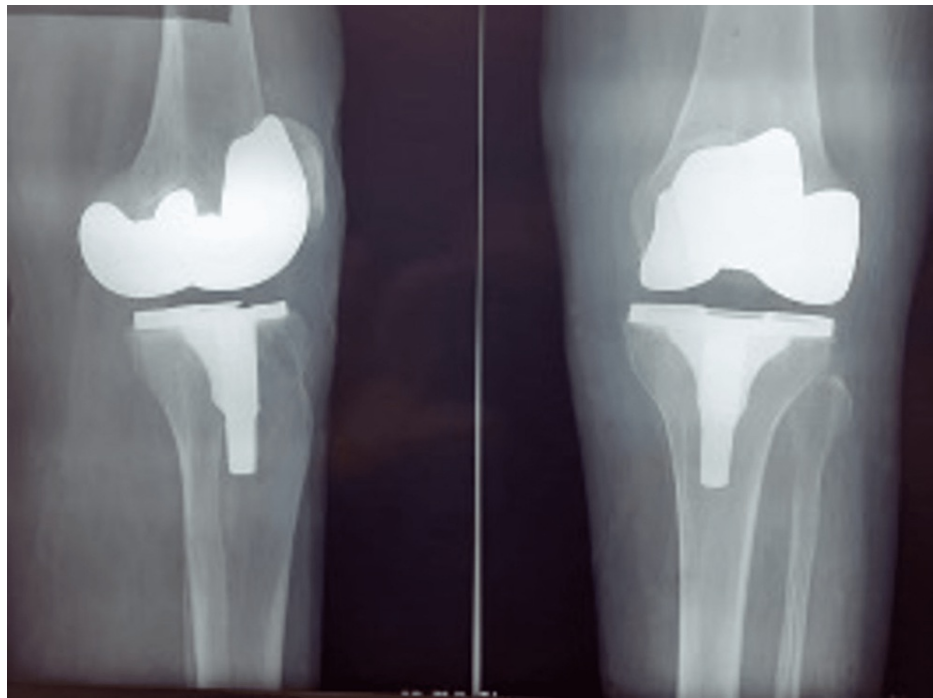
**FIGURE 2: Postoperative control two years after Total Knee Arthroplasty**

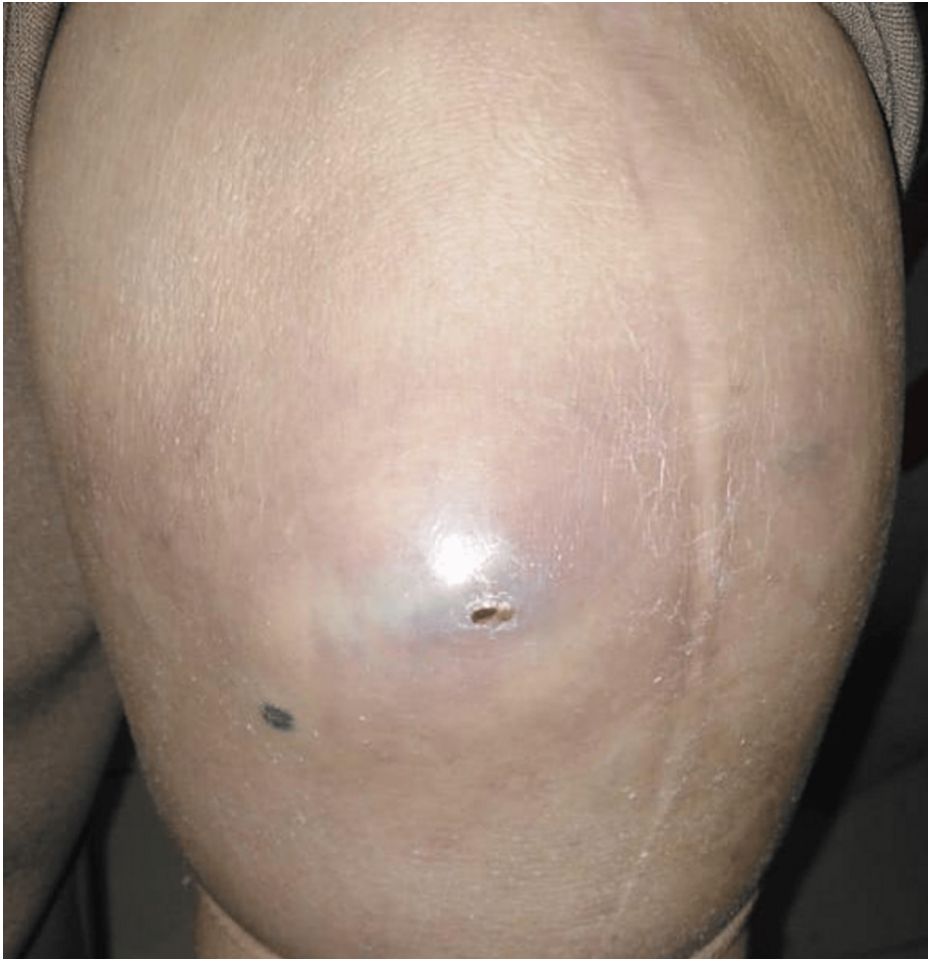
**FIGURE 3: Swollen left knee of the patient**

Swollen left knee articulation showing an internal anterior protrusion corresponding to the polyethylene dislocation four years after Total Knee Arthroplasty.

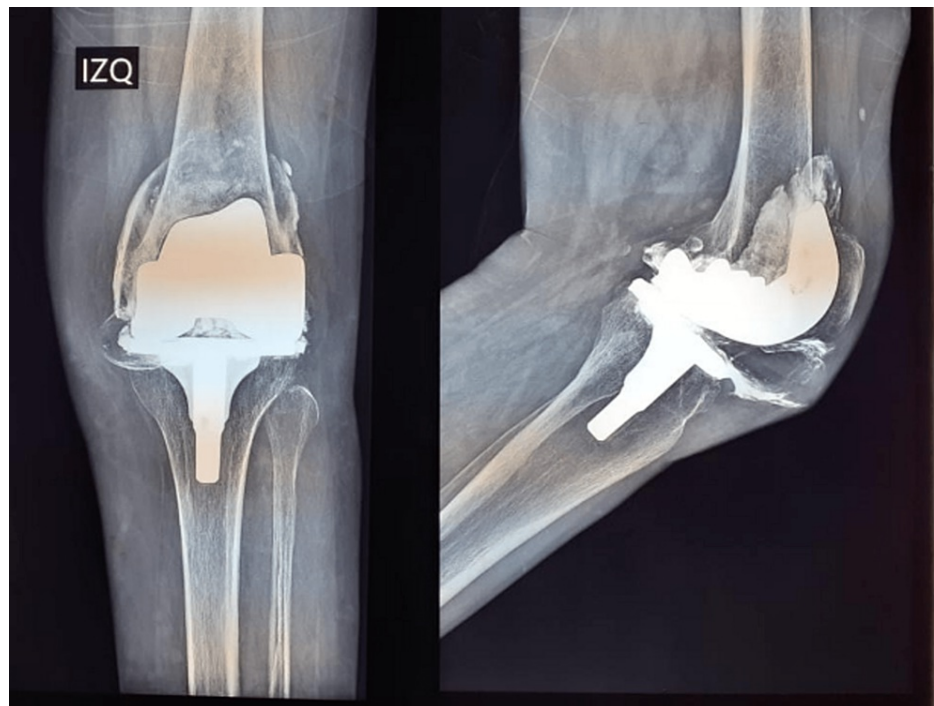
**FIGURE 4: Radiograph images of the swollen knee**

Initially, she had a 18° valgus, a KSS (Knee Society Score) of 3, and a Function score of 45. Her postoperative course was uneventful until October 2019 when he stumbled and fell on her left knee causing pain and increasing disability. Since her symptoms did not improve, the patient came for clinical assessment after one month. At physical examination, swelling and a growing mass in the internal anterior angle were observed (Figure 3). Her initial workup revealed normal inflammatory markers in serum and a negative articular puncture for infection. Radiographs revealed a narrowing of the joint space and a thin hyperdense line outlining a portion of the joint capsule which probably corresponded to the “metal line sign” observed metal-induced synovitis (Figure 4).

Thin hyperdense line outlining a portion of the joint capsule which probably corresponded to the "metal line sign" observed metal-induced synovitis.

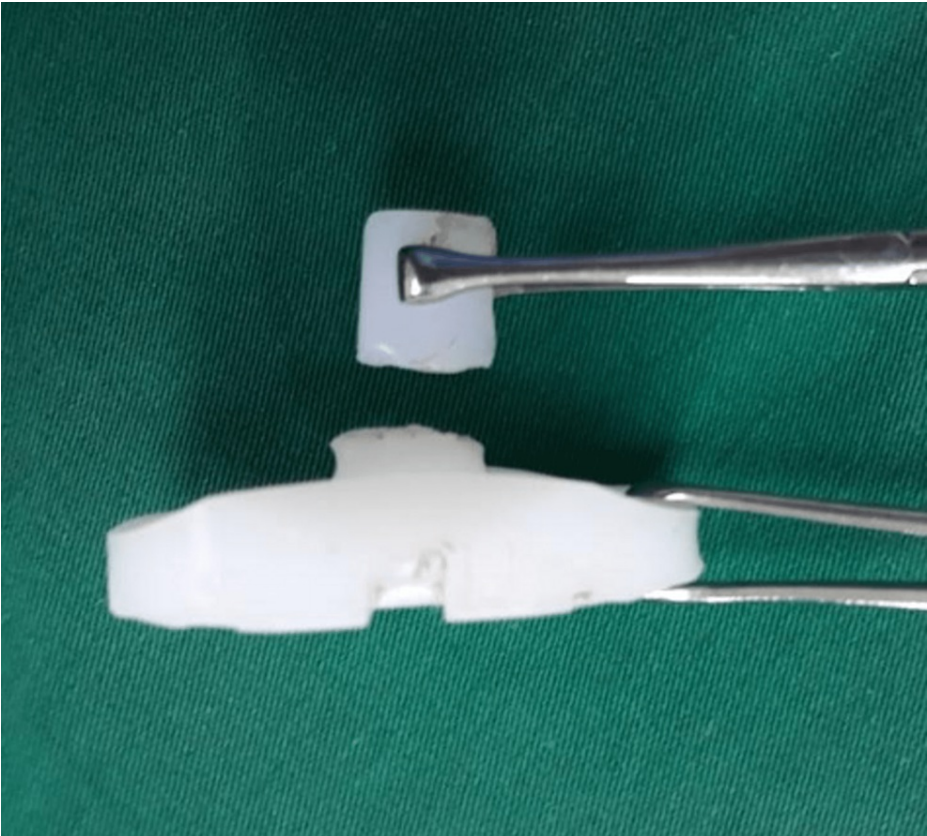
At revision surgery, polyethylene liner dislocation towards the internal anterior knee compartment and a profuse metallosis was observed. Skin integrity was intact. Femoral and tibial components were well fixed with no evidence of loosening. However, delamination of the femoral component in the inferior external region was noted. Post was detached from the tibial plate making the whole rollback (post/cam) mechanism obsolete (Figure 5). A synovectomy was performed demonstrating diffuse dark black synovial thickening (Figure 6). Debridement of soft tissue impacted by insert dislocation, medial and lateral gutters and all damaged tissue down to healthy appearing tissue was performed. Samples were sent for histopathological assessment and culture. Insert was replaced by a new one of the same size. The culture was negative for infection and histopathology reported granulation tissue, neutrophilic and lymphocytic infiltration, and black pigment within macrophages. The patient was discharged after one week and post-operative controls were performed to assess soft tissue and the potential risk for loosening recurrence. Second-time revision surgery was planned for the future. However, the overall prognosis was good, and no further surgery was expected to occur. Now, the patient has not suffered from any episode as before and therefore, has not required additional treatment.

**FIGURE 5: Intraoperative finding in revision surgery**  
Post detachment from the tibial plate.

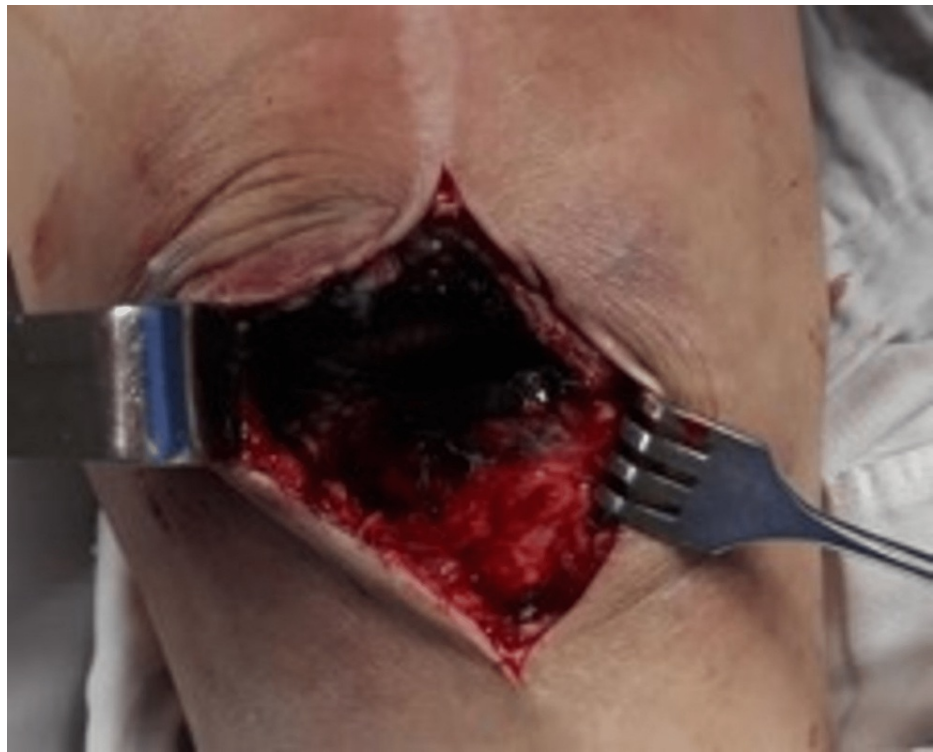
**FIGURE 6: Intraoperative finding in revision surgery**

Diffuse dark black synovial thickening was seen.
