Inappropriate Implantable Cardioverter-Defibrillator Therapy During Total Hip Arthroplasty

We present a case of a patient with an ICD with a generator located in the left pectoral region who underwent left total hip arthroplasty and experienced inappropriate ICD therapy. This report highlights the risk of EMI despite following recommended guidelines for the intraoperative management of ICDs.

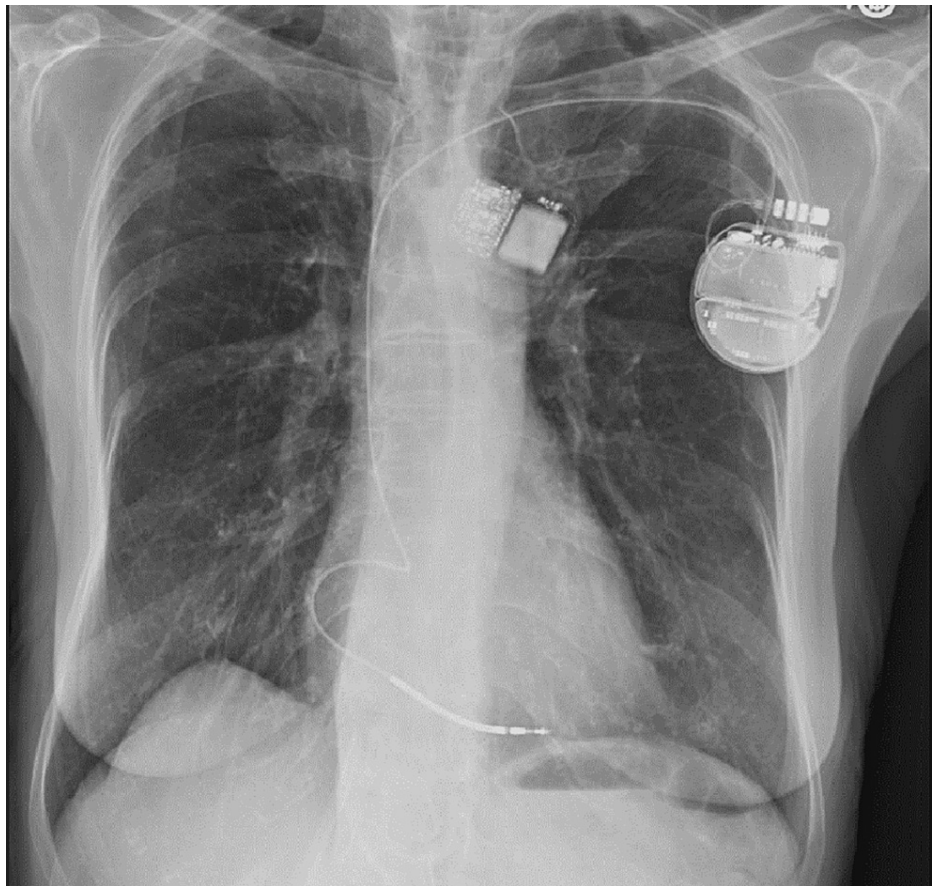
FIGURE 1: Chest radiograph

The radiograph indicates the location of the ICD generator

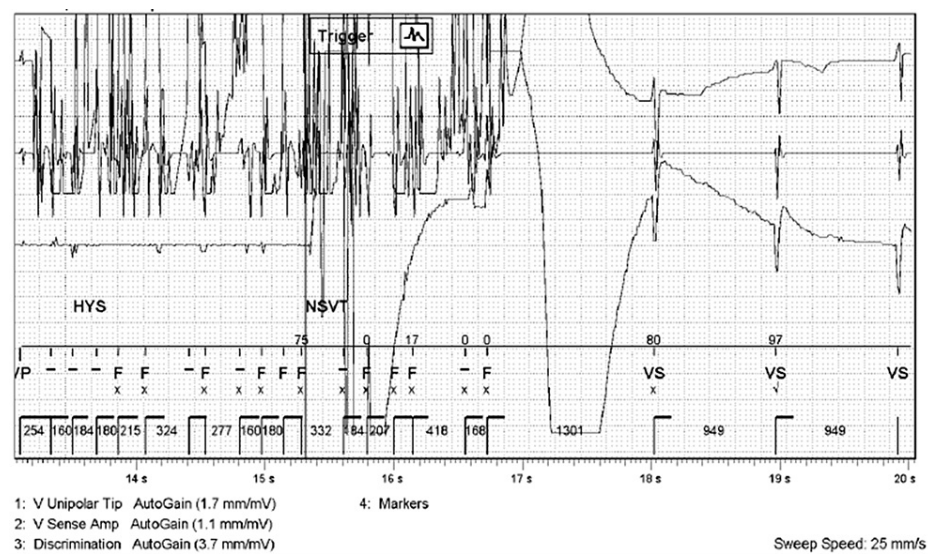
FIGURE 2: Pacemaker interrogation report

The patient's intracardiac device was remotely interrogated six days after surgery. The remaining battery life was 4.1 years compared to 5.6 one month before surgery. The patient was noted to have had nine shocks and four anti-tachycardia pacing events, all of which occurred during the surgery. Her event monitor indicated 30 ventricular fibrillation zone episodes and 28 NSVT episodes. The cardiologist noted that based on the information recorded by the ICD, the event was "suggestive of oversensing of EMI noise, all therapies inappropriate, and no true ventricular arrhythmias detected" (Figure 2). Each therapeutic shock delivered 30 J, and the ventricular fibrillation rates at the time of each shock were noted to be 240 to 480 bpm. The patient's subsequent hospital and postoperative course proceeded uneventfully.

The figure illustrates one NSVT event that triggered an inappropriate implantable ICD therapy

Other cases of underbody dispersion pads associated with inappropriate ICD therapy have been reported [4,5]. As proposed by Singleton et al. [3], the current may have traveled close enough to the sensing electrode despite a far distance to the pacemaker generator. Thus, the EMI may have traveled to the sensing electrode of the patient's ICD.

When a patient has an ICD and is undergoing surgery below the umbilicus, we recommend placing the dispersion pad below the umbilicus (e.g., contralateral leg for a total hip arthroplasty). If such placement is impractical, a magnet may be used to suspend the anti-tachycardia functions. If the patient is also pacemaker dependent, and the dispersion pad is placed at or above the umbilicus, reprogramming to an asynchronous mode should be considered with anti-tachycardia functions suspended.
