Pacemaker Malfunction During Passive Proton Beam Therapy for Localized Prostate Cancer: Case Reports and a Literature Review

TABLE 1: Characteristics of patients with pacemaker treated with PBT for prostate cancer

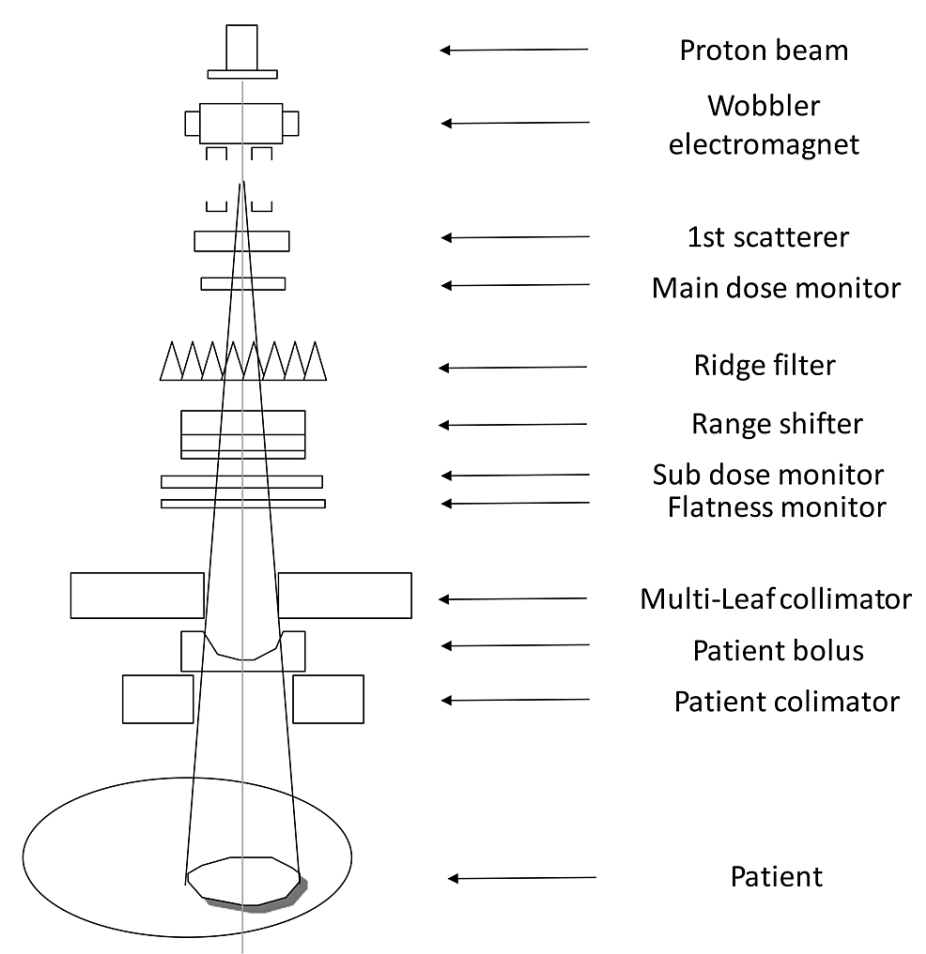
FIGURE 1: Schematic of the passive scattering proton beam delivery system

several scattering materials (1st scatterer, ridge filter, and range shifter) and collimators (multi-leaf collimator and patient collimator) in our proton therapy system (Figure 1). Secondary neutrons are more frequently generated using passive scattering systems than pencil beam scanning systems. Moreover, secondary neutrons from the passive scattering system are more commonly detected than those from the pencil beam scanning system at a position distant from the beam isocenter [4].

The proton beam is delivered to patients through the beam modulators and collimators

Secondary neutrons are generated from several scattering materials (1st scatterer, ridge filter, and range shifter) and collimators (multi-leaf and patient collimators)
