# Keep Right: Inadvertent Placement of a Temporary Pacing Lead in the Left Ventricle

DOI: 10.7759/cureus.72095

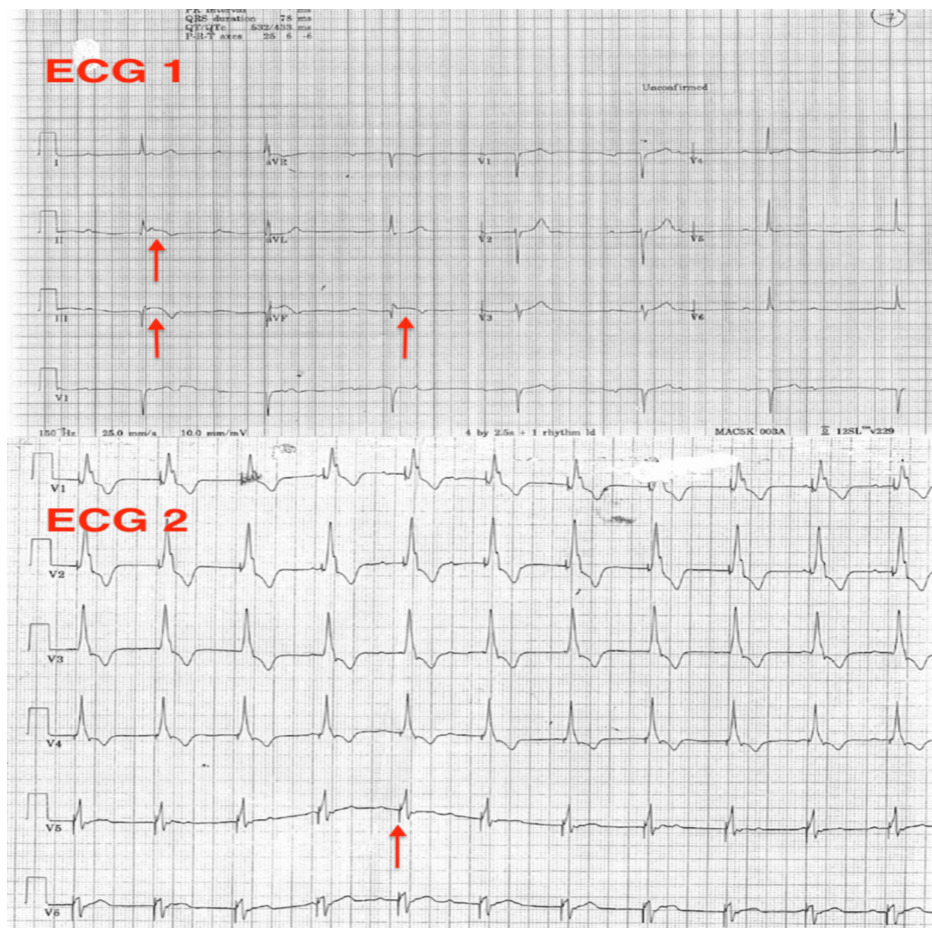
A 40-year-old man, with no past medical or family history, presented 24 hours after developing chest pain. Initial evaluation with an ECG showed complete atrioventricular (AV) block, narrow QRS and ST segment elevation in leads II, III, aVF with Q waves and reciprocal ST depression in aVL in keeping with a recent acute inferior MI (ECG 1: Figure 1). Heart rate was 40/per minute, and the blood pressure was 110/70 mmHg.

**FIGURE 1: ECG 1: ECG at the time of presentation showing inferior MI (ST elevation marked by red arrows in lead II, III and aVF) and complete heart block. ECG 2: ECG demonstrating RBBB with pacing spikes (Pacing spikes marked by red arrow. Each pacing spike is followed by broad complexes in keeping with a right bundle branch pattern).**

The next morning, the patient complained of intermittent dizziness that corresponded to intermittent loss of pacing on the cardiac monitor. A review of the 12 lead ECG showed right bundle branch block (RBBB) with pacing spikes (ECG 2: Figure 1).

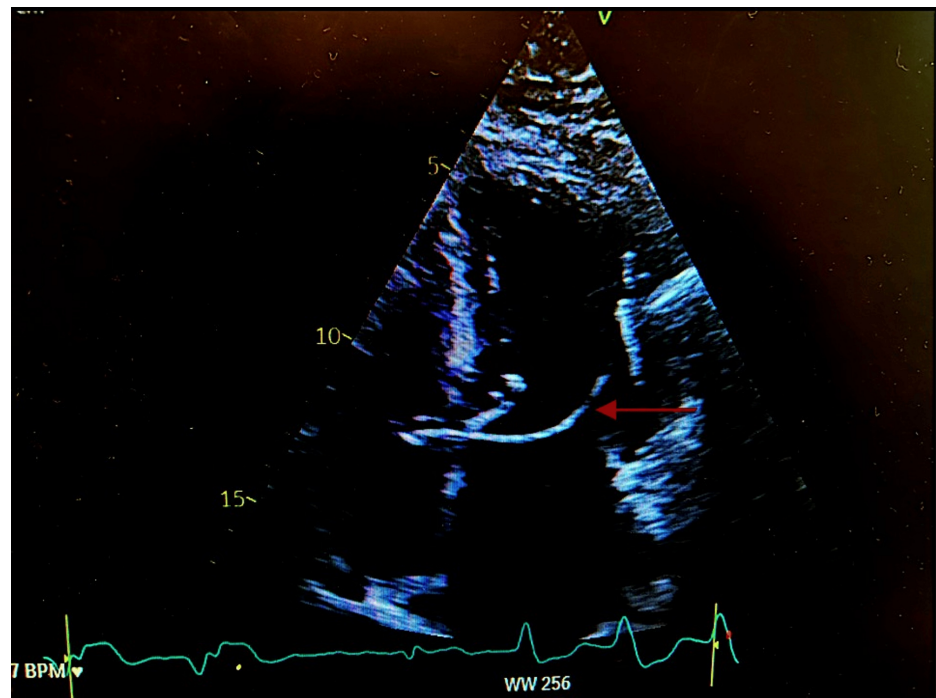
An urgent antero-posterior (AP) and lateral chest X-rays raised the suspicion of lead malposition in the LV. An echocardiogram showed that the pacing wire crossed the interatrial septum, entered the left atrium and then traversed across the mitral valve with the tip of the pacing lead in the LV (Figure 2).

**FIGURE 2: Four chamber view on transthoracic echocardiogram. Red arrow points to the temporary pacing lead traversing the interatrial septum and entering the left ventricle.**

Another temporary pacing wire was inserted via a trans-venous approach, into the right ventricle in an apical position. A chest X-ray was obtained before removal of the initial pacing lead. Post insertion ECG confirmed that the lead was in the RV as evidenced by left bundle branch block (LBBB) pattern. The patient made a full recovery with resumption of 1:1 AV conduction and the temporary pacemaker was removed. Repeat echocardiography did not demonstrate any shunt or pericardial effusion.

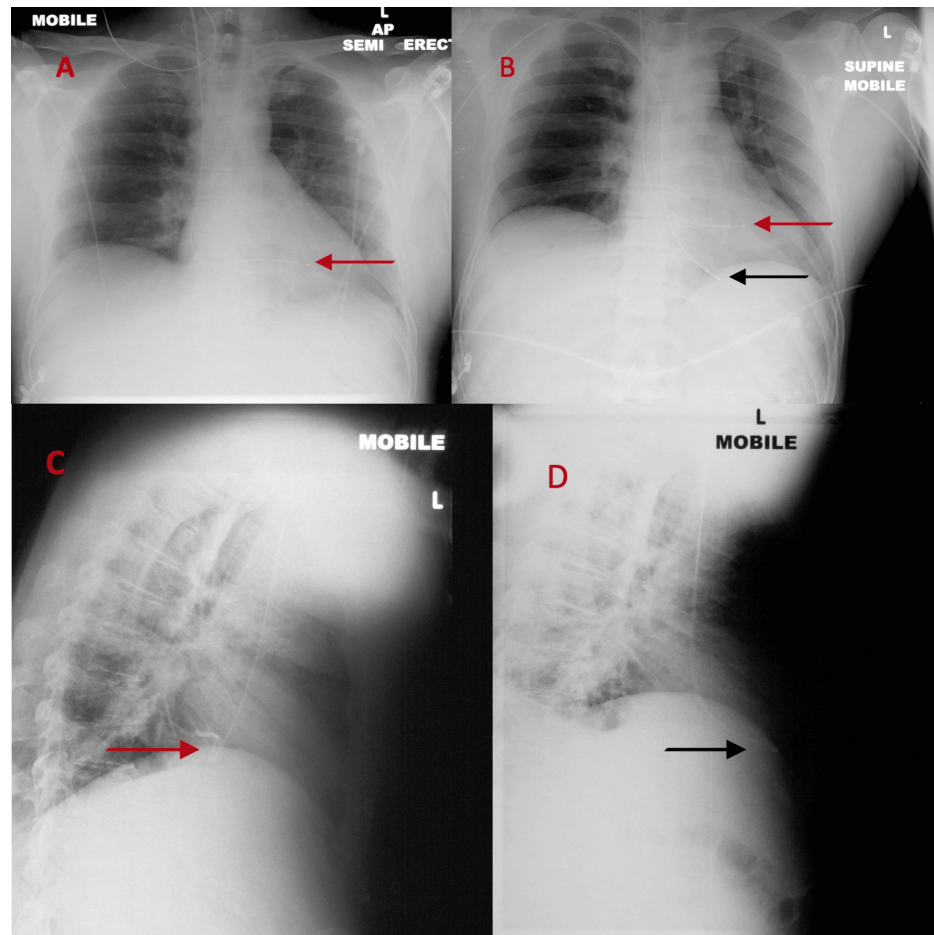
Figure 3 shows the X-ray images before and after the insertion of the second wire to demonstrate the positions of right and left ventricular leads. Figure 4 shows ECG following insertion of the RV lead and after removal of the LV lead.

**FIGURE 3: Chest X-ray AP Panel Views (A & B). Panel A: After initial pacing wire insertion, there is suggestion that the lead is in the LV. Panel B: After insertion of the second temporary pacing wire, panel B shows both leads in distinctly different positions. Chest X-ray Lateral Panel Views (C & D). C: Shows position of the first temporary wire directed posteriorly toward the spine (in LV). D: Shows lead positioning of the second wire anteriorly in the RV away from the spine. Note that the initial temporary wire had been removed. Black arrow- RV lead. Red arrow- LV lead.**

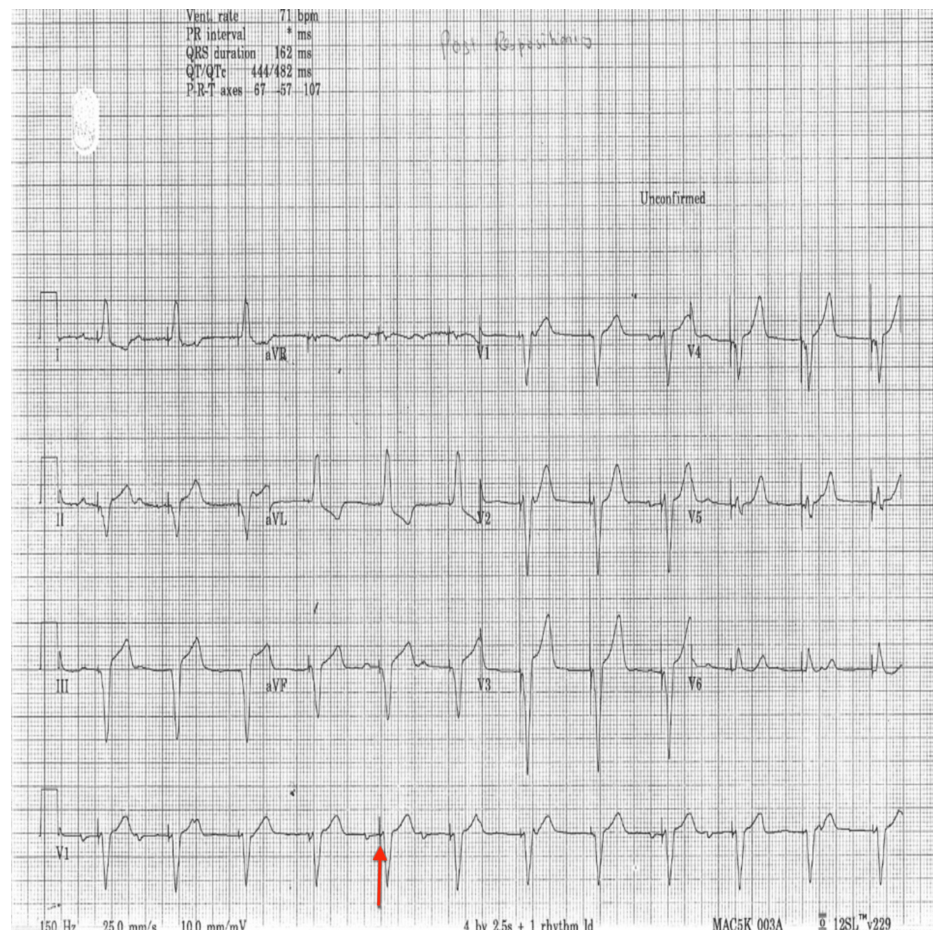
**FIGURE 4: ECG following insertion of the RV lead and after removal of the LV lead. Arrow points to the pacing spike followed by broad QRS complex which is in keeping with LBBB.**
