Inadvertent Intraoperative Defibrillation Secondary to Electrocautery Grounding Pad Placement

Categories: Anesthesiology

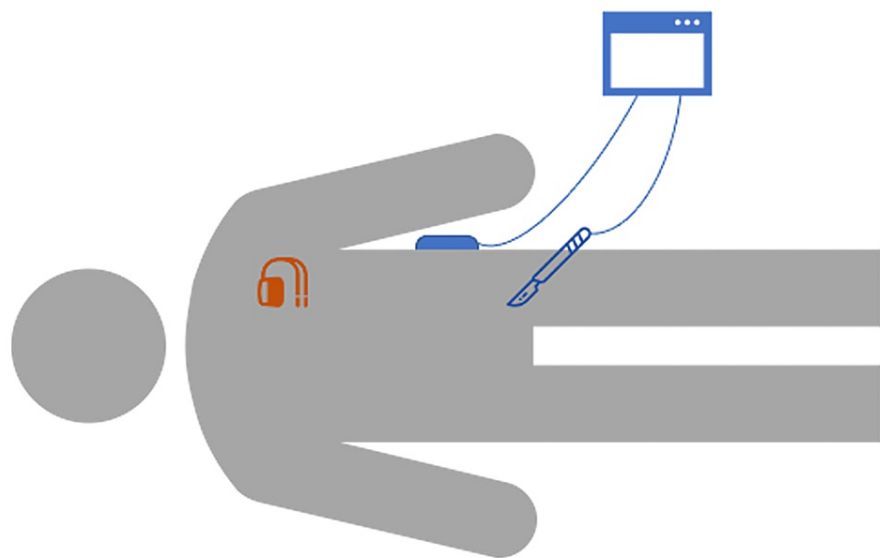
On the day of surgery, a spinal block with monitored anesthesia care was planned for anesthetic management. The spinal block was completed using 2mL of 0.75% hyperbaric bupivacaine injected intrathecally. The patient was placed in a supine position and the EDP was placed on the patient's left flank (Figure 1). After induction of anesthesia with a propofol infusion, both a nasal and oral airway was inserted to allow for adequate patency of airways, considering the patient's obstructive sleep apnea history. During the operation, the patient's AICD defibrillated on two separate occasions that were both concurrent with monopolar electrocautery usage. The surgical procedure was paused, and the EDP was repositioned from the left flank to the right flank. A magnet was placed over the AICD generator to inhibit its antitachycardia therapy functionality. The procedure was then resumed and completed with no additional complications. Postoperatively, a 12-lead ECG was ordered, and the electrophysiology team was consulted. The consultants found that the AICD had no abnormalities or malfunctions, and the inadvertent intraoperative defibrillations were confirmed. The patient recovered well postoperatively and suffered no clinically detectable myocardial damage.

FIGURE 1: Electrodispersive Pad Placement in Patient with Automatic Implantable Cardioverter Defibrillator.
