Navigated Percutaneous Sacroiliac Screw Fixation in Unstable Pelvic Ring Fracture

Categories: Orthopedics, Healthcare Technology, Trauma

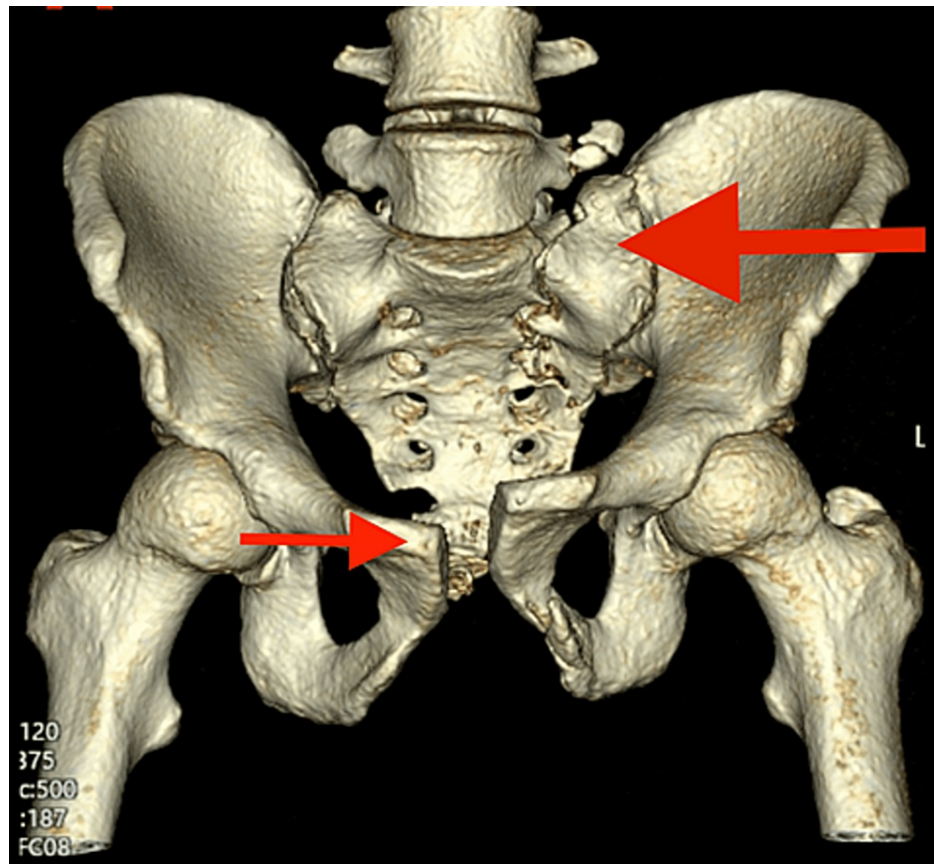
configuration detail or any intraarticular involvement which is important for preoperative planning. CT reported that the patient sustained a closed left sacral ala fracture with intra-articular extension into the adjacent left sacroiliac joint of the left ilium as well as a widening of the pubis symphysis measuring more than 2 cm of disruption (Figure 1).

FIGURE 1: CT scan of the first patient showing symphysis pubis diastasis with left sacral ala fracture.

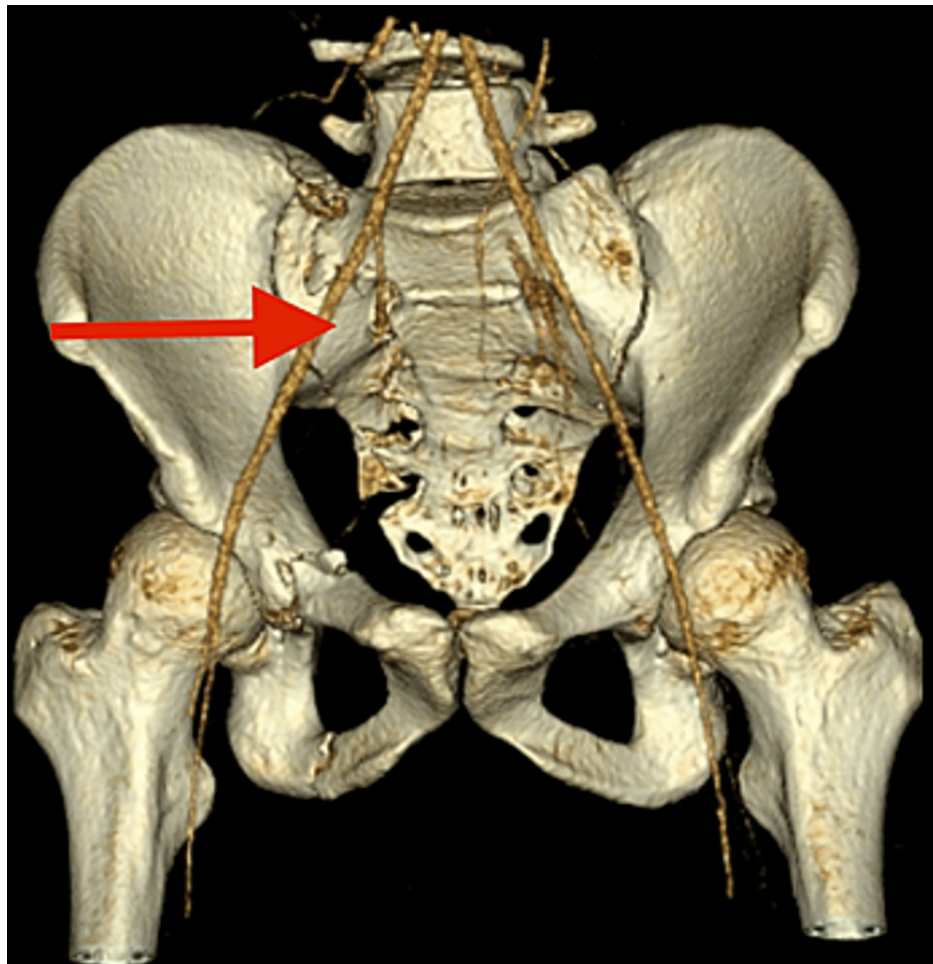
CT pelvis was performed as part of adjunct to the primary survey. CT reported that the patient sustained a right sacral ala longitudinal fracture with ipsilateral superior and inferior pubic rami fracture (Figure 2).

FIGURE 2: CT scan of the second patient showing right sacral ala fracture with ipsilateral superior and inferior pubic rami fracture.

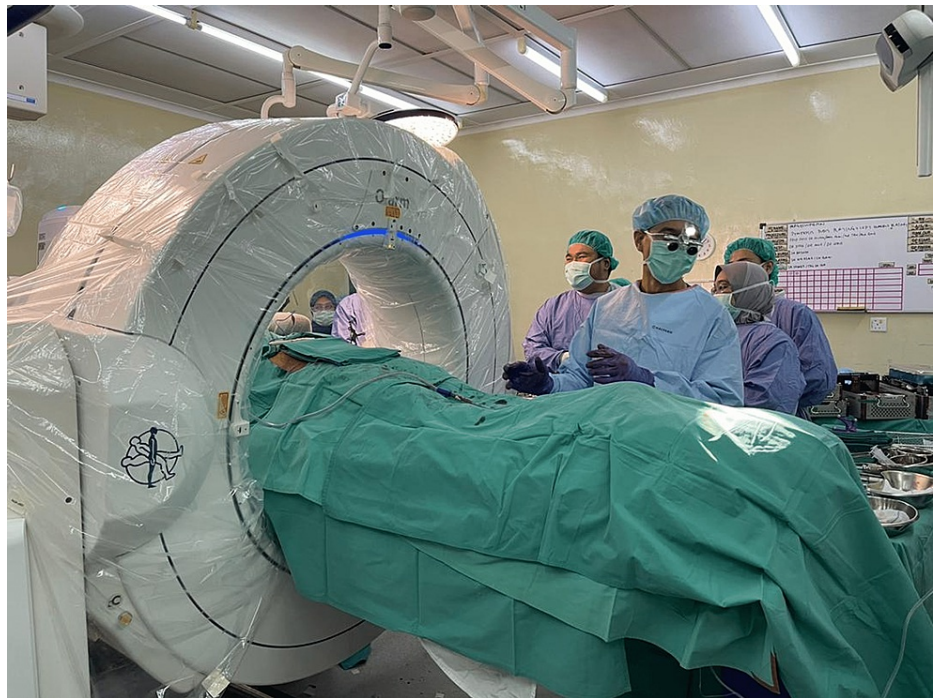
Both operations were done under general anaesthesia with the patient placed on a Jackson table in a supine position. The navigation system, Stealth Station (Medtronic), was connected to the O-arm machine (Medtronic). The machine was positioned isocentrically over the patient. A reference probe was fixed to the anterior superior iliac spine of the unaffected pelvis to serve as a signal receiver (Figure 3).

FIGURE 3: The O-arm machine placed isocentrically to the patient.

The technology that we used for both surgeries is the O-arm machine and Stealth Station navigation system from Medtronic. It provides a combination of 3D surgical imaging with real-time navigation during the surgery. The navigation system in general provides us with better-intended trajectory aids and accuracy in implant placement intraoperatively for unstable posterior pelvic ring fracture [3,6,7]. The images generated

However, navigation systems in general take a longer setup time [3,6,7]. The machine needs to be properly positioned by the staff who are familiar with the machine in order not to interfere with the surgical field and at the same time to allow the reference probe to receive the signal properly. Any intraoperative interference of the signal may also contribute to the delay in operation time. In our example, the total setup time took approximately 30 minutes for the first patient and 20 minutes for the second patient to complete. However, once the whole process of merging the image is done, fixation of the pelvis takes a significantly shorter time to complete [3,6,7]. For instance, screw placement for the first patient only took 1 hour and 15 minutes to complete, meanwhile, the second patient took 1 hour to complete.

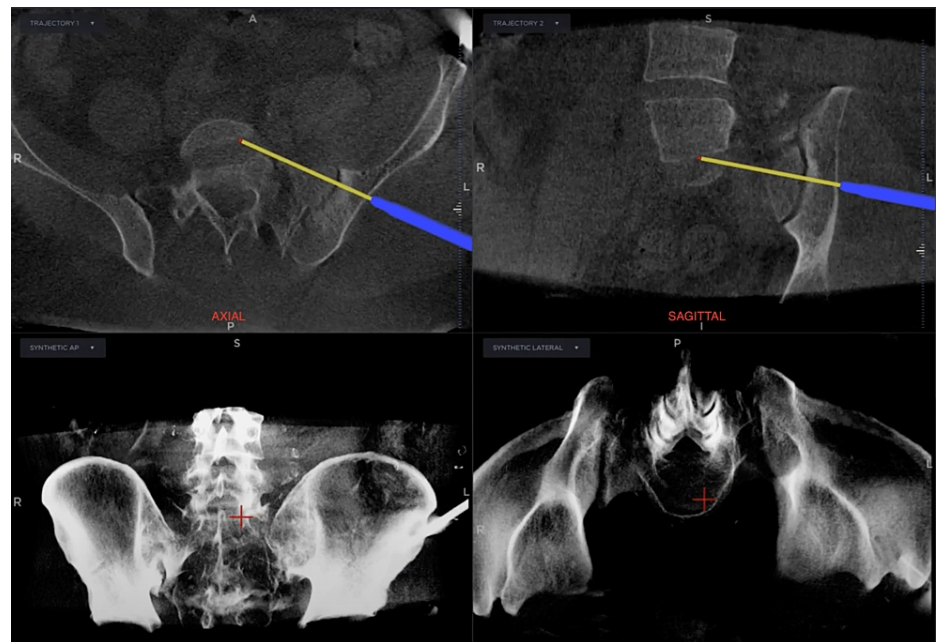
After the image had been generated, we proceeded with screw fixation of the sacroiliac joint. A stab incision was made over the lateral aspect of the hip and a 3.2mm guidewire wire passed perpendicular to the sacroiliac joint under navigation guidance. Two cannulated half-threaded 6.5mm screws with a washer inserted perpendicular to the sacroiliac joint. Screw placement was confirmed intraoperatively in all planes including sagittal, coronal and transverse using the navigation system (Figure 4).

FIGURE 4: Live 3D images in the axial and sagittal planes from the Stealth Station screen showing the screw trajectory for the first patient.

by the machine were 3D, high-resolution live images of the screw as well as the bone. The system provides images in an anteroposterior, axial and coronal plane view of the bone and screw on the screen as compared to the conventional C-arm machine, which only provides images in a 2D plane.

It is believed that the incidence of sacroiliac screw malposition rates was as low as 0.1% when using a navigation system as compared to a conventional C-arm, which accounts for 2.6% [7]. Therefore, in both of our cases, the proper length and diameter of the screw along with its trajectory can be easily visualised on the screen [3,7]. Moreover, with the help of these live images, any risk of perforation of the sacral neuroforamina and sacral cortices can be avoided [7].

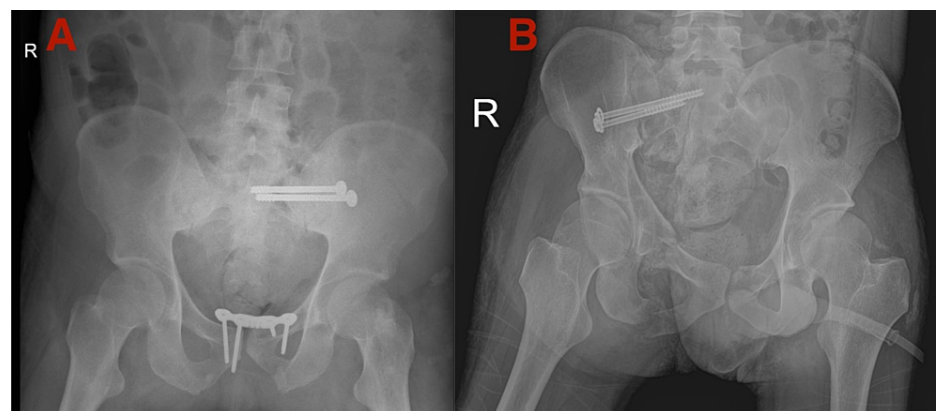
The total operation duration for the first patient was 1 hour and 45 minutes while it took 1 hour and 20 minutes for the second patient. Repeated pelvic radiographs on day 1 post-operation showed an acceptable reduction with the implant in situ (Figures 5A, 5B). The patient recovered well with no neurological deficit and was discharged on day 3 postoperatively.

FIGURE 5: Postoperative radiograph showing left sacral ala screw fixation and reduced symphysis pubis disruption for the first patient (A) and right sacroiliac screw fixation for second patient (B) following osteosynthesis.
