Early Failure of Primary Total Knee Arthroplasty Due to Massive Osteolysis Caused by Bio-Absorbable Interference Screws

Categories: Orthopedics

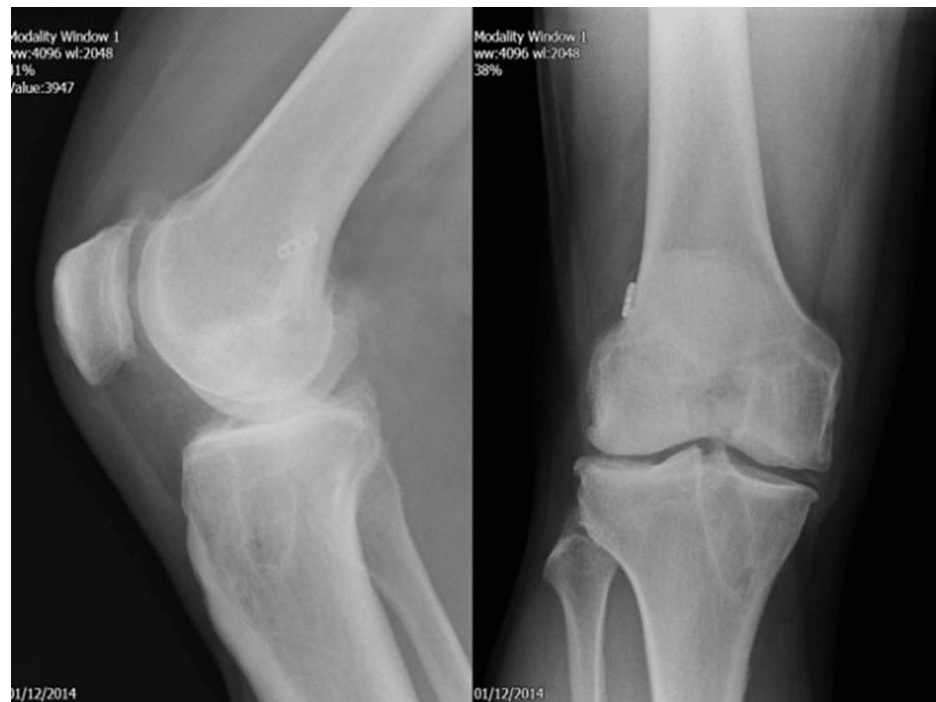
FIGURE 1: Radiographs of the right knee done in December 2014. Lateral (left) and antero-posterior (right) views showing the tibial and femoral tunnels with a suspensory fixation on the femoral side.

A 54-year-old male underwent TKA for arthritis after previous ACLR. ACLR was done 11 years ago, using suspensory fixation and a bio-absorbable screw on the femoral and tibial sides, respectively (Figure 1). Radiographs showed osteoarthritis without any evidence of osteolysis (Figure 1). A cemented TKA (Vanguard, Zimmer Biomet, Warsaw, IN, USA) was undertaken, as shown in Figure 2. During surgery, no osteolytic defects were noted, except the presence of the aperture in the tibial tunnel with the graft remnant. Post-operative recovery was uneventful.

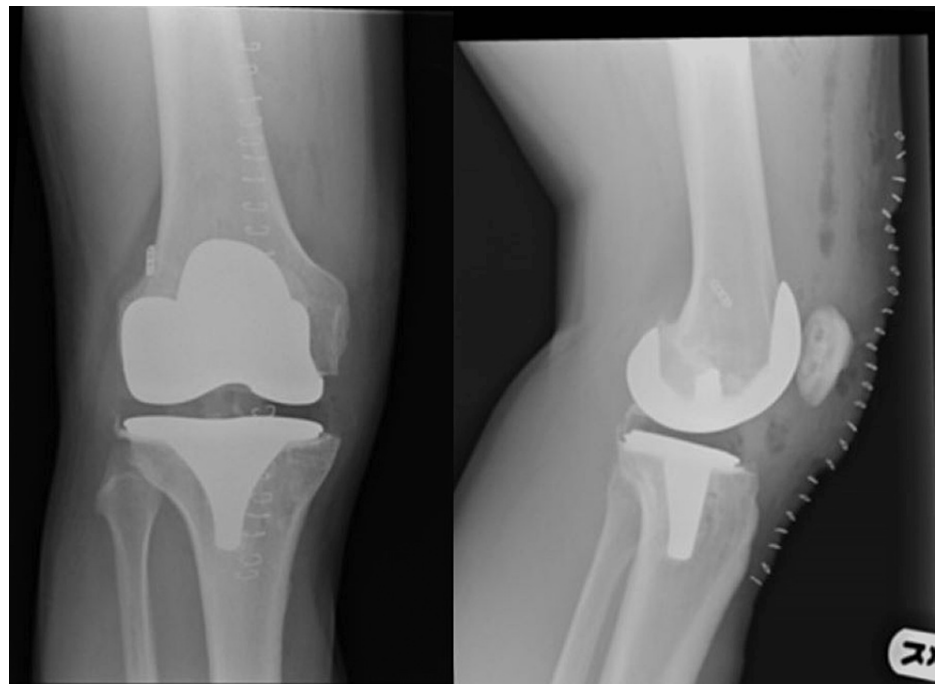
FIGURE 2: Post-operative radiographs done in February 2016. Antero-posterior (left) and lateral (right) radiographs following primary knee arthroplasty.

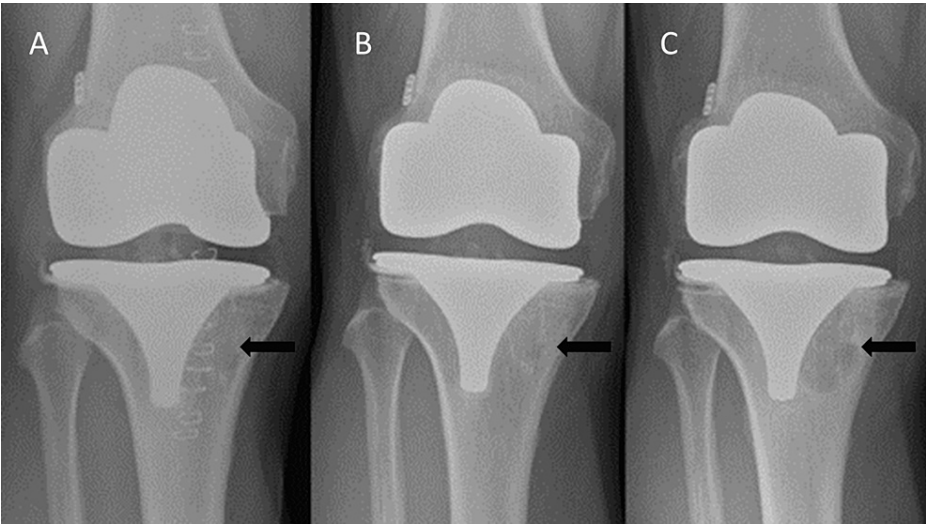
FIGURE 3: Series of radiographs depicting progressive osteolysis. Osteolysis in comparison depicted by an arrow on antero-posterior radiographs taken in (A) February 2016, (B) July 2017 and (C) June 2019.

A year after surgery, the patient complained of pain and recurrent swelling. Serial radiographs confirmed progressive osteolysis in the region of tibial tunnel, as shown in Figure 3. An alignment radiograph confirmed restoration of the mechanical axis (Figure 4), whereas CT scans showed a large radiolucency around the tibial component, suggestive of loosening (Figure 5). Serum inflammatory markers

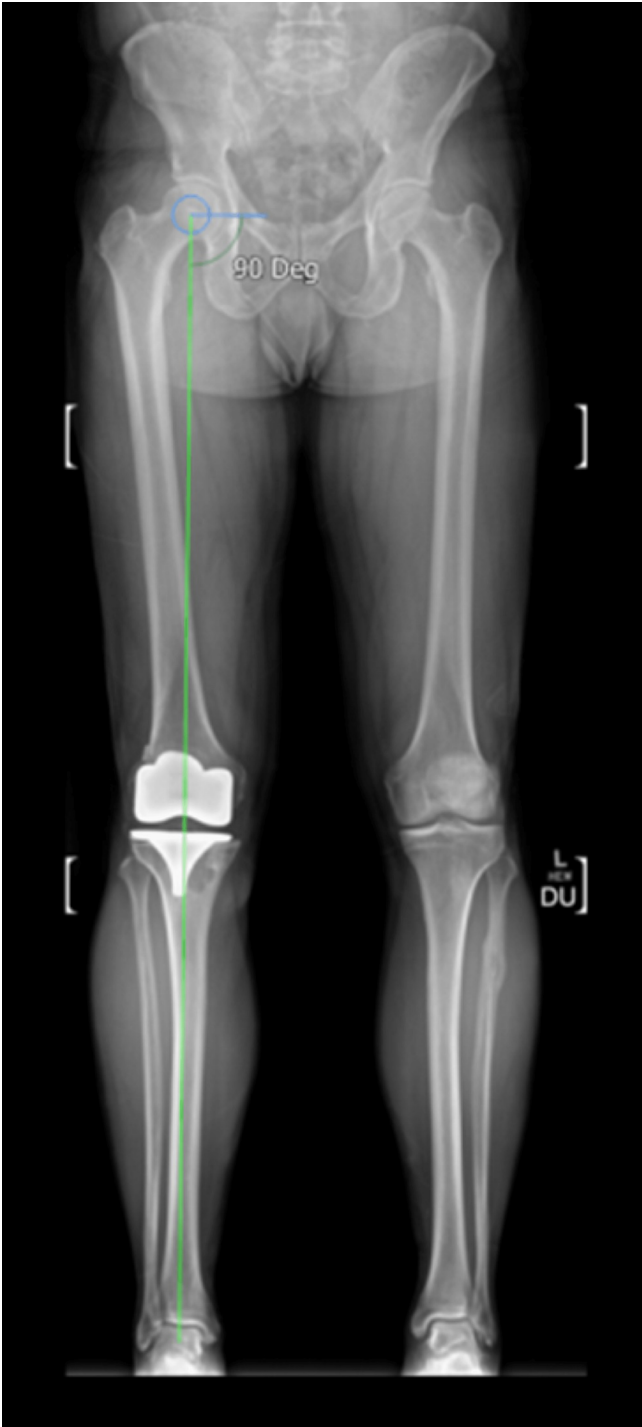
FIGURE 4: Long leg alignment radiograph before planning revision total knee replacement. The mechanical axis is depicted by the green line drawn from the centre of the femoral head to the centre of the ankle joint.

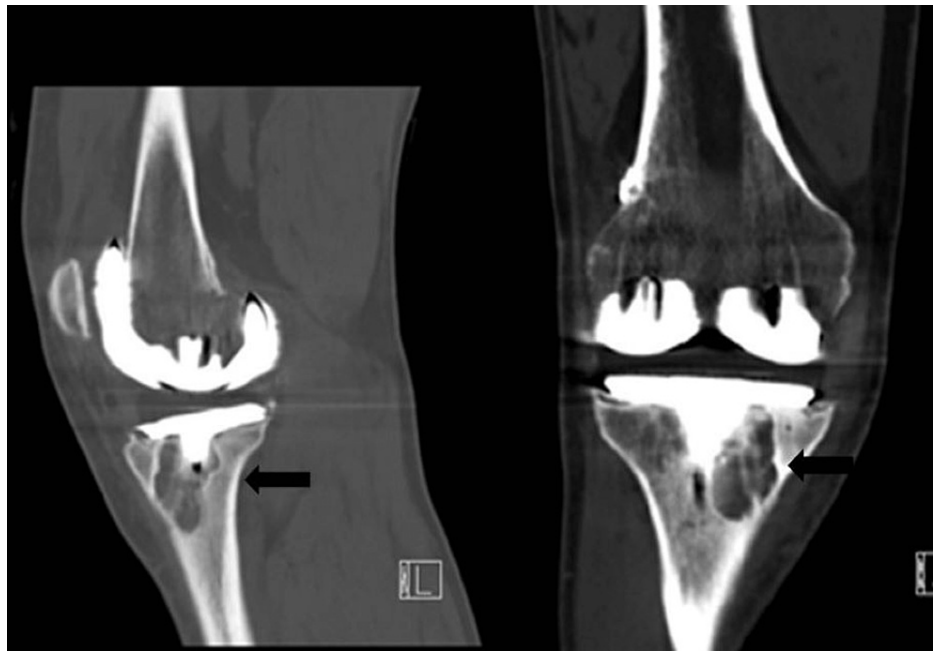
FIGURE 5: CT scan images. Depicting osteolysis around the tibial component in nine coronal and sagittal views indicated by arrows around the tibial stem.

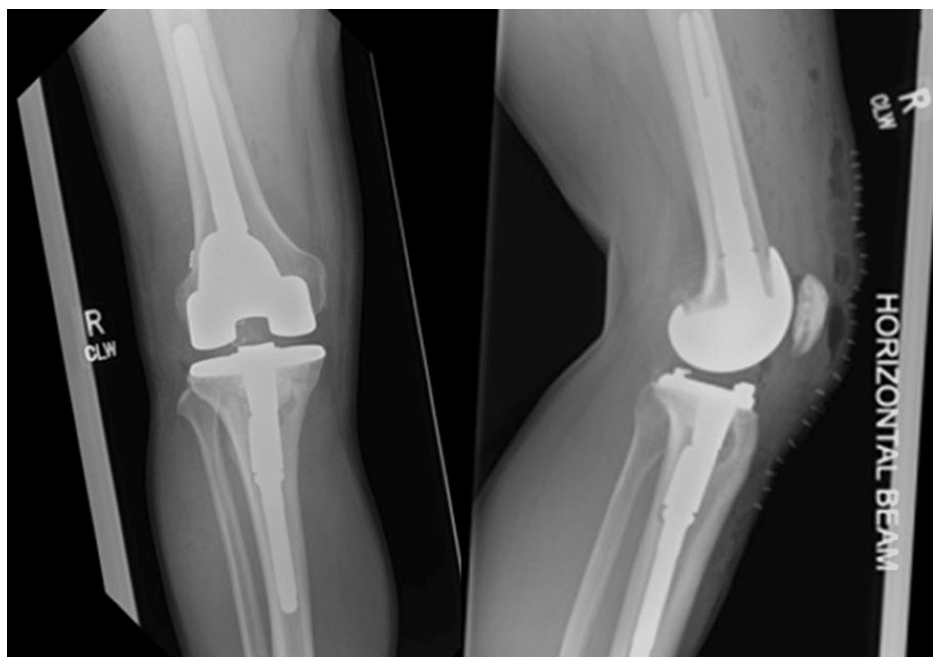
FIGURE 6: Post-operative radiographs following revision total knee arthroplasty. Antero-posterior (left) and lateral (right) views done in November 2019.

were normal, and fluid and tissue sampling of the knee ruled out infection. Post-diagnosis of aseptic loosening, single-stage revision TKR with Vanguard 360 done (Figure 6).

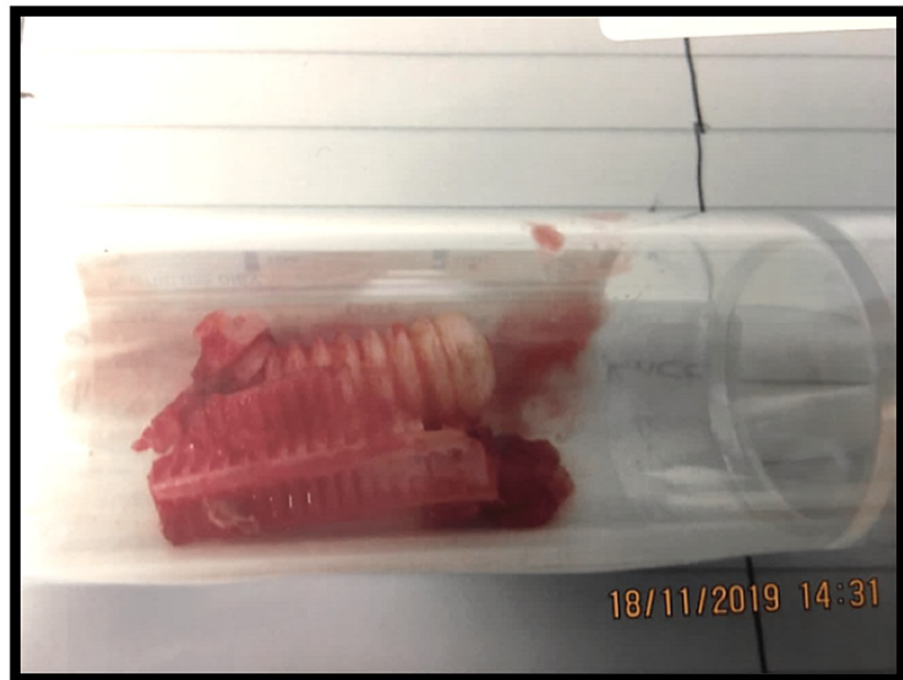
Intraoperatively, after explantation of the loose tibial component, a large cavity filled with jelly-like mass with a fragmented but unabsorbed bio-absorbable screw was encountered (Figure 7). Fluid and tissue samples taken ruled out infection, and histological analysis of the tissue showed mild chronic inflammatory infiltrate predominantly composed of pigment-laden macrophages and occasional giant cells. There was no evidence of a significant polymorph infiltrate. These histological findings were suggestive of a reaction to

wear debris and metallosis.

FIGURE 7: Intraoperative finding showing a fragmented bio-composite screw. The bio-absorbable screw was still present even after years of implantation.

Although the exact aetiology is unclear, we hypothesise that the massive osteolysis was caused by the

fragmentation of the unabsorbed bio-absorbable screw during the implantation of TKA. This fragmentation evoked an accelerated inflammatory response, leading to osteolysis. The other explanation could be an accelerated inflammatory response due to changes in the surrounding environment of the bio-absorbable screw after TKA.

We advocate caution in TKA patients with prior ACLR and recommend further imaging to rule out tunnel osteolysis. If present, the pathology should be managed by a stemmed tibial component to bypass the defect, which should be curetted and filled with either cement or bone graft, depending upon the size.
