# Treatment of Recurrent Total Hip Arthroplasty Dislocation Caused by Distorted Proximal Femoral Anatomy Due to a Previously Healed Trochanteric Fracture

Christos I. Vosinakis <sup>1</sup>, Ioannis C. Vossinakis <sup>2</sup>

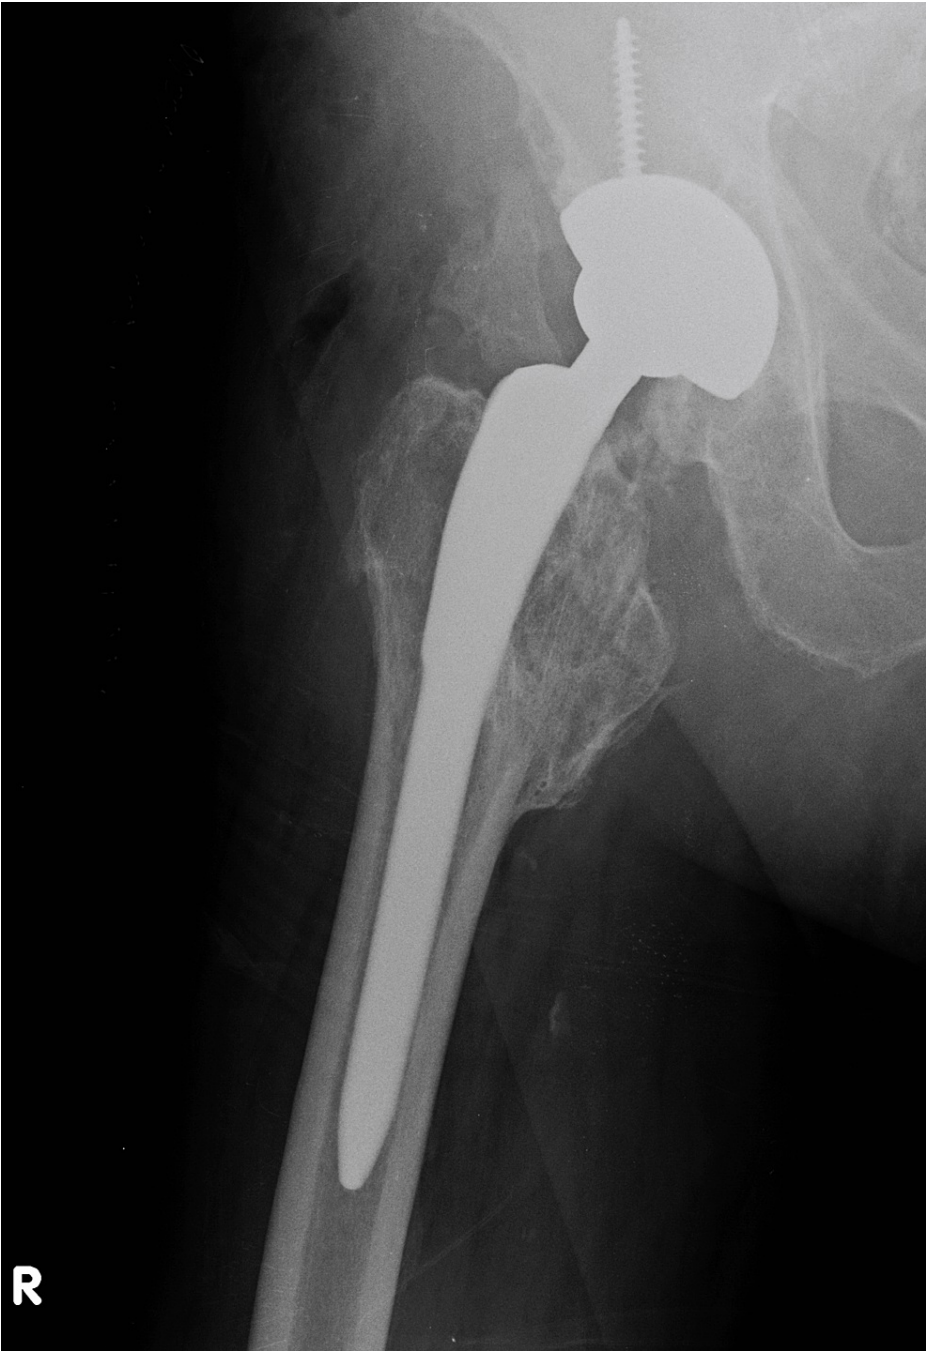
**FIGURE 3: An obviously small offset partly due to anteversion**

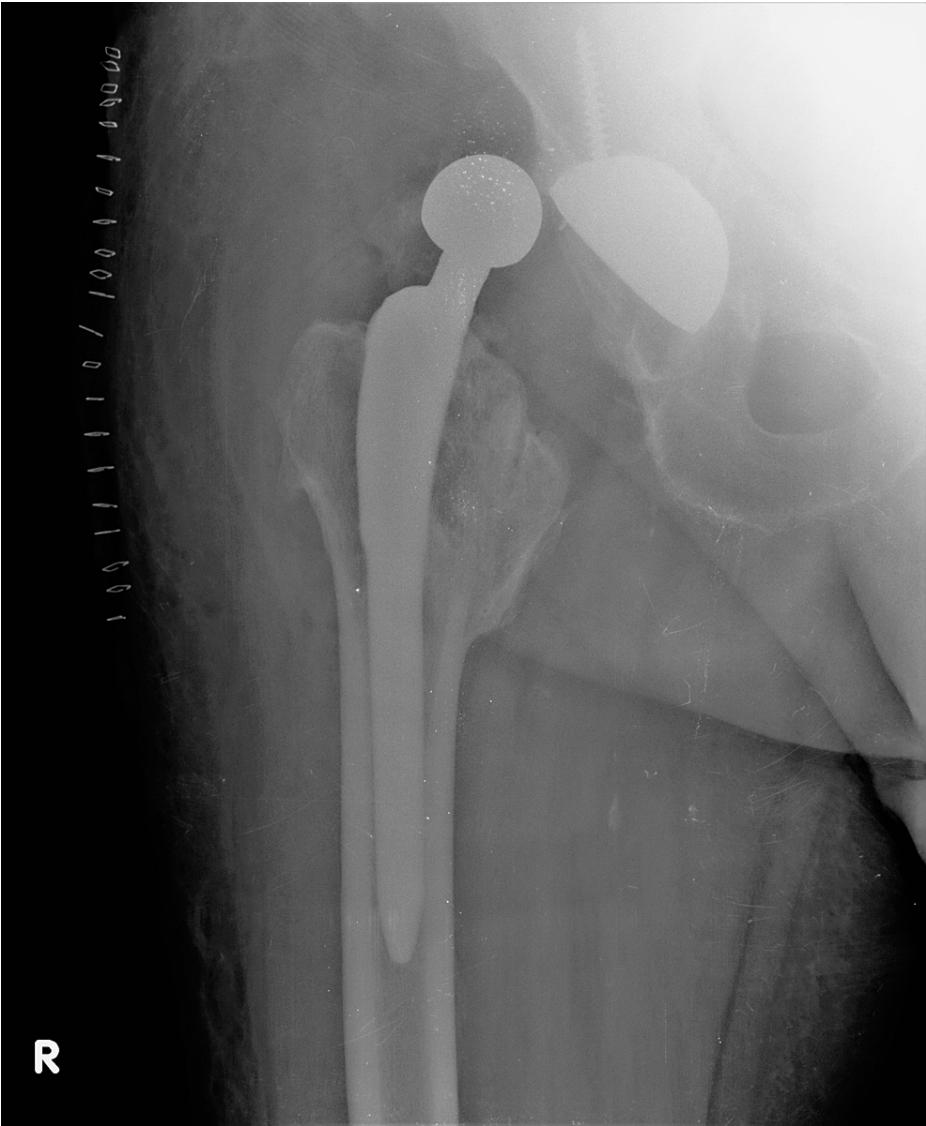
**FIGURE 5: Immediate postoperative dislocation following first revision**

and variation as possible (actual offset increased approximately 4,5mm) (Figure 4). Following a difficult reduction, the hip felt stable through a full range of movements. Unfortunately, on the third postoperative day, the hip dislocated anteriorly while the patient tried to turn in bed (Figure 5). There was a strong suspicion of a new liner dislodgement due to a clanking noise during reduction.

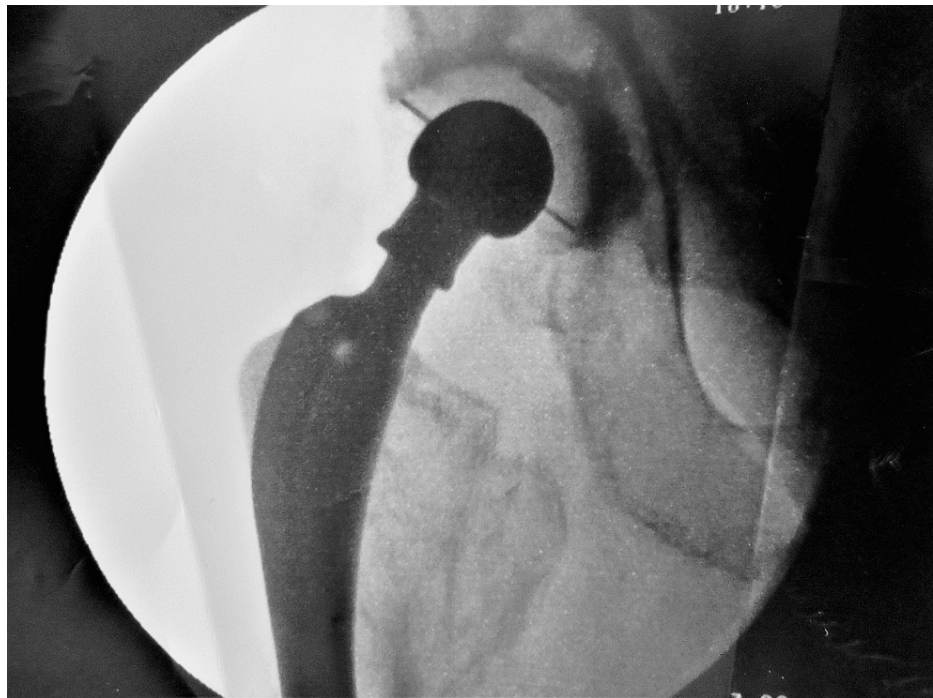
**FIGURE 9: Successful closed reduction**

Following four weeks of rehabilitation, the patient was able to walk and manage stairs without discomfort or signs of instability. At five weeks, he suffered an anterior subluxation in bed at home, that was reduced with gentle internal rotation of the leg. He was taken to the operating theatre, where under fluoroscopy, the hip was taken through a full range of movements, with levering in a figure-of-four position, but it proved impossible to dislocate. The following day, while attempting to stand up from a sitting position, he sustained an anterior dislocation (Figure 8). This was reduced under sedation and a new attempt to dislocate the hip even in a forced figure-of-four position proved unsuccessful (Figures 9-10). After careful evaluation, with a new CT scan, of the altered hip mechanics due to the previous fracture, the iliopsoas tendon was deemed to be the culprit and it was severed through a small incision. At five years of follow-up, no more dislocations have occurred.

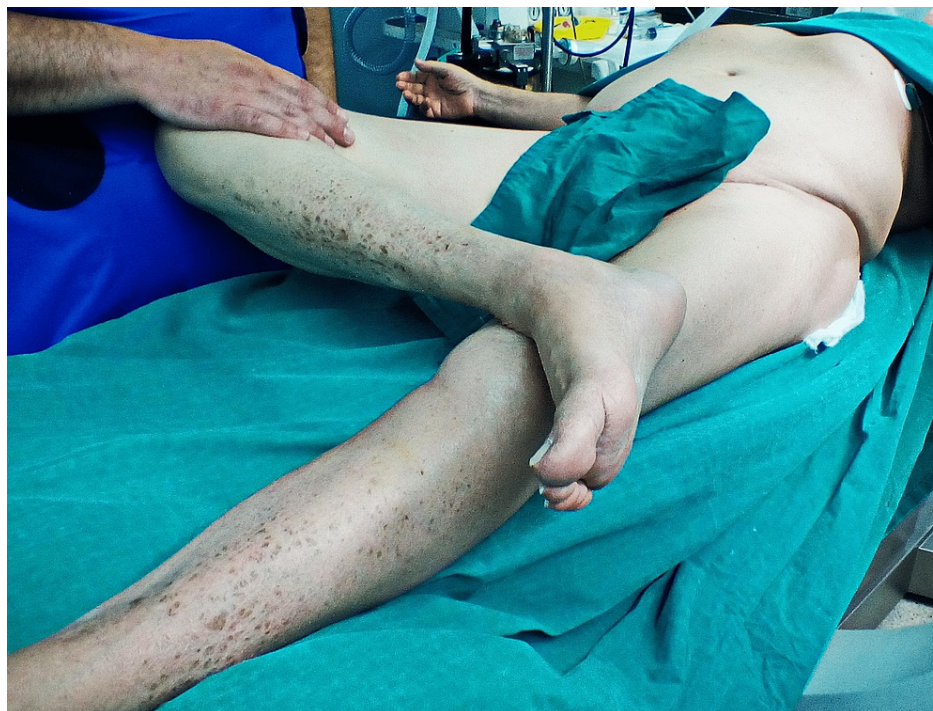
**FIGURE 10: Unsuccessful attempt to re-dislocate in a figure-of-four position**
