Endovascular Retrieval of a Fractured Tunneled Hemodialysis Central Venous Catheter Using the Loop Snare Technique

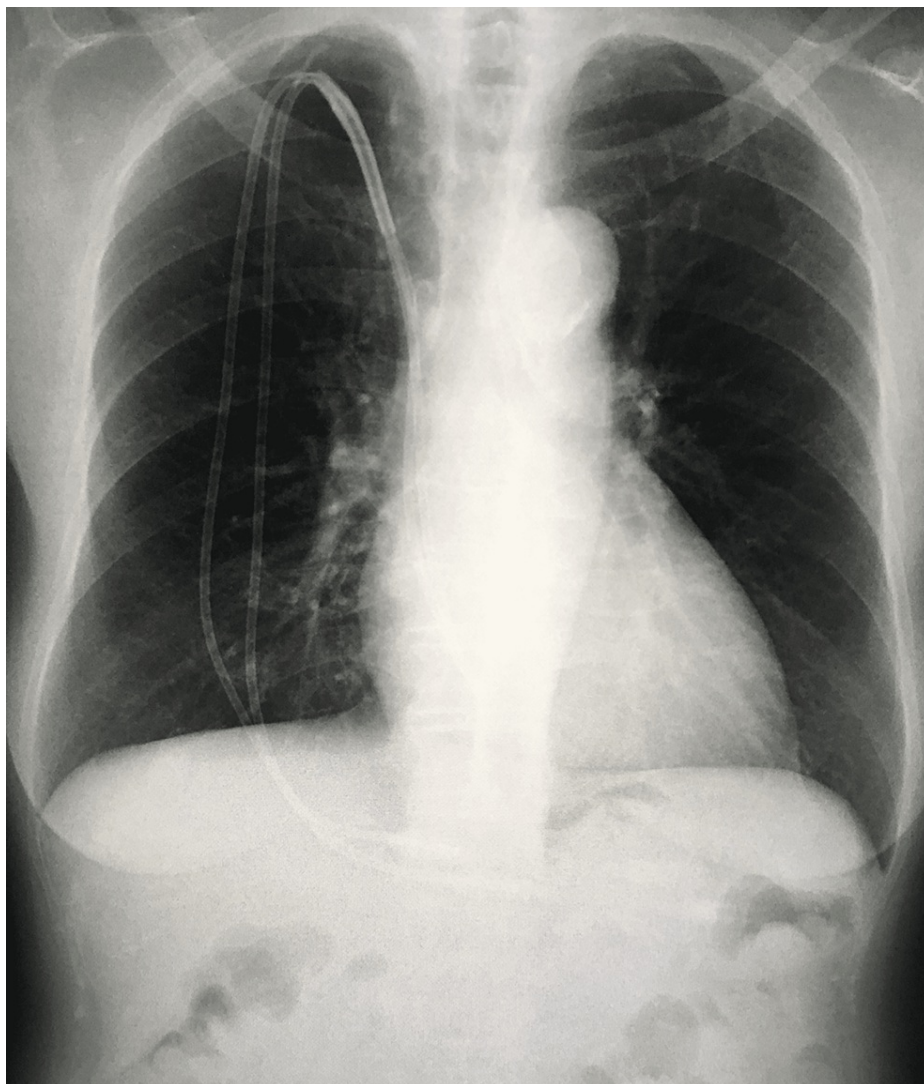
FIGURE 1: Chest radiograph showing the tunneled cuffed hemodialysis catheter inserted into the right subclavian vein.

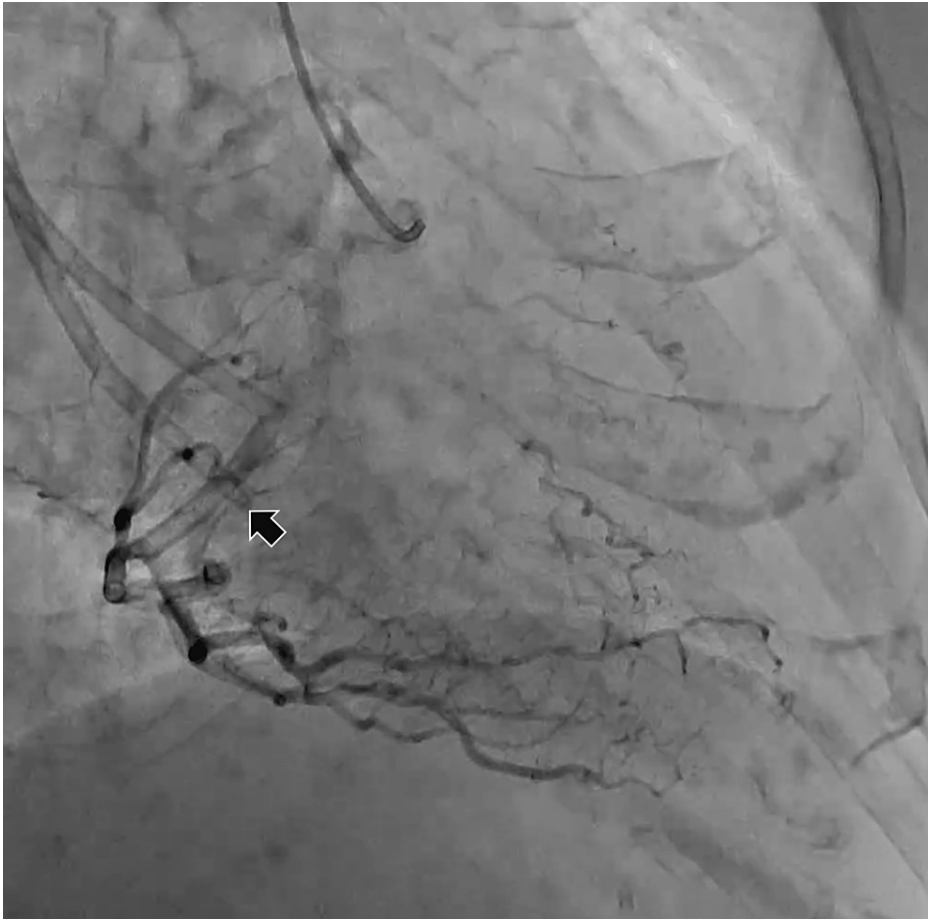
FIGURE 2: Coronary angiography showing the distal-end fracture of the hemodialysis central venous catheter (arrow).

As the field of endovascular intervention has made remarkable progress, inserting medical devices into patients is considered a common and safe practice. However, there is always a risk of device fracture and displacement in the body. The causes of intravascular fragment fracture include inappropriate techniques and procedures, device problems, and patient-related factors [4]. In a series of 215 cases of venous catheter embolization, pinch-off syndrome, a spontaneous catheter fracture due to the compression between the first rib and the subclavian, occurred in 40.9% of all cases, and the mechanisms were as follows: catheter damage during insertion, catheter disconnection, and proximal or distal catheter fracture [5]. In the present case, the distal portion of the catheter was almost torn off. The catheter was deeply positioned in the right subclavian vein; therefore, its distal part was possibly touching the tricuspid valve in the RA. The physical impact of valve movement was considered to have caused the catheter fracture.

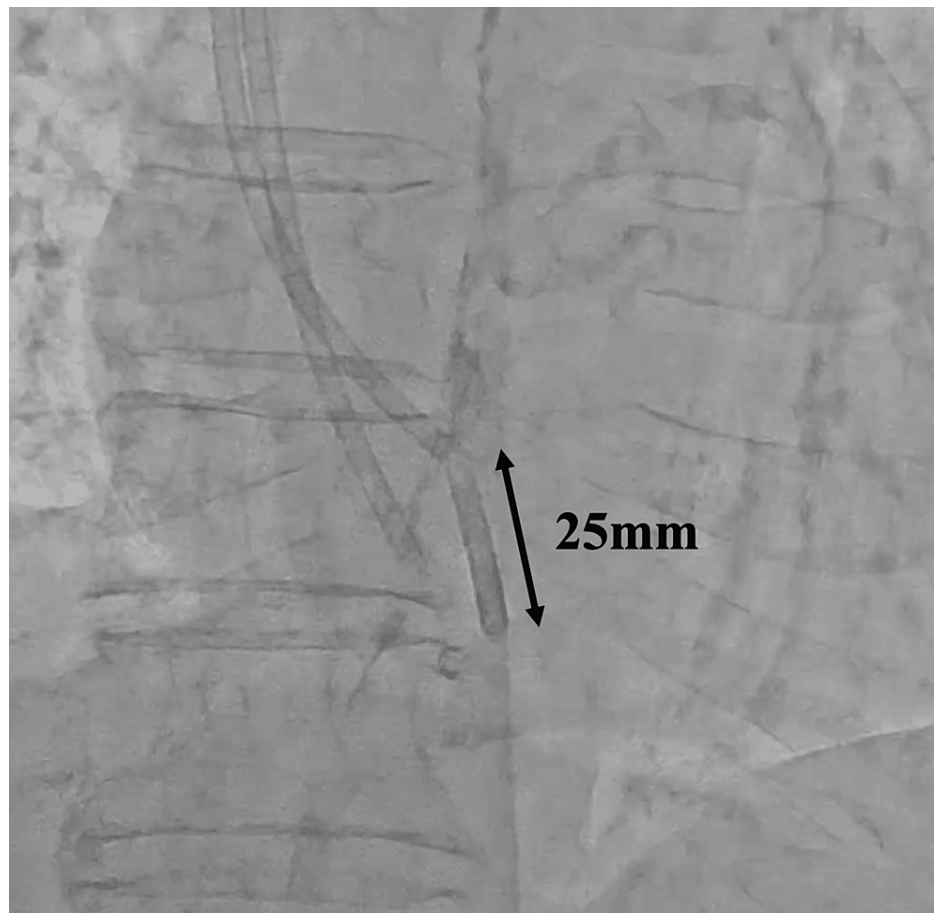
FIGURE 3: The fragmented central venous catheter (25 mm in length) in the right atrium.

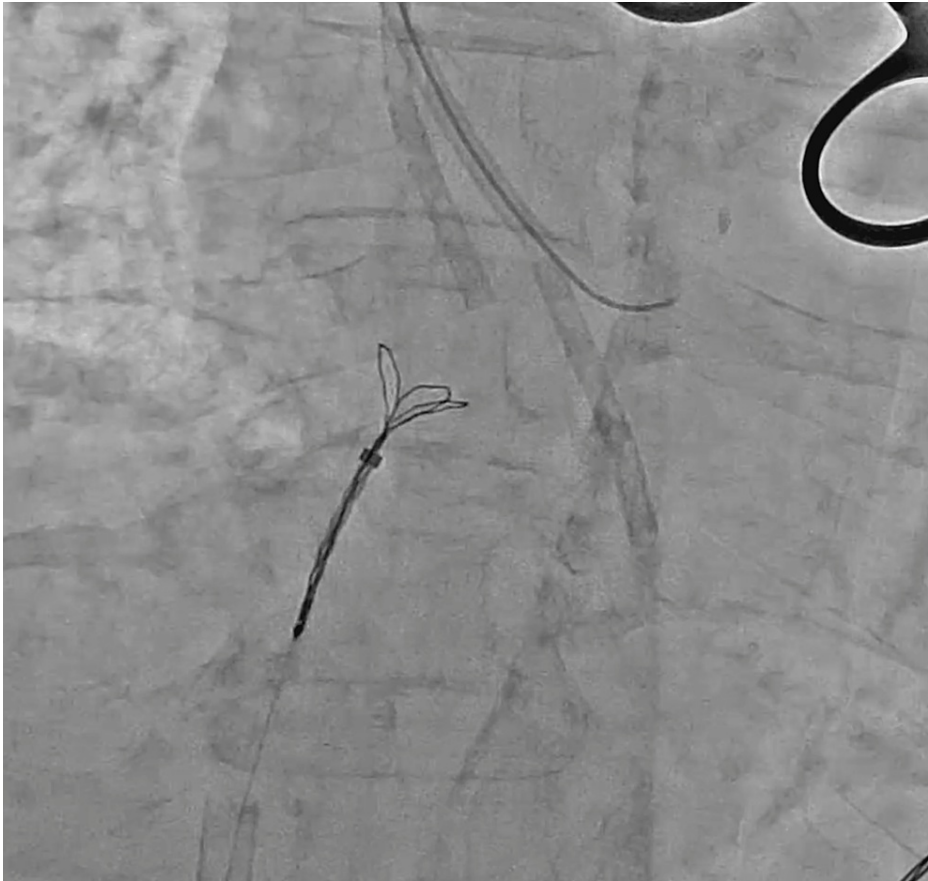
FIGURE 4: Advancing the 0.035-inch wire into the fractured part of the central venous catheter to be caught by the triple-loop snare.

To retrieve the broken central venous catheter, the endovascular approach was used. For access, the right femoral vein was punctured, and a 14-Fr sheath was placed in the inferior vena cava. An EN Snare® Endovascular Snare System (Merit Medical Systems, Inc., Utah, United States) was advanced into the RA. A 0.035-inch, 150-cm wire (Terumo Corporation, Tokyo, Japan) was introduced through the lumen of the tunneled catheter, and an attempt was made to advance the wire into the fractured part of the catheter antegradely (Figure 4). However, this procedure caused the complete fragmentation of the fractured segment, which was luckily blocked by the tricuspid valve and remained in the RA, avoiding a pulmonary embolism (Figure 5). An 8-Fr 4.0 Judkins left (JL) guiding catheter (Asahi Intecc Co., Ltd, Aichi, Japan) was inserted to help reposition the fractured catheter (Figure 6), and the snare was loaded into the JL guiding catheter. Using the snare, the fractured segment was captured and safely withdrawn into the 14-Fr sheath (Figures 7-8). Despite the success of the dislodged catheter retrieval process, it was easily recognized that the distal part of the other lumen was also almost fragmented. The 0.035-inch wire was readvanced into the lumen of the venous catheter antegradely and captured by the snare to perform externalization (Figure 9). The fractured catheter was not pulled back into the 14-Fr sheath, and the hemodialysis central venous catheter was carefully removed from the right subclavian vein (Figure 10). The entire procedure of retrieving the fragmented catheter is shown in Video 1.

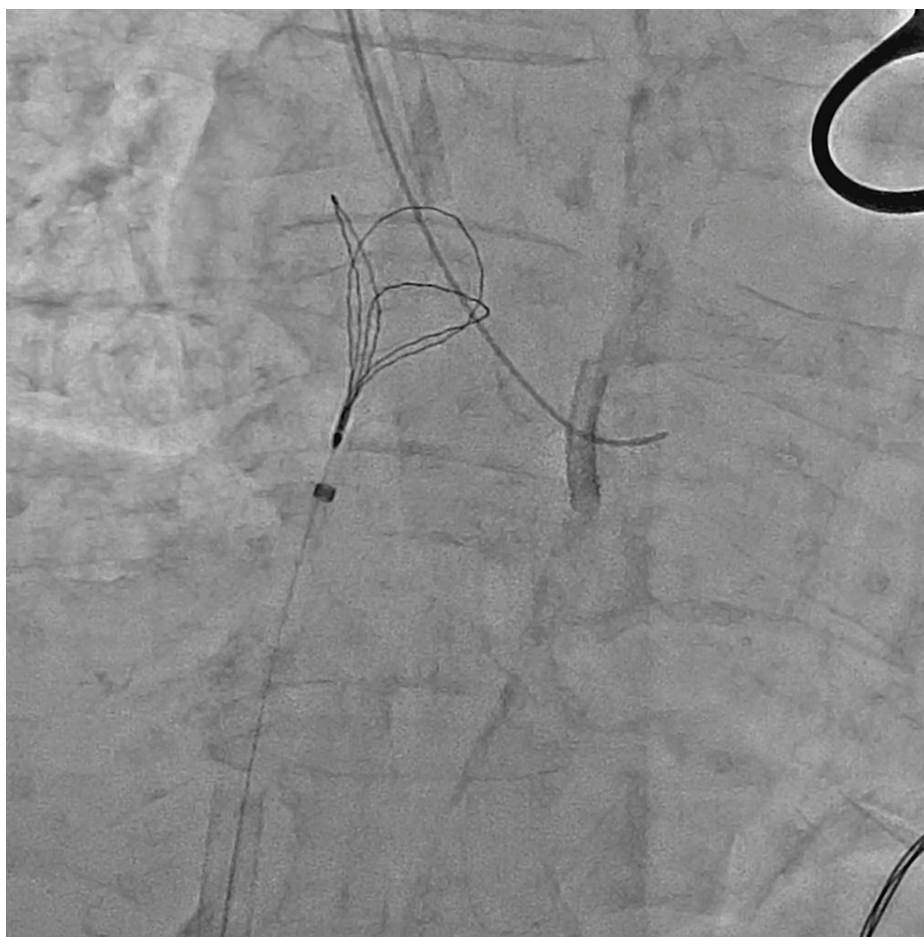
FIGURE 5: The dislodged distal portion of the central venous catheter blocked by the tricuspid valve.

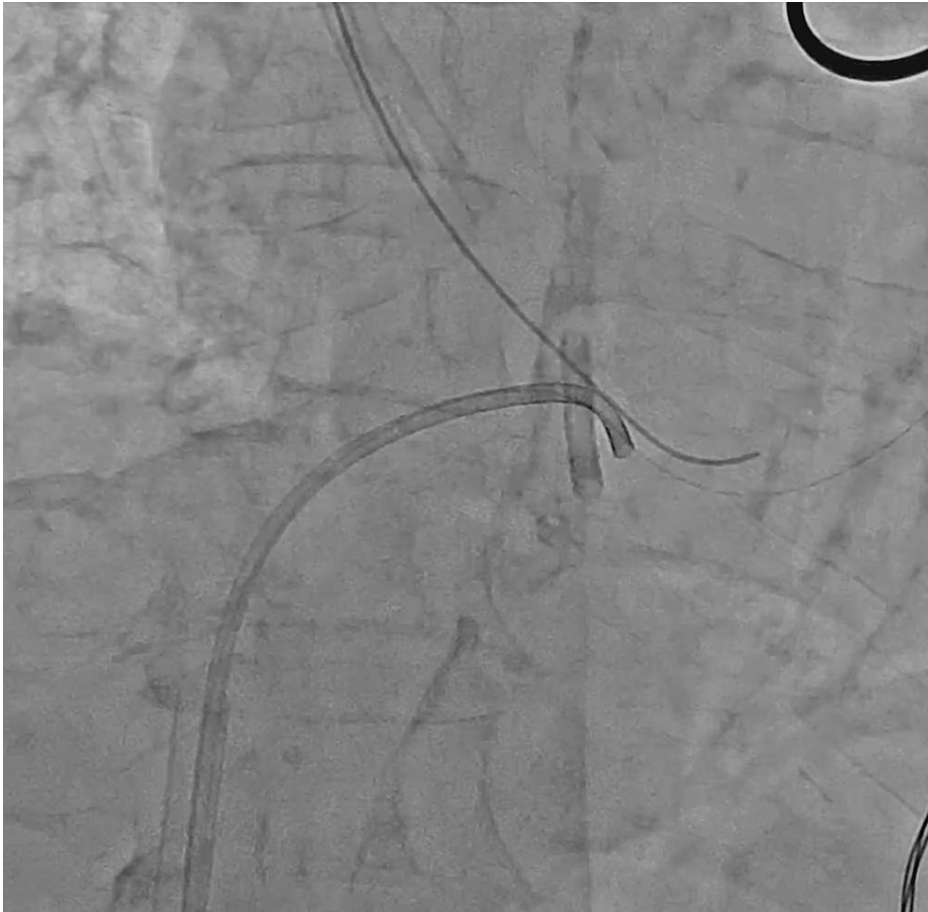
FIGURE 6: Using the 8-Fr Judkins left catheter to reposition the fractured segment of the central venous catheter.

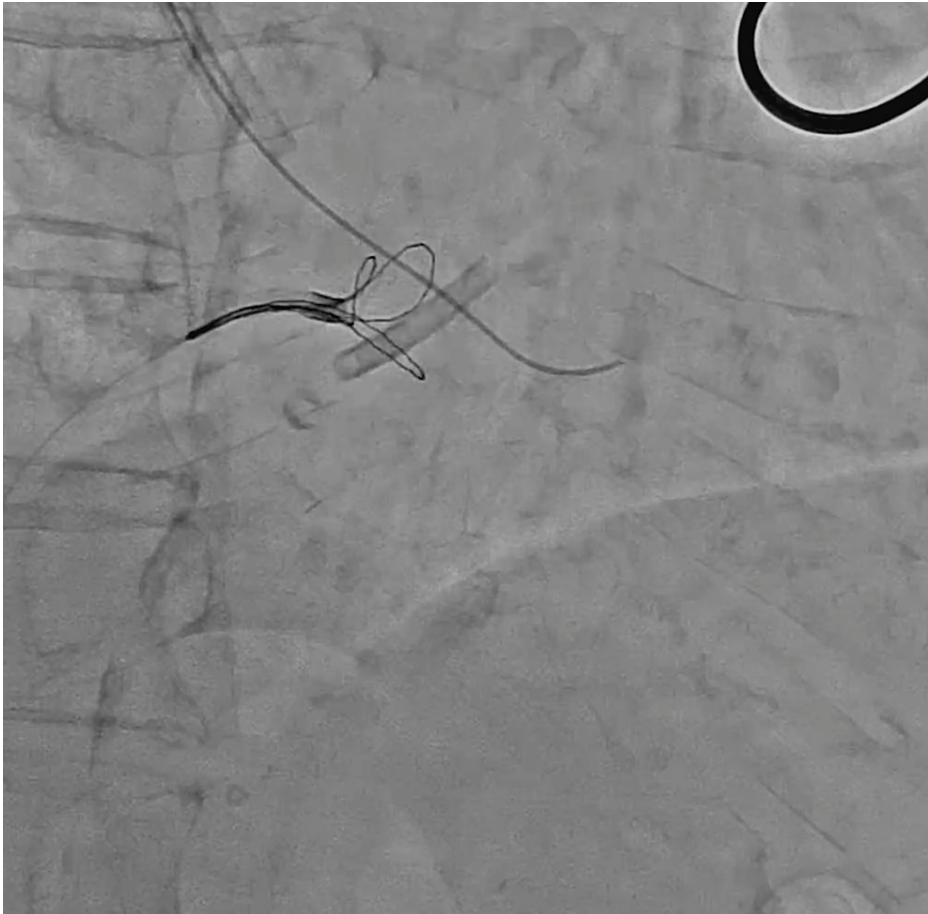
FIGURE 7: The triple-loop snare forming a loop over the dislodged central venous catheter.

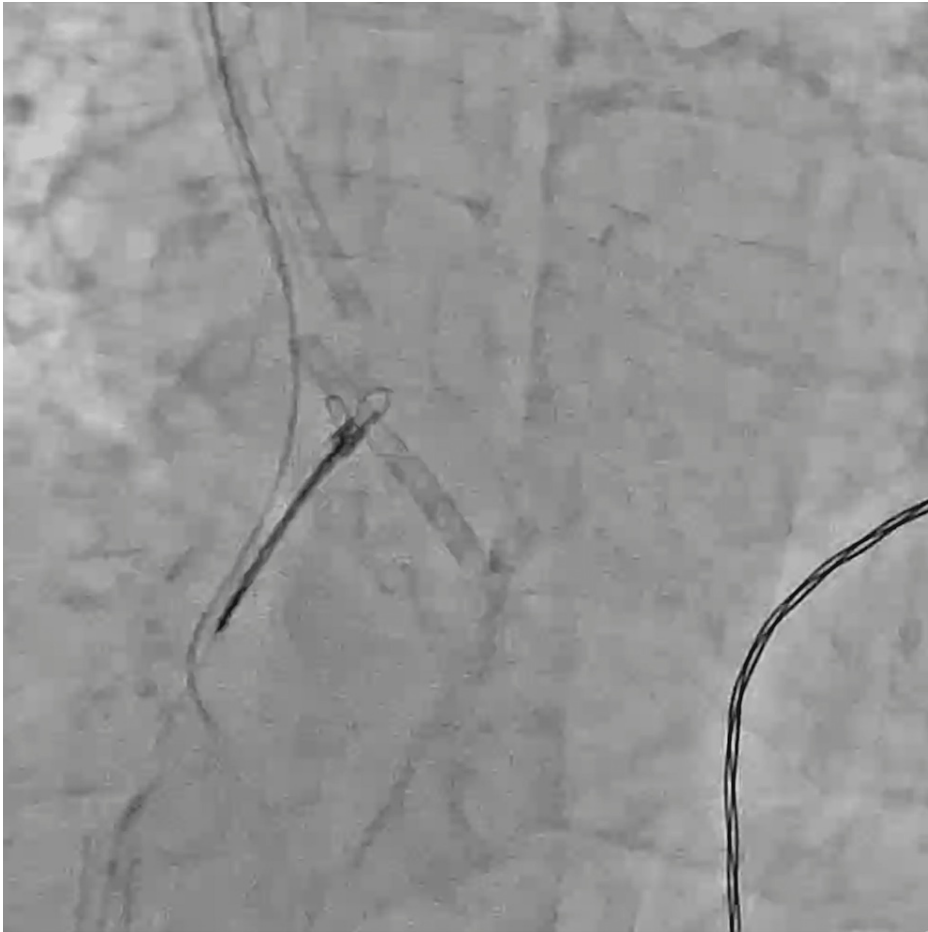
FIGURE 8: The triple-loop snare catching the fractured catheter and being pulled back into the 14-Fr sheath.

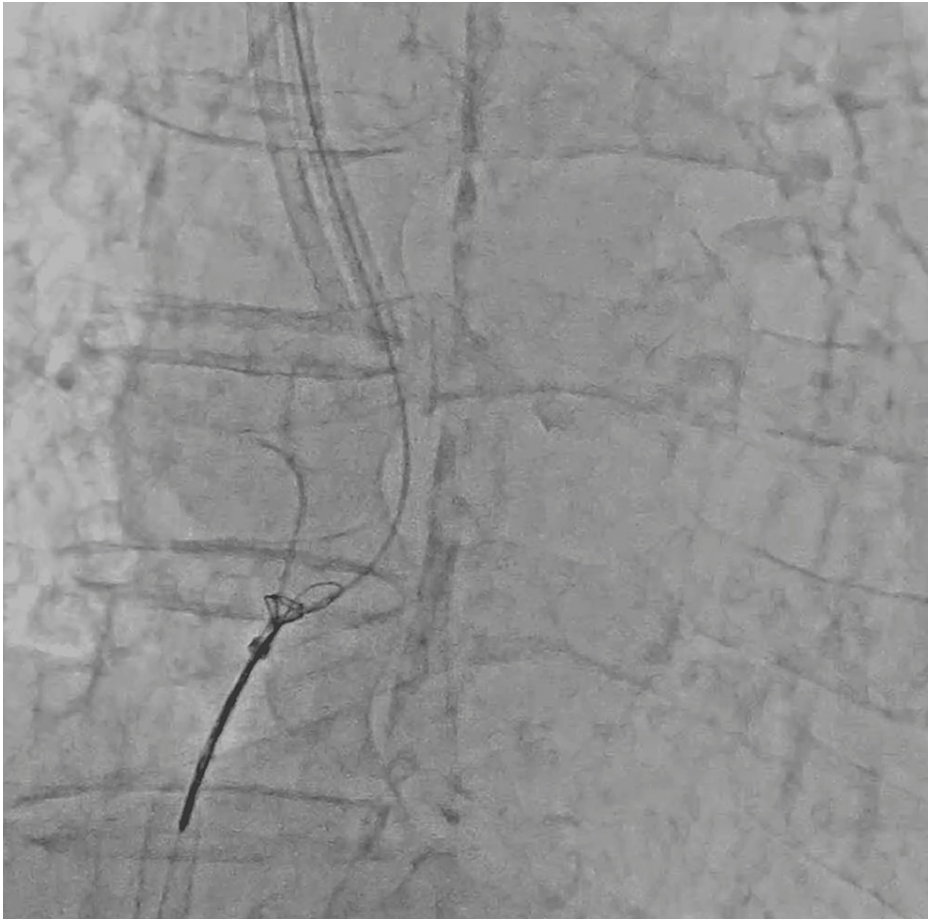
FIGURE 9: The triple-loop snare grasping the 0.035-inch wire, which was introduced into the other lumen of the catheter.

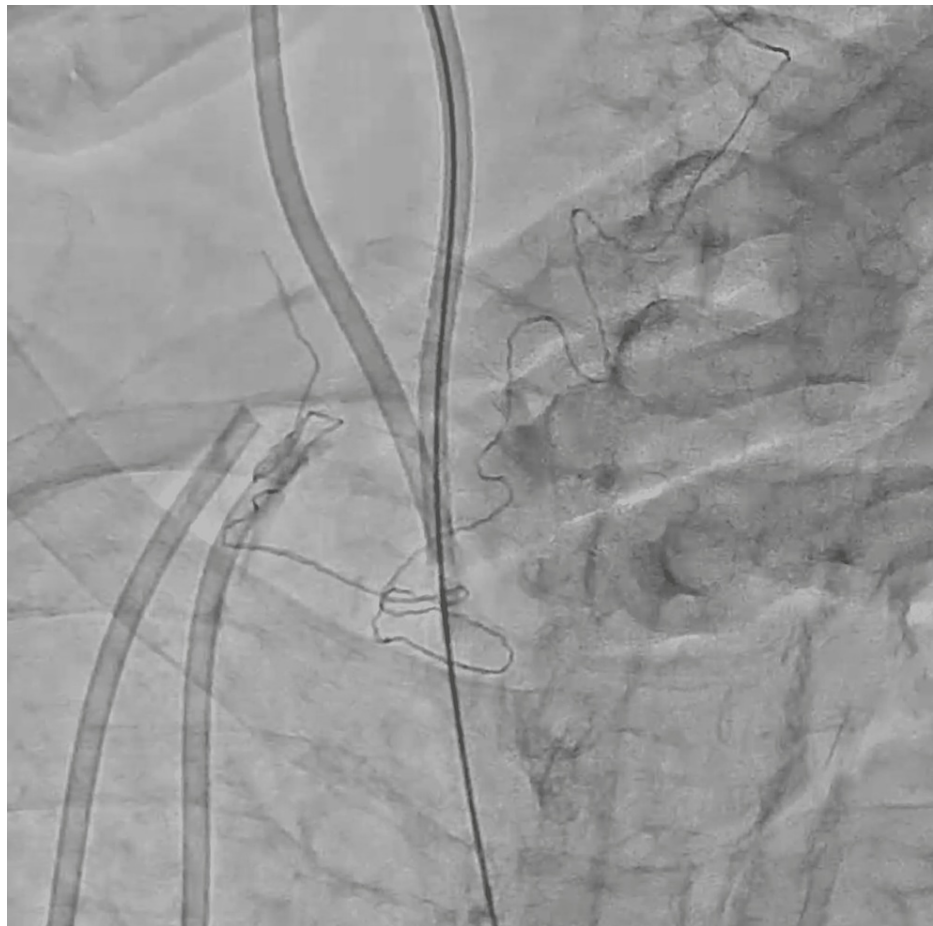
FIGURE 10: Retrieval of the whole central venous catheter from the right subclavian vein.
