# Bilateral Patellar Tendon Rupture Following Total Knee Arthroplasty in a Patient With Alkaptonuria: A Case Report

Johnlevi S. Lazaro <sup>1</sup>, Rex Lutz <sup>1</sup>, Gregory K. Deirmengian <sup>2</sup>

1. Orthopedic Surgery, Jefferson Health New Jersey, Stratford, USA 2. Orthopaedic Surgery, Rothman Orthopaedic Institute, Philadelphia, USA

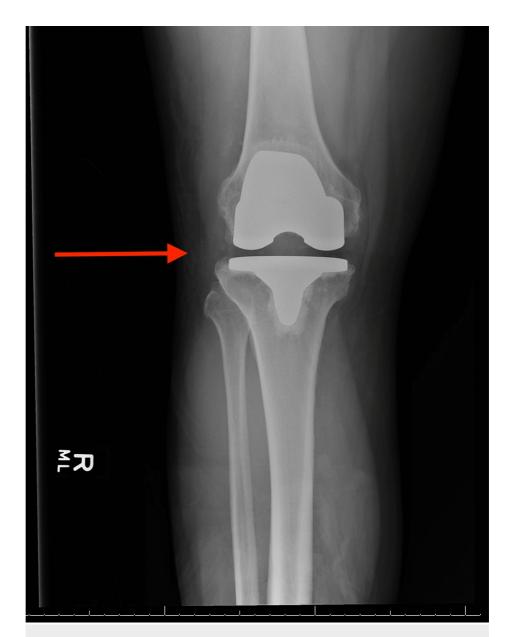
FIGURE 1: AP radiograph of the right knee

Red arrow pointing to stable femoral and tibial components, no radiographic evidence of periprosthetic fracture

A 46-year-old male with a medical history of AKU and a surgical history of bilateral TKAs seven years prior to presentation, bilateral Achilles tendon rupture repair, and a quadriceps tendon repair was chasing a bat in his home when he felt a pop in both knees and fell to the ground. The patient was unable to get up following the injury. Radiographs were performed showing findings suggestive of patellar tendon injury (Figures 1-4).

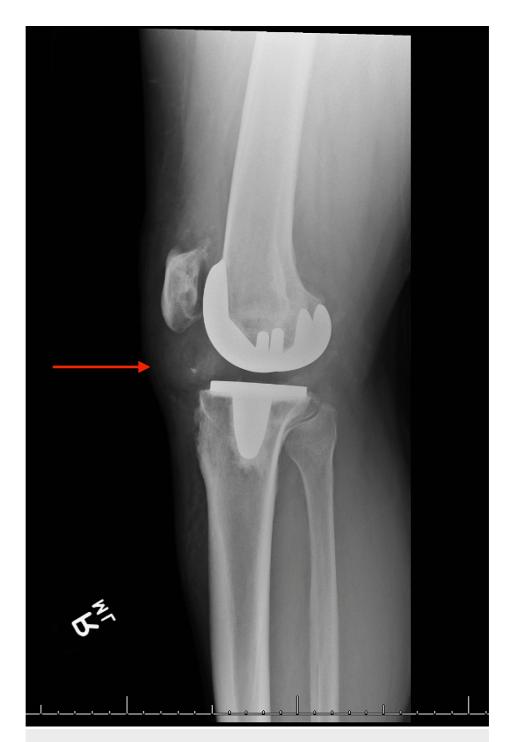
FIGURE 2: Lateral radiograph of the right knee

Red arrow pointing to stable femoral and tibial components, showing a patella alta and an apparent avulsion about the tibial tubercle

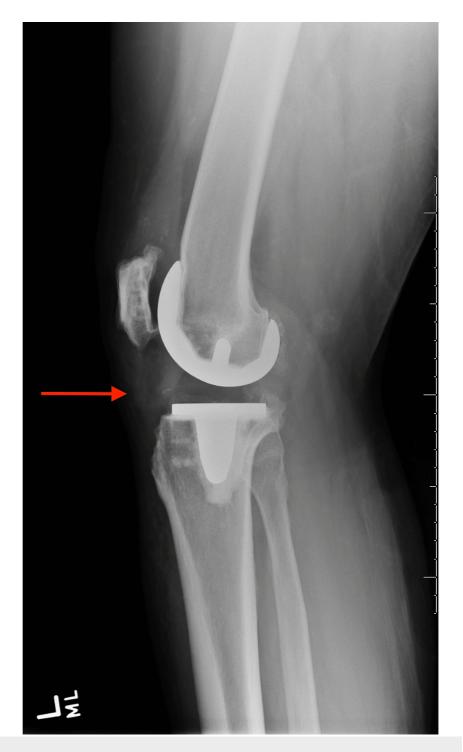
FIGURE 4: Lateral radiograph of the left knee

Red arrow pointing to stable femoral and tibial components, with a patella alta

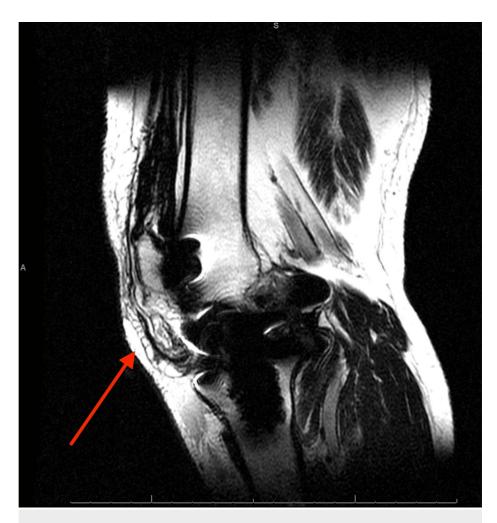
FIGURE 5: Sagittal magnetic resonance imaging of the right knee

Red arrow pointing to patellar tendon rupture

MRI imaging was performed which showed bilateral patellar tendon rupture (Figures 5, 6).

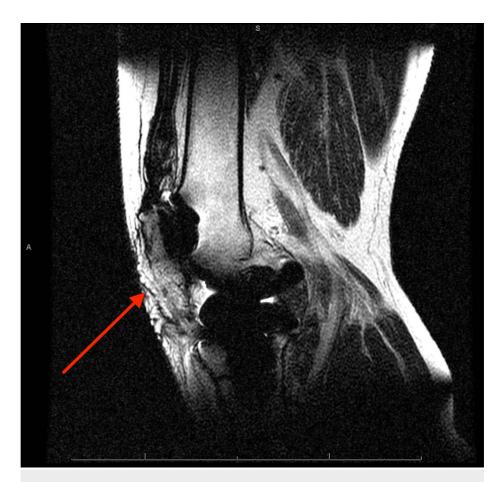
FIGURE 6: Sagittal magnetic resonance imaging of the left knee

Red arrow pointing to patellar tendon rupture

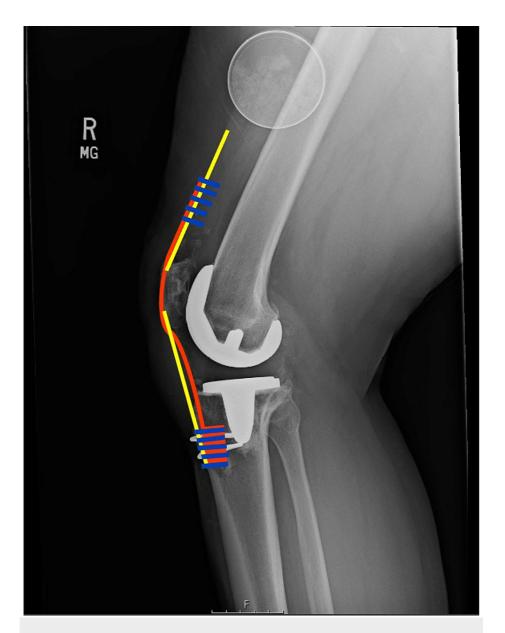
FIGURE 7: A representation of the repair projected from a lateral view

Yellow represents the quadriceps and patellar tendon. Blue represents suture. Orange represents allograft

At this point in time, attention was turned to the patient's native patellar tendon which was ruptured. A small hole was placed at the level of the bottom of the patella through its tendon. At this point in time, two Krackow sutures were used creating four limbs of the sutures below the tendon which was secured. These four limbs were passed through drill holes and into the patient's remaining patellar tendon at the level of the tubercle [18]. These were tied giving a repair of the patient's native tendon. Prior to tightening the sutures down, two Krackow stitches were placed within the tendon of the allograft using heavy non-absorbable sutures. These were passed from an under to over position through the hole that was made at the level of the patient's patella. The tendon was then laid over the patient's patella and quadriceps tendon. The sutures of the native tendon were tied down in full extension of the knee. The Achilles allograft tendon was then secured to the patient's peripatellar tissue and quadriceps tendon with sutures. Sutures were used to secure this.

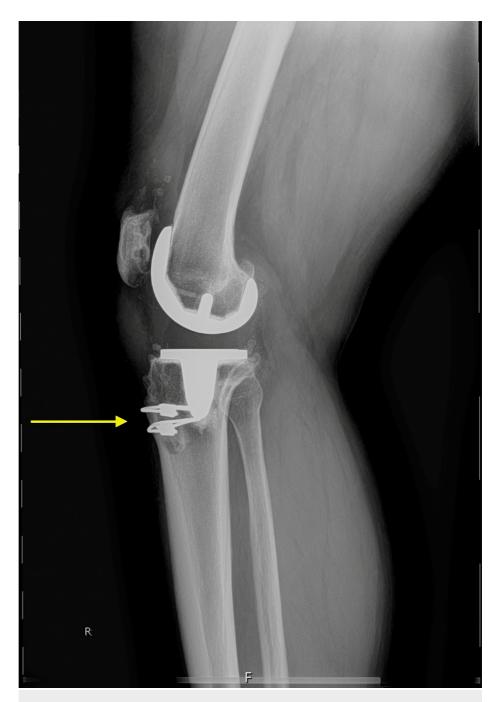
FIGURE 9: Post-operative lateral radiograph of the right knee

Yellow arrow pointing to cerclage wires securing bone plugs to the tibia

The identical extensor tendon mechanism reconstruction procedure performed for the right knee was performed on the left knee in order to repair the patient's native tendon and reconstruct it with allograft. Of note, in closing the surrounding parapatellar tissues at the end of the case, it became evident due to the patient's severe nature of the left knee that a closure was tenuous at the area of the medial release due to poor tissue quality. To that end, the remnant of the allograft tendon that was cut was used as a patch over this area and secured with sutures. Hinged knee braces were then applied bilaterally (Figures *8-10*).
