Restorative Rehabilitation of a Patient With Tooth Wear: A One-Year Clinical Follow-Up Report

This case report discusses the comprehensive rehabilitation of a patient diagnosed with tooth wear, including dental erosion and generalised attrition. The treatment aimed at restoring the anterior guidance, improving the aesthetics and establishing a stable occlusion for the patient with minimal intervention.

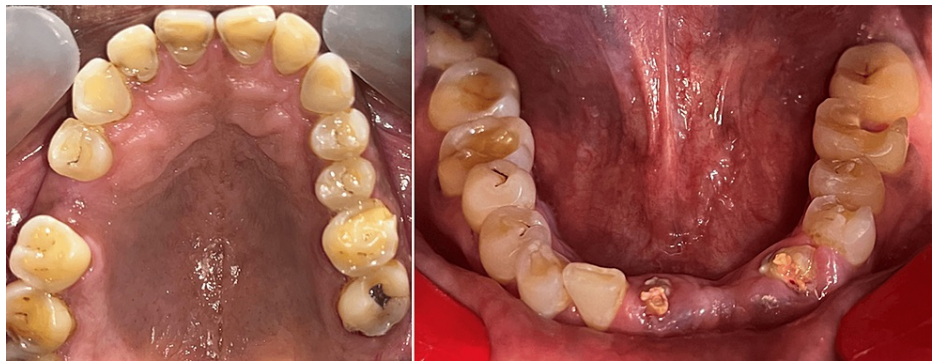
The patient presented with a medical history of gastroesophageal reflux disease and was on medication for the condition. The examination of the temporomandibular joint presented with no clicking or deviation. The intraoral clinical examination revealed a missing right upper first molar and left lower central and lateral incisors and a dislodged fixed partial denture with extensively damaged lower front teeth (Figure 1).

FIGURE 1: Preoperative view of the maxillary and mandibular arch

The clinical examination of teeth from right to left maxillary canines, revealed extensive erosive damage on the palatal aspect with exposed dentin and short nonaesthetic crowns. The tooth wear lesions exhibited an intact enamel surface along the palatal gingival margin. They were classified as Class III based on the anterior clinical erosive (ACE) classification [7]. The maxillary and mandibular posterior teeth presented a flattened cusp morphology, glossy occlusal surfaces and abrasive defects. There was also a lack of anterior guidance and signs of functional occlusal interferences.

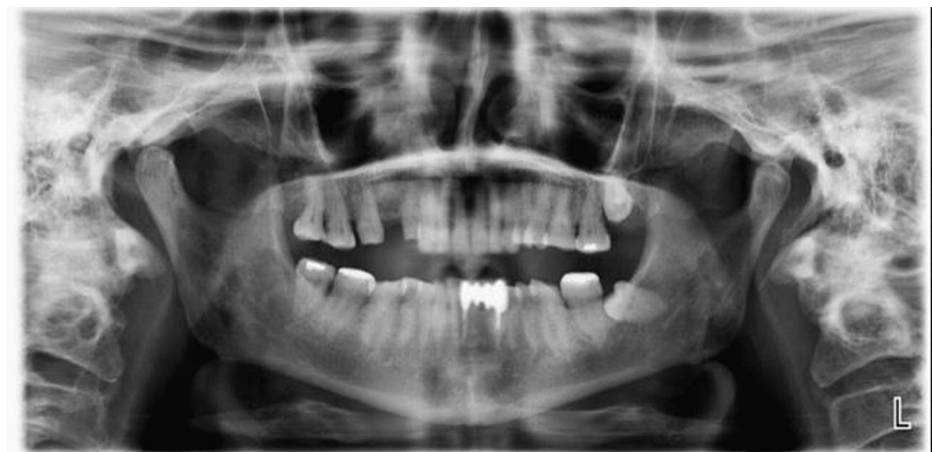
The extensively damaged left mandibular canine and right central incisor required root canal therapy and a cast post to retain the cores. A cast post was planned due to an oval root canal teeth anatomy. The left mandibular first molar tooth presented a fractured distobuccal cusp, with normal lamina dura and no pulpal involvement.

FIGURE 2: OPG image after completion of post and core

Orthopantomography (OPG) image showing the preoperative status of tooth wear.

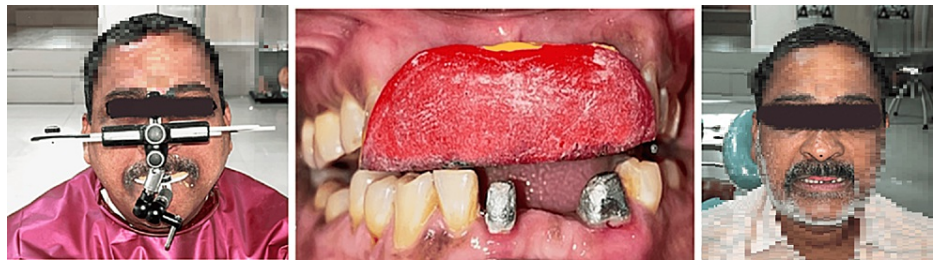
On a subsequent appointment, after the completion of the root canal treatment, post and core, diagnostic casts were mounted on a semi-adjustable articulator (A7 Plus, Bio-Art, Confident Pvt Ltd, India) using facebow (Elite BioArt, Confident Pvt Ltd, India) orientation, and interocclusal records were obtained and an orthopantomograph was taken (Figure 2). The centric and dynamic occlusal contacts were assessed via diagnostic mounting on the articulator (Figure 3).

FIGURE 3: Interocclusal records obtained using facebow

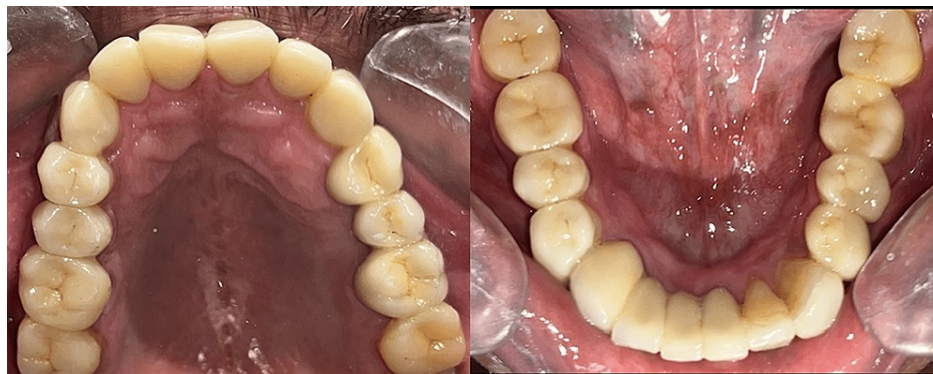
FIGURE 6: Postoperative View with the Maxillary and Mandibular Prosthesis

A porcelain-fused-to-metal fixed partial denture was placed for the following maxillary teeth. The right first molar with the right maxillary second premolar and right second molar as abutments. The right maxillary first and second premolar, the right mandibular first and second premolar and the left maxillary first molar were rehabilitated using lithium disilicate veneer overlays. This was followed by rehabilitating the left and right mandibular first molar with an overlay and a tabletop prosthesis, respectively.

Rehabilitation of the maxillary left and right second molar, and the right mandibular second molar was performed at the end of the treatment using lithium disilicate tabletop prosthesis. The final fixed partial dentures and bonded restorations were cemented using the standard veneer cementation protocol (Variolink Veneer, Ivoclar Vivadent) (Figure 6).

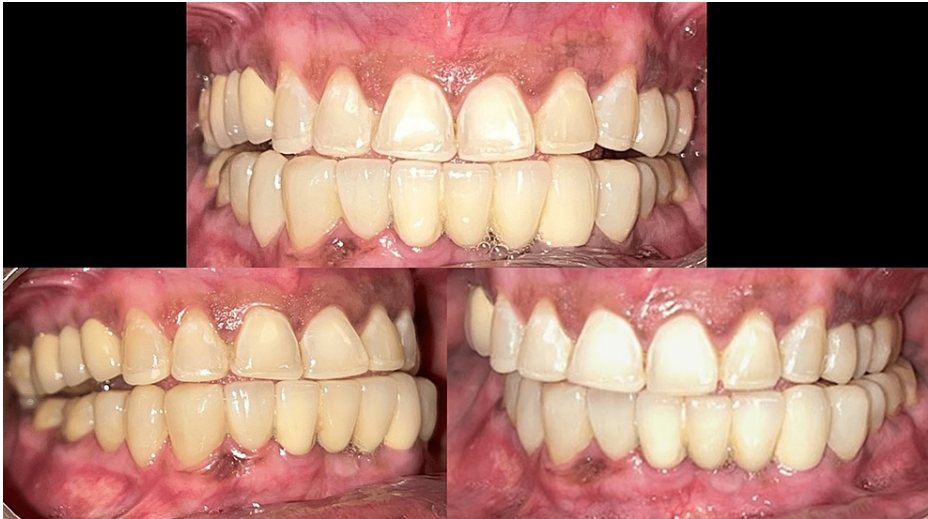
Occlusal adjustments were performed over two follow-up appointments with a one-week interval. The patient was counselled on oral hygiene practices and the dietary and lifestyle modifications necessary for maintaining the prosthesis. The patient was evaluated postoperatively every six months (Figure 7).

FIGURE 7: Clinical follow-up after six-months

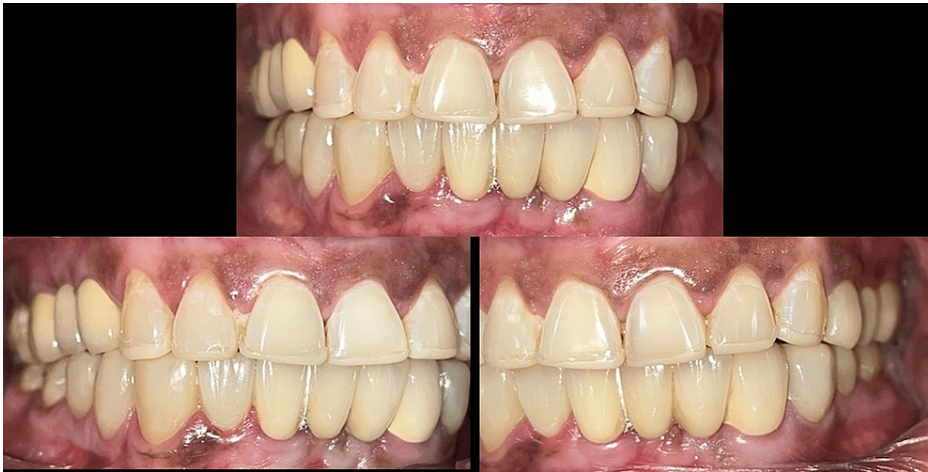
A one-year clinical and radiographic examination revealed good prosthesis adaptation; the patient was comfortable and content (Figures 8, 9).

FIGURE 8: One-year clinical follow-up

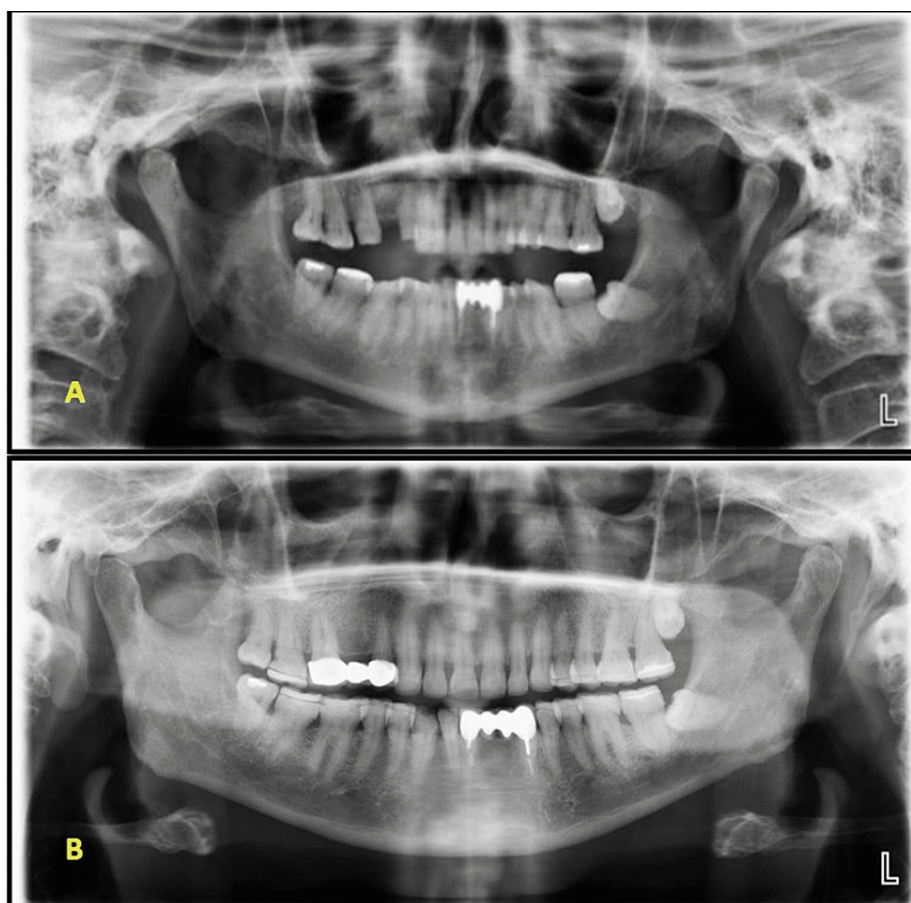
FIGURE 9: Preoperative and postoperative radiographs

A: preoperative radiograph, B: one-year postoperative radiograph
