# Milled Crown on Post Crack Tooth Syndrome as the Denture Abutment Tooth: A Case Report

This clinical case describes using a milled crown on a cracked tooth as the abutment for a removable partial denture. A 63-year-old male patient diagnosed with lipoma undergoing chemotherapy and radiotherapy presented with symptomatic crack tooth syndrome on tooth 36 and partial edentulism. Conservative treatment using a molar band to extracoronally splint the tooth was conducted to determine the prognosis of the crack line. A lower partial cobalt-chromium denture was constructed by incorporating the milled crown of tooth 36 as the abutment. After six months of follow-up, there were no crack tooth symptoms, and regular review was adopted to monitor the tooth. The construction of a milled crown of a cracked tooth presented good and promising clinical outcomes in preserving tooth vitality and preventing crack propagation in partially dentate dentition for the long term.

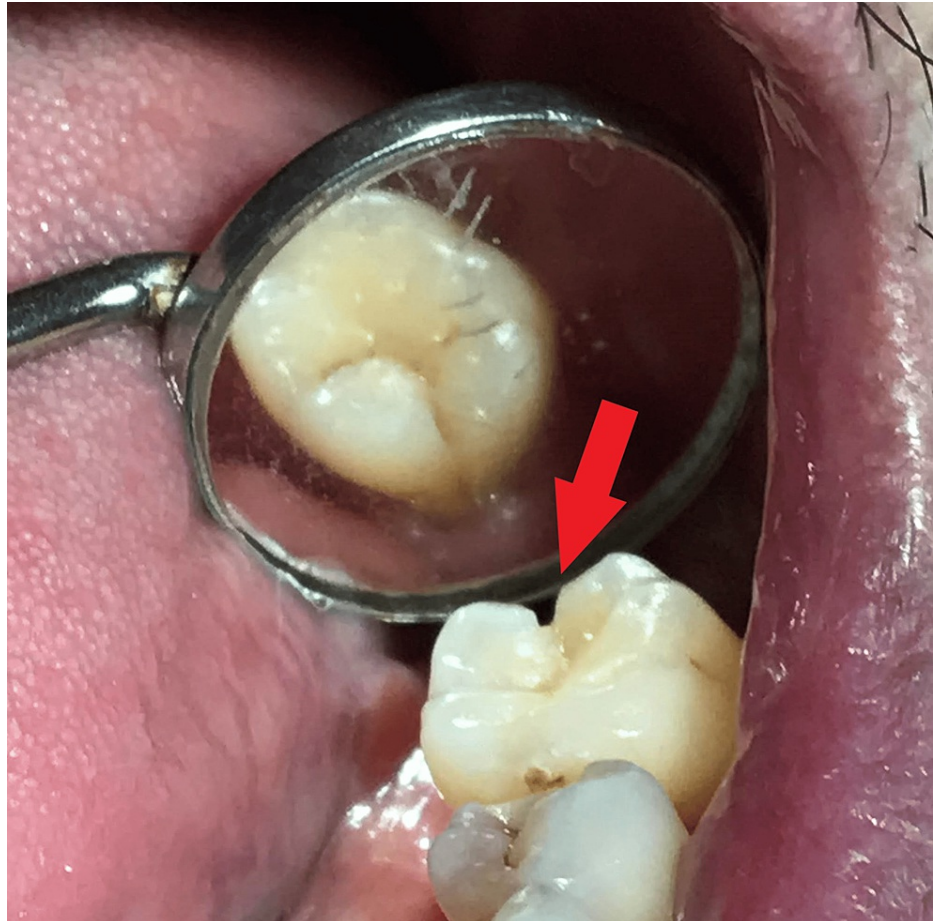
**FIGURE 1: Pre-treatment clinical photo prior to molar band placement showing extension crack line at distoocclusal area (red arrow).**

Upon clinical examination, tooth 36 presented with abrasion at the cervical area and a visible crack line from the distal marginal ridge to the equigingival level (Figure 1). The patient experienced slight discomfort at biting upon the bite test, and the tooth responded to the sensibility test. Radiographically, an intraoral periapical radiograph of tooth 36 was taken to assess the crack line and its periapical condition (Figure 2).

The patient was diagnosed with reversible pulpitis associated with CTS on tooth 36 as in Figures 1, 2, localised periodontitis stage III grade B without modifying risk factors, multiple carious teeth, and non-carious tooth surface loss due to his improper oral hygiene practice.

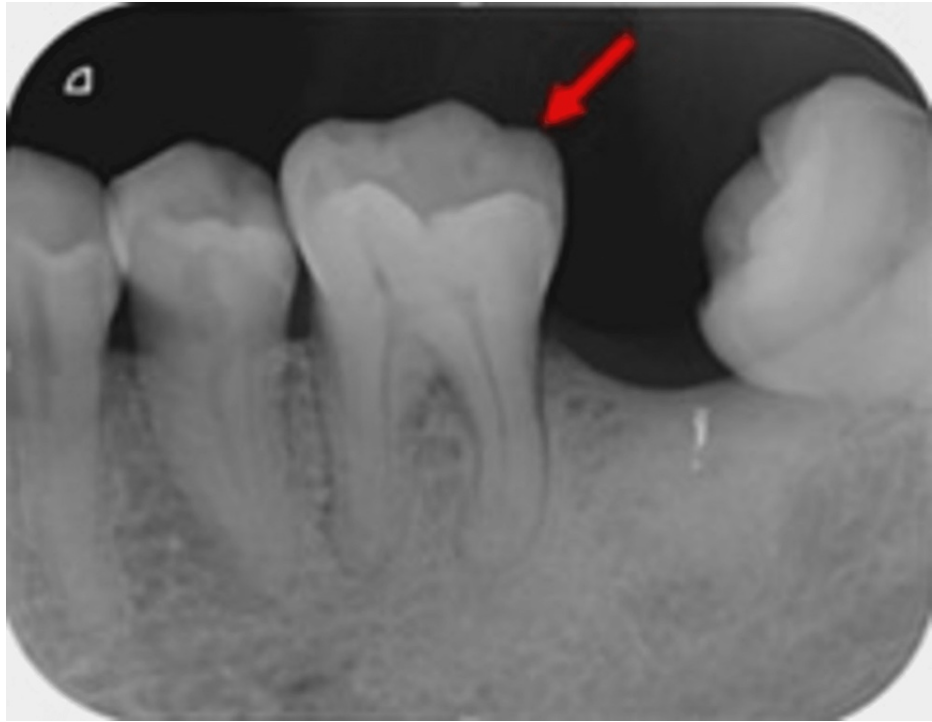
**FIGURE 2: Periapical radiograph showing widening of periodontal ligament of tooth 36 and crack line noticeable at distoocclusal area (red arrow).**

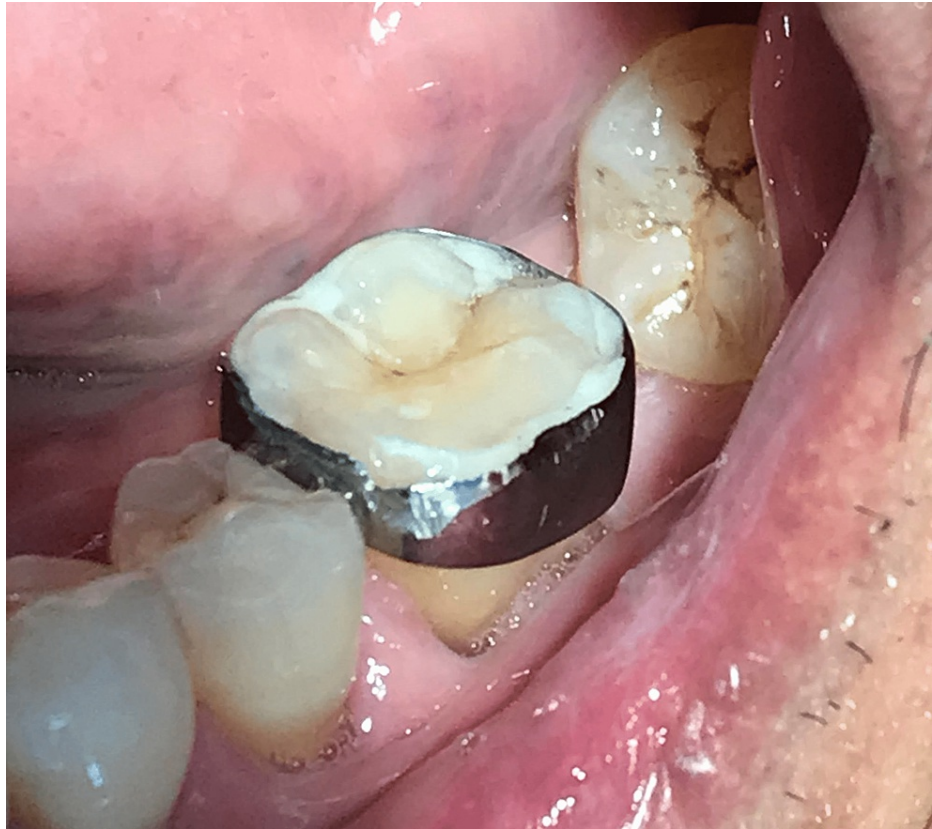
**FIGURE 3: Placement of molar band #LL29 on cracked tooth syndrome tooth 36.**

The first-line management was done with extracoronal splinting using a molar band placed on the tooth (Figure 3). Post-operative instructions were given, especially emphasising to avoid chewing hard food on that region. Apart from that, scaling, root surface debridement and restoration of multiple carious and tooth surface loss teeth were done. The construction of a full metal milled crown on the cracked tooth has also been incorporated with a lower partial denture to restore his dentition.

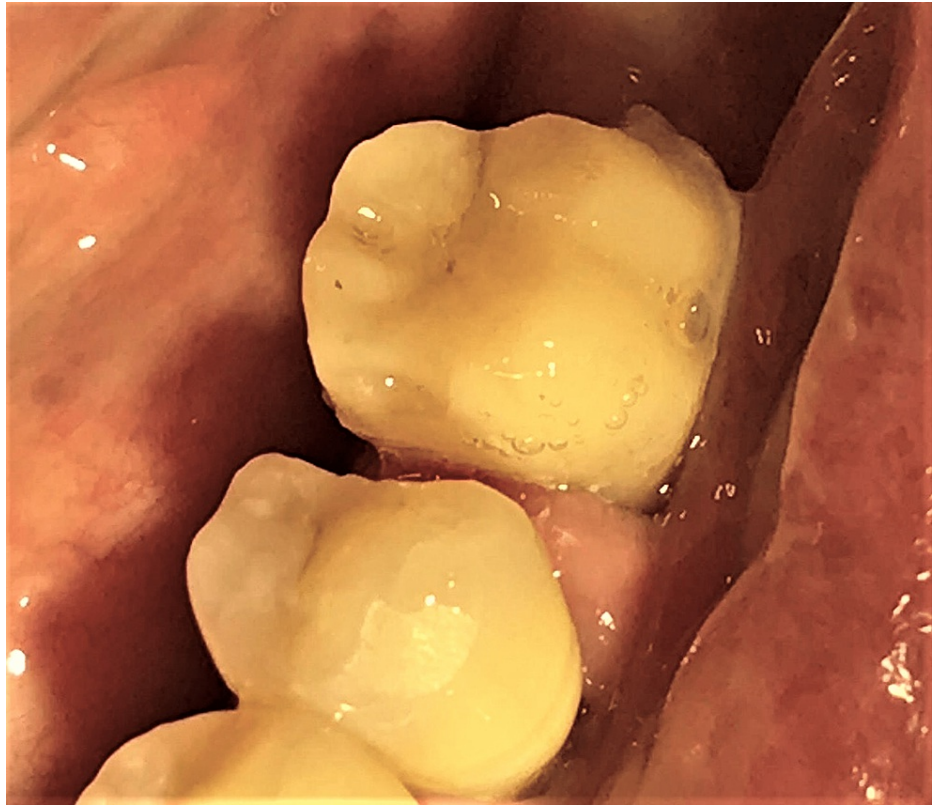
**FIGURE 4: Final tooth preparation of tooth 36.**

The tooth margin was prepared supragingivally on buccal and lingual surfaces, but the distal margin was prepared apically beyond the crack line to remove the visible crack line (Figure 4).

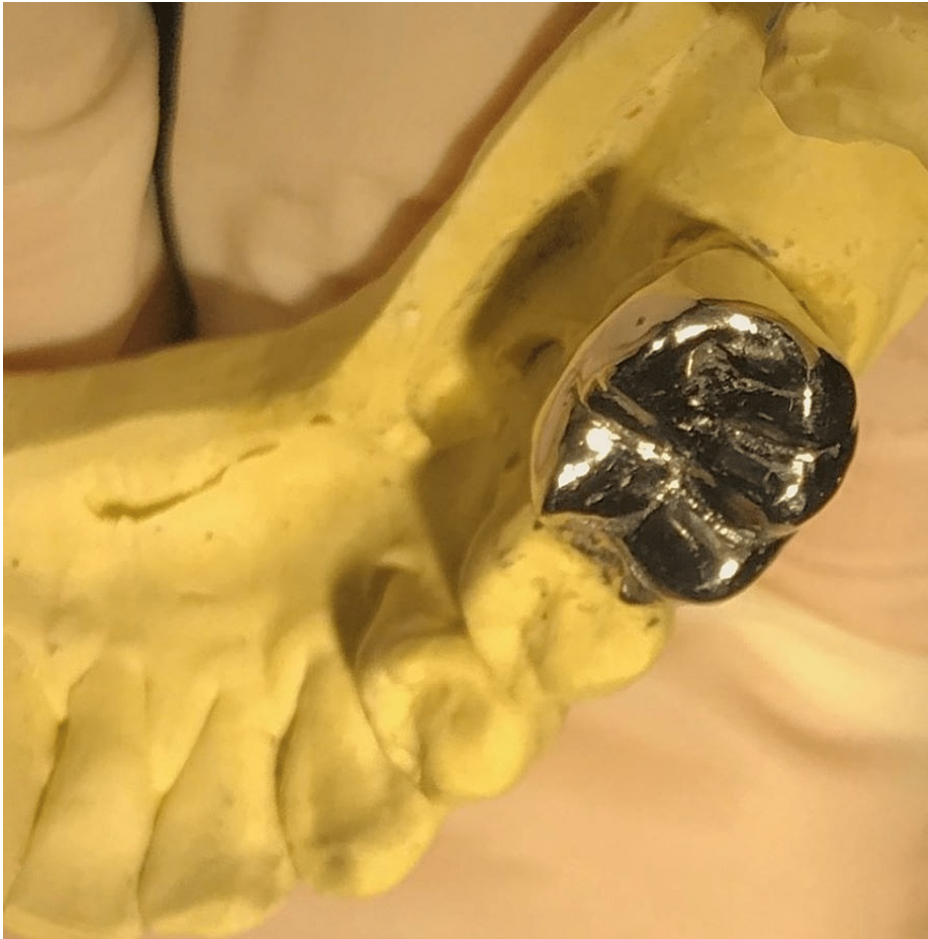
**FIGURE 5: Full metal crown on master cast.**

A temporary crown was placed on tooth 36 using bis-acryl composite for diagnostic purposes prior to the construction of the definitive crown. During the one-month follow-up visit, the patient claimed no symptoms arose from the tooth and temporary crown. Therefore, the final impression was taken using light and medium body polyvinyl siloxane material and sent to the lab to construct a full metal crown (Figures [5](#), [6](#)).

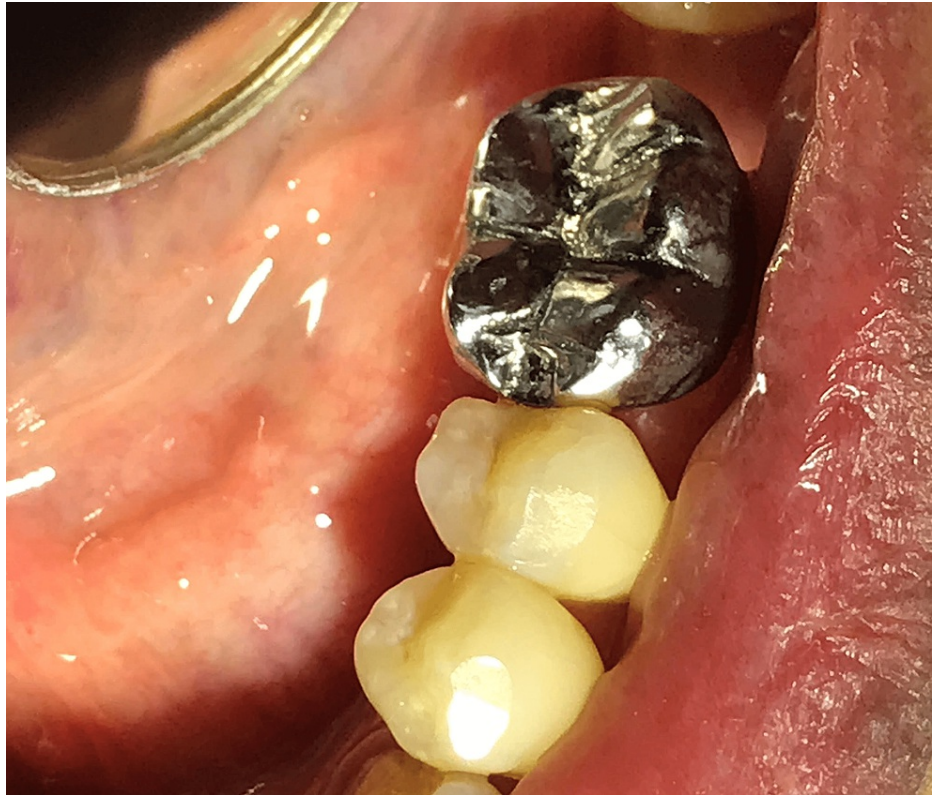
**FIGURE 6: Full metal crown cemented on tooth 36 with mesial rest seat.**

In this case, tooth 36 is the abutment for the lower RPD. The full metal crown has been designed with an occlusal rest seat [10] and a buccal undercut to facilitate the placement of a C-clasp from the metal framework. It is interesting to highlight that even though the tooth presented with CTS prior to the construction of the crown, it is still being utilised as the abutment for cobalt-chromium denture due to the unavailability of a posterior abutment with missing tooth 37 and mesially tilted 38. The best treatment option would be to implant placement to replace the missing teeth to avoid the use of tooth 36 as the abutment for the lower partial denture. However, in this case, the prognosis of the treatment is considered good since the diagnostic evaluations of crack symptoms and progression had been conducted by placing a stainless-steel molar band for three months and placing a temporary crown for one month prior to the construction of a definitive crown [11]. The six-month review visit was also uneventful.

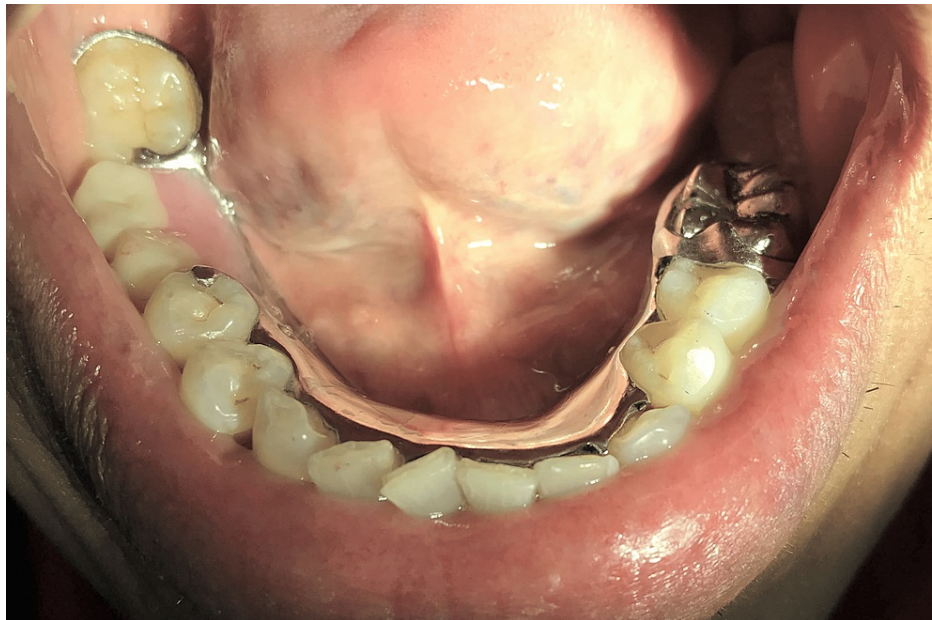
**FIGURE 7: Milled crown with lower cobalt-chrome partial denture.**

The crown was polished prior to cementation. The cobalt-chromium partial denture was constructed for the lower arch after the cementation of the crown (Figure 7).
