# The Management of Fractured Dental Instruments: A Case Series

## Case Presentation

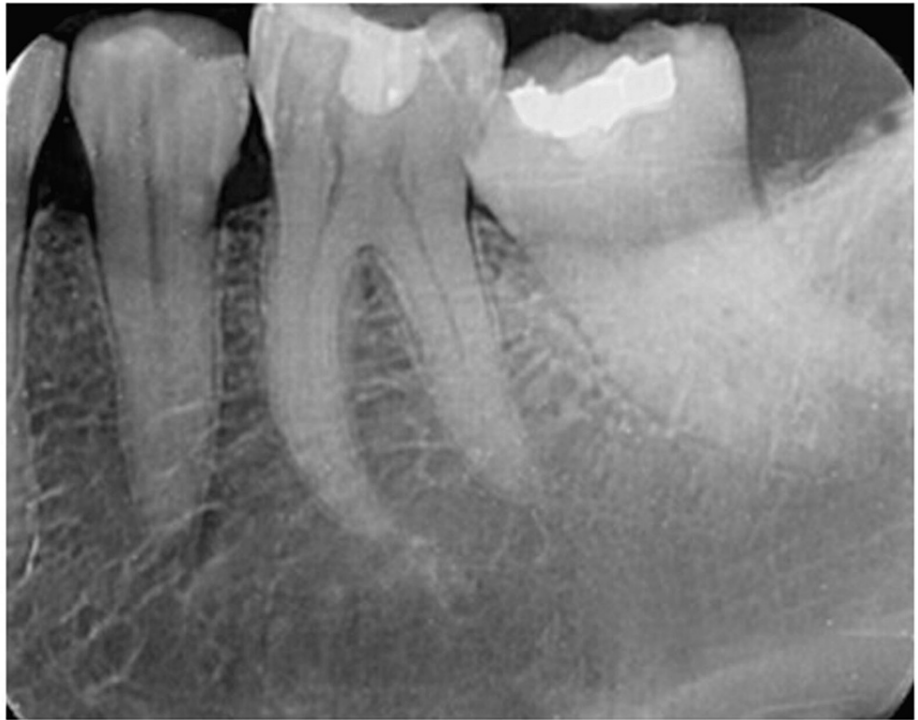
**FIGURE 1: Pre-operative radiograph of 36**

A 35-year-old male patient reported with pain in the lower left back tooth region for the past three days. Pain was dull aching, continuous, and aggravated on mastication. Clinically, composite restoration was seen in tooth 36 and was tender to percussion. An intraoral periapical radiograph (IOPA) revealed that the restoration was approximating the pulpal horn, and periodontal ligament widening was seen (Figure 1). Sensibility tests revealed no response. A diagnosis of pulpal necrosis with symptomatic apical periodontitis in 36 was made. Root canal treatment was initiated under local anesthesia (LA) with a rubber dam. Access opening was done, and canals were initially negotiated using size 10 and 15 K files. During negotiation, a 15 K file of approximately 4 mm was separated in the mesiobuccal canal of 36. IOPA showed that the file was present in the apical third of the canal, and an attempt to bypass the fragment was initiated (Figure 2A). The separated file was bypassed using a 10 K file and was enlarged with subsequent files until the 20 K file. It was

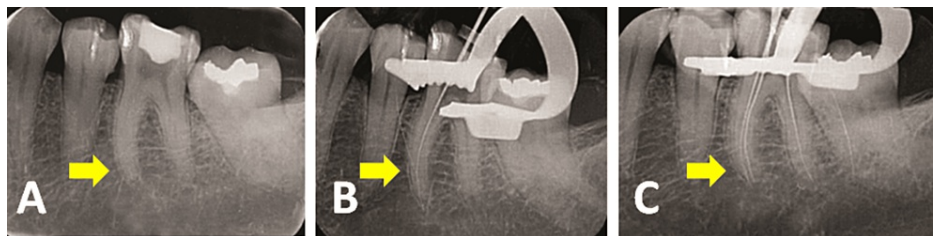
**FIGURE 2: Intraoral periapical radiographs of 36**

(A) A 15 K file separated in the apical third of the mesiobuccal canal, (B) separated file bypassed using a 15 K file, and (C) working length determination

confirmed using a radiograph with a 15 K file. (Figure 2B). Patency was checked in between cleaning using size 8 and 10 K files. Working length was determined (Figure 2C). Further, cleaning and shaping were done using ProTaper files (Dentsply Sirona, Charlotte, NC) until size F2 taper in all three canals. Obturation was completed (Figure 3A, 3B), and permanent coronal restoration was done. The patient was asymptomatic, and the tooth had normal function after six months of follow-up.

The proper decision of whether to retrieve or to bypass the fragment depends on various factors. In cases 1 and 2, the instrument was separated beyond the curvature of the canal. To retrieve the fragment, proper visibility and straight-line access are required. Since it is beyond the curvature of the canal, achieving proper visualization was difficult, which may induce excess scrapping of the dentin and the weakening of the tooth structure. Considering the limitations in the first two cases, bypassing the segment was done rather than attempting for removal. Bypass was done by introducing a smaller-sized file in between the fractured instrument and dentin, thereby negotiating the canal until the root apices.

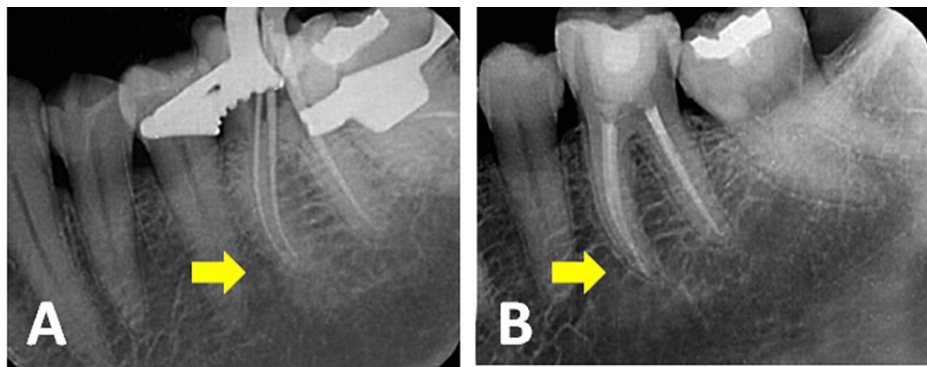
**FIGURE 3: Intraoral periapical radiographs of 36**

(A) Master cone verification and (B) postoperative radiograph

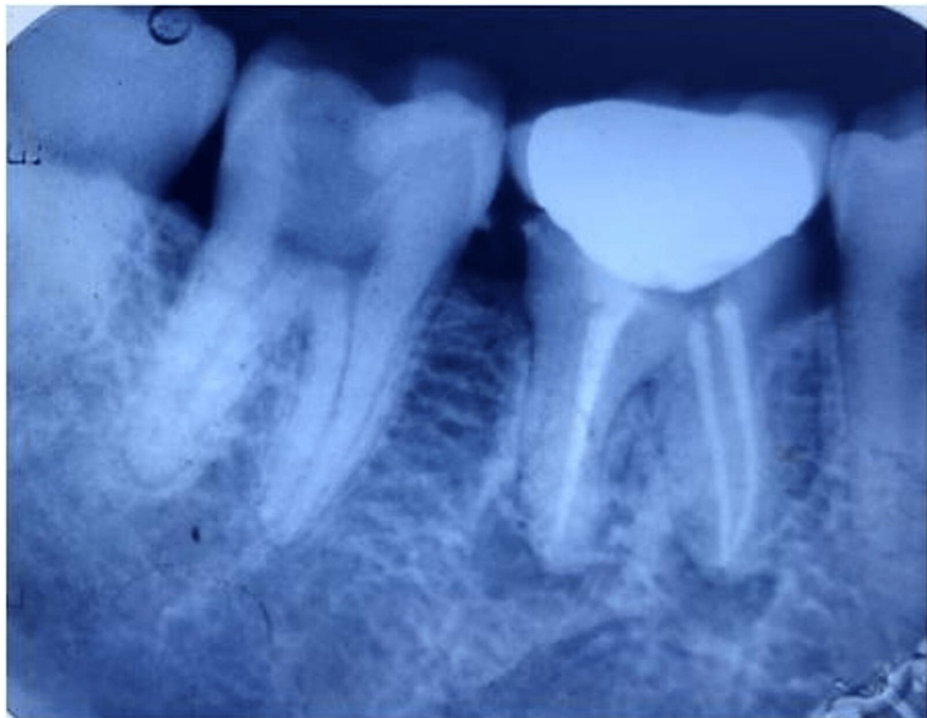
**FIGURE 4: Pre-operative radiograph of 47**

A 40-year-old female patient reported with pain in the right lower back tooth region for the past week. History revealed a sharp and pricking pain, which aggravated on mastication. On examination, caries was present and had tenderness to percussion in tooth 47. Sensibility tests revealed positive response and lingering pain in 47. A diagnosis of symptomatic irreversible pulpitis with apical periodontitis was made in 47 (Figure 4). Under local anesthesia and a rubber dam, an access opening was done. During the negotiation of the canal, a size 15 K file of approximately 5 mm was fractured. In the radiograph, the file was seen below the curvature (apical third) of the mesiolingual canal of 47 (Figure 5A). Instrument bypass was attempted to attain a successful treatment outcome. The fragment was bypassed using size 8 and 10 K files, and the file was enlarged with subsequent files until a 20 K file. It was confirmed with the help of a radiograph using a 15 K file (Figure 5B). Patency was checked in between cleaning using size 6-8 K files. Working length was confirmed, and cleaning and shaping were done until ProTaper size F2 in all the canals (mesiobuccal, mesiolingual, and distal) (Figure 5C). After an interappointment dressing with calcium hydroxide, obturation was completed, and permanent coronal restoration was done in 47 (Figure 6A, 6B). The patient was asymptomatic, and the tooth had normal function after six months of follow-up.

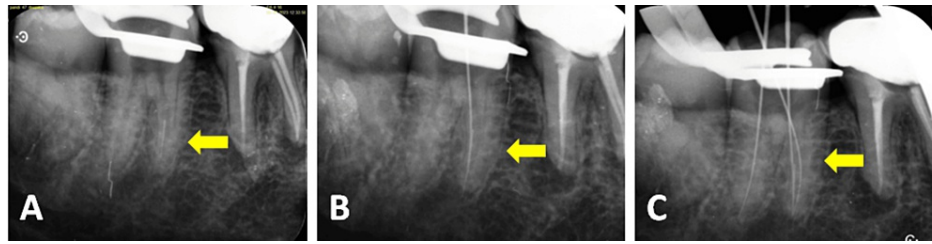
**FIGURE 5: Intraoral periapical radiographs of 47**

(A) A 15 K file separated in the apical third of the mesiolingual canal, (B) separated file bypassed using a 15 K file, and (C) working length determination

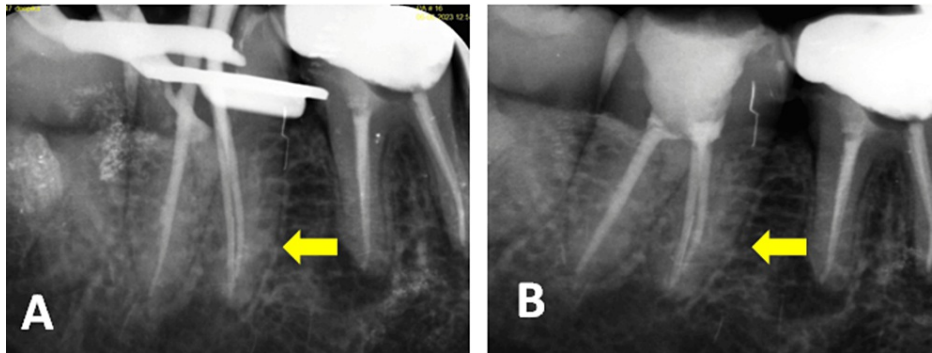
**FIGURE 6: Intraoral periapical radiographs of 47**

(A) Master cone verification and (B) postoperative radiograph

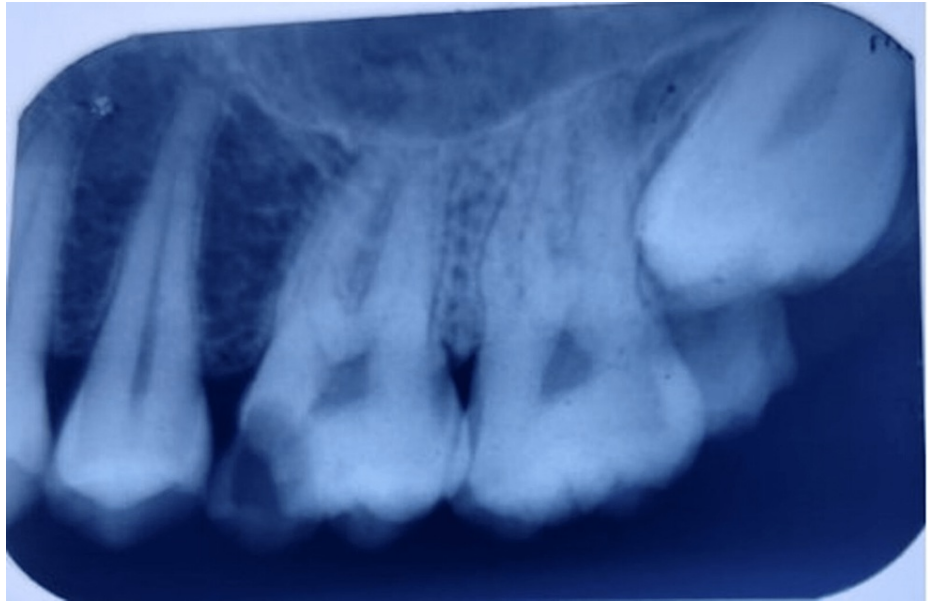
A 28-year-old female patient came with a complaint of pain in the upper left back tooth region for the past week. The pain was sharp and a pricking type, which aggravated on eating hot and cold food items. A history of nocturnal pain was also present. On clinical examination, a carious lesion was present on the mesial aspect of tooth 26, and the tooth was tender to percussion. On pulp sensibility tests, the tooth elicited a positive response and lingering pain. Radiographic examination unveiled a radiolucency present toward the mesial aspect approximating the pulp. Slightly widened periodontal ligament space was seen (Figure 7). A diagnosis of symptomatic irreversible pulpitis with apical periodontitis in 26 was made. Under LA along with rubber dam isolation, access opening was done in 26. The negotiation of canals was done with size 10 and 15 K files until their apex. The working length was determined and affirmed using a radiograph (Figure 8A). Ni-Ti rotary files were used for the cleaning and shaping of the canals under copious irrigation with 5.25% sodium hypochlorite (NaOCl). During preparation, ProTaper F1 rotary instrument of approximately 10 mm fractured in the distobuccal canal extending from cervical to apical extent in 26. The separation was confirmed with the help of a radiograph (Figure 8B). The aim was made to remove the broken segment from the distobuccal canal using ultrasonics. Initially, a modified GG drill was used to establish a staging platform. The troughing of dentin was done to create a space around the separated instrument using an ultrasonic Satelec ET25 tip (Mérignac, France). Further, the Satelec ET25 tip was activated at a power setting 6 and vibrated in the space created between the root dentin and the separated fragment (Figure 8C). The instrument jumped out of the canal after about 30 minutes and was confirmed with the radiograph (Figure 9A, 9B). The preparation of mesiobuccal and distobuccal canals was done up to size F1 taper, and the palatal canal was done up to F2 taper. Obturation was done (Figure 10A). In a later appointment, post space preparation was done, and fiber post placement with permanent coronal restoration was done (Figure 10B). The patient was asymptomatic, and the tooth had normal function after six months of follow-up.

FIGURE 7: Pre-operative radiograph of 26

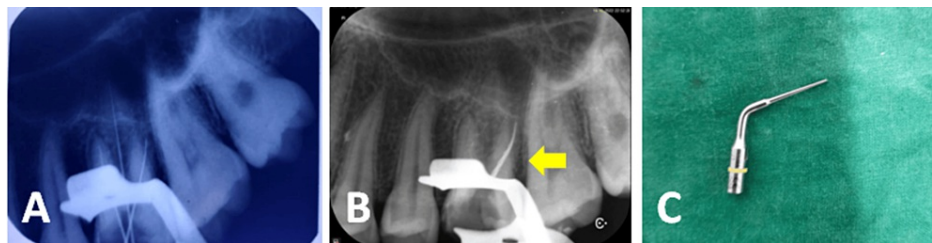
FIGURE 8: (A) Working length determination, (B) file separated in the distobuccal canal of 26, and (C) Satelec ET25 ultrasonic tip

The Endo Success™ Retreatment kit (Satelec, Mérignac, France) was recently introduced for use in the Satelec piezoelectric ultrasonic device to aid in the removal of separated instruments. It consists of six titanium-niobium tips, which are available in various lengths and tapers. According to Shiyakov and Vasileva [18], the success rate of ET25 (Satelec) ultrasonic tip was reported to be 90%. Additionally, it contains a special "feedback" mechanism that gauges the resistance of the tip, controls the movement of the tip, and decreases the risk of tip breaking [18]. In this case series, bypassing the fractured instrument and the retrieval of the fragment have been done with the use of ultrasonic tips, which helped in the minimal loss of root dentin.

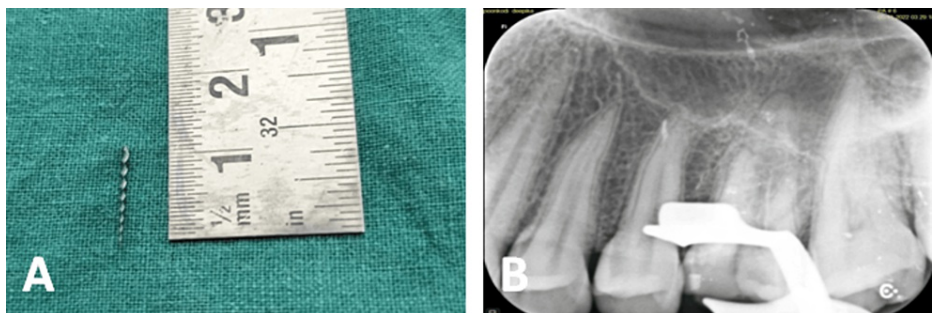
FIGURE 9: (A) A 10 mm-length file retrieved and (B) a file retrieved from the distobuccal canal

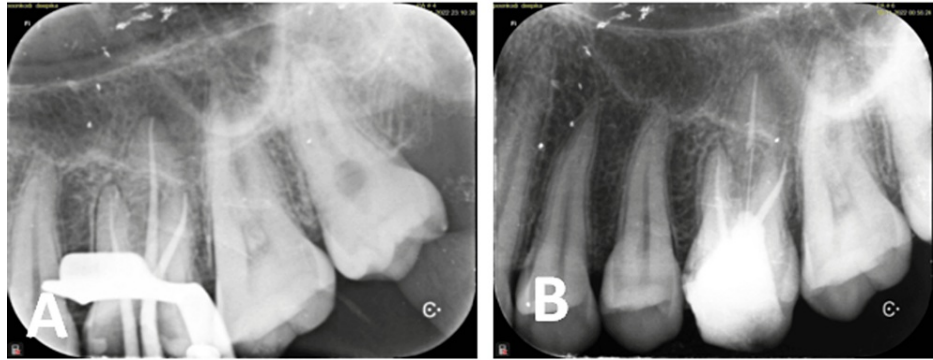
**FIGURE 10: Intraoral periapical radiographs of 26**

(A) Master cone verification and (B) postoperative radiograph
