DOI: 10.7759/cureus.48590

Perforation of the Brachial Artery During Percutaneous Lower Extremity Angioplasty via the Brachial Artery Approach Resulting in Difficulties in Balloon Catheter Removal: A Case Report

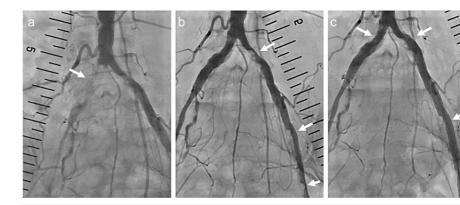
FIGURE 1: Lower extremity arteriography findings during the previous hospitalization.

(a) The right common iliac artery (CIA) is completely occluded (arrow). (b) The left CIA and left external iliac artery show stenosis (arrows). (c) No significant stenotic lesions are visible at the stent placement sites of both iliac arteries (arrows) associated with the previous treatment.

A 50-year-old woman with chronic kidney disease on hemodialysis presented with rest pain in the right lower extremity. Her serum electrolytes were kept within normal range by regular hemodialysis. She had a history of right common iliac artery (CIA) occlusion and previously underwent percutaneous vascular intervention with a right brachial and right femoral artery approach and stent placement in the right CIA (Figures 1a, 1b). She had a minor hematoma at the right brachial artery puncture site and post-operative pain for several days. Subsequently, she underwent percutaneous endovascular intervention with a left common femoral artery (CFA) approach for left CIA and left external iliac artery stenosis (Figures 1b, 1c).

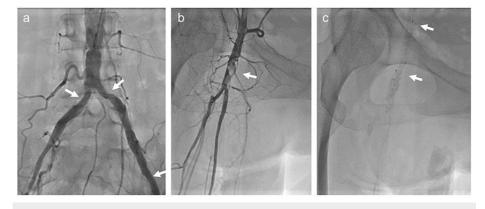
FIGURE 2: Lower extremity arteriography findings during the present hospitalization.

(a) No significant stenotic lesions are visible at the stent placement sites of both iliac arteries (arrows). (b) The right common femoral artery shows a severe stenotic lesion with significant calcification (arrow). (c) The balloon catheter could not pass through the stenosis (arrows).

At the current admission, she presented with a low ankle-brachial index in the affected leg (left: 0.71, right: 0.25) and a calcified, severely stenotic lesion in the right CFA (Figure 2b). Owing to the previous vascular intervention complication, a 4-Fr short sheath was inserted into the right brachial artery for angiography. Treatment was initiated with the 4-Fr short sheath, without changing to a 6-Fr long sheath. However, the monorail balloon catheter could not pass beyond the lesion (Figure 2c) and became difficult to remove when forcibly advanced.

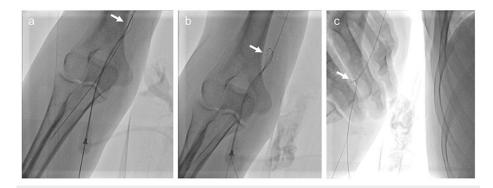
FIGURE 3: Guidewire kinking during the therapy.

The catheter was retracted to the point of resistance but could not be retrieved distal to the right subclavian artery. Additionally, the guidewire could not be straightened in the brachial artery (Figures 3a, 3b). A microcatheter was inserted, but the guidewire remained kinked (Figure 3c), and the balloon catheter could not be removed.

(a) Balloon catheter removal was difficult owing to guidewire kinking (arrow). (b) The guidewire was twisted above the sheath at the right brachial artery puncture site (arrow) during forceful manipulation of the balloon catheter. (c) Straightening the guidewire was attempted, but the kink was difficult to eliminate (arrow).

The present patient underwent vascular intervention with a small-diameter short sheath to avoid bleeding complications. As a result, the balloon catheter was difficult to remove. Regarding the cause of the catheter removal difficulty, the guidewire may have kinked and curled in the central portion of the guidewire lumen outlet of the balloon catheter when the balloon catheter was forcefully advanced. The guidewire may have twisted during forceful manipulation of the balloon catheter, which caused the vessel wall perforation when the guidewire was retracted to straighten it [7].

The guidewire kinking could have been prevented with the use of a long sheath or by carefully handling the catheter and guidewire. In cases where the catheter is kinked and cannot be removed, there is a technique for catheter kink management via "swallowing" a long sheath [2]. However, in cases where the vessel has already been perforated, forceful catheter removal may damage the vessel further. Therefore, it is important to stop the interventional procedure immediately and consider surgical removal.
