Tibial Lateral Condyle Fracture After Cementless Oxford Unicompartamental Knee Arthroplasty (UKA): A Report of Four Cases

Categories: Orthopedics

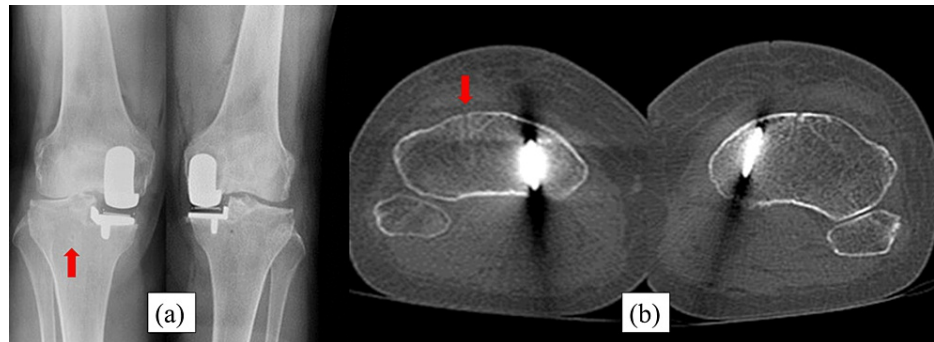
FIGURE 1: Immediately postoperative radiography and computed tomography (CT).

(a) Postoperative radiography shows no fracture line.

(b) Postoperative CT shows the level of a pinhole.

The red arrows show the place of the pin. The pin was placed outside the tibial mechanical axis.

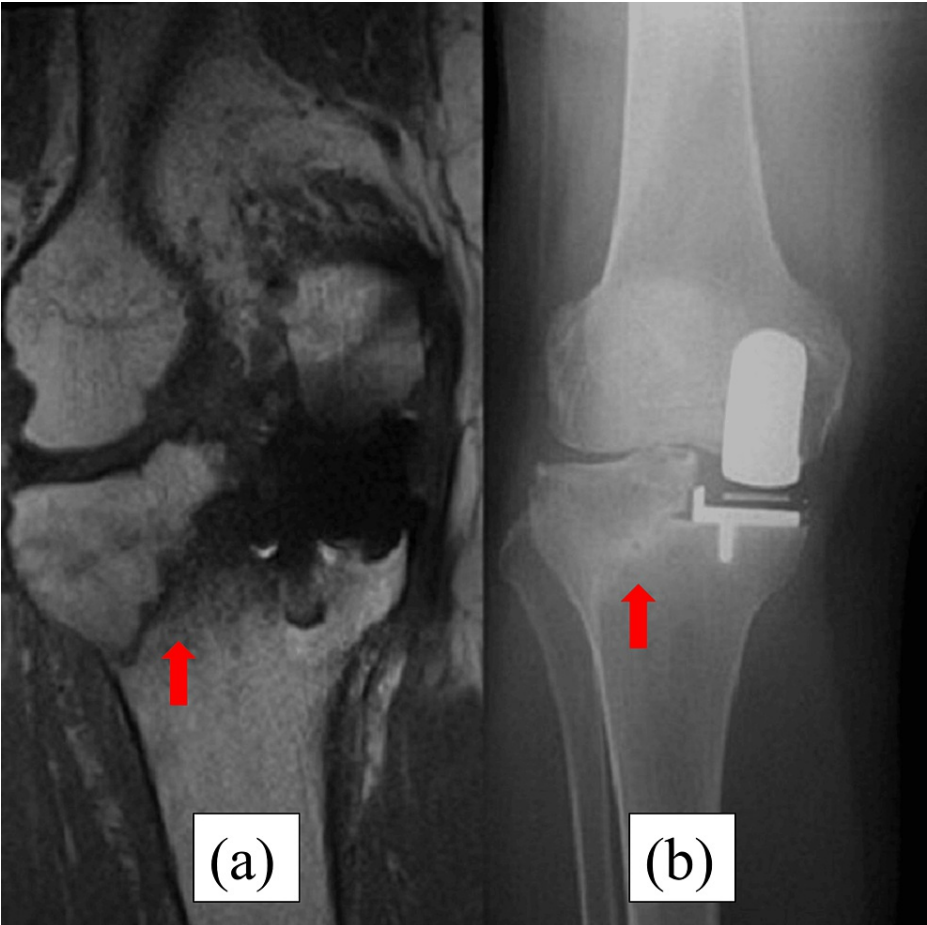
FIGURE 2: Magnetic resonance imaging (MRI) and radiography at five weeks postoperatively.

(a) The red arrow of the MRI shows a fracture line from the intersection of the longitudinal and transverse tibial osteotomies through the lateral pinhole to the end of the lateral tibial diaphysis of the right knee.

(b) The red arrow of radiography shows the same fracture line as MRI.

The fracture line originated from the intersection of the longitudinal and transverse cuts, passing the pinhole to the lateral tibial cortex. One of the causes of medial tibial plateau fractures was thought to be the pinholes [8]. In case the vertical cut is too deep, or the pinhole is located too far inside, there can be stress concentration at and around the pinhole [8]. In our hospital, to avoid this stress concentration, only a lateral pinhole is used when the tibial cutting guide is fixed. Additionally, a pin with a head is used for strong fixation. Further, to prevent the vertical cut from becoming too deep after finishing the horizontal cut, a thin metal plate is inserted in this area. Despite these preventive measures in this technique, fractures still occur. The lateral pinholes were placed outside the tibial mechanical axis in three of the four cases. The direction of the lateral bony cortex of the tibia is relatively close to the anteroposterior direction of the tibia [10]. In cases wherein the pinhole is too close to the cortical bone, it may be a cause of a decrease in bone strength. Moreover, if the transverse cut is excessive, it can become too close to the pinhole, which may be a cause of fractures.

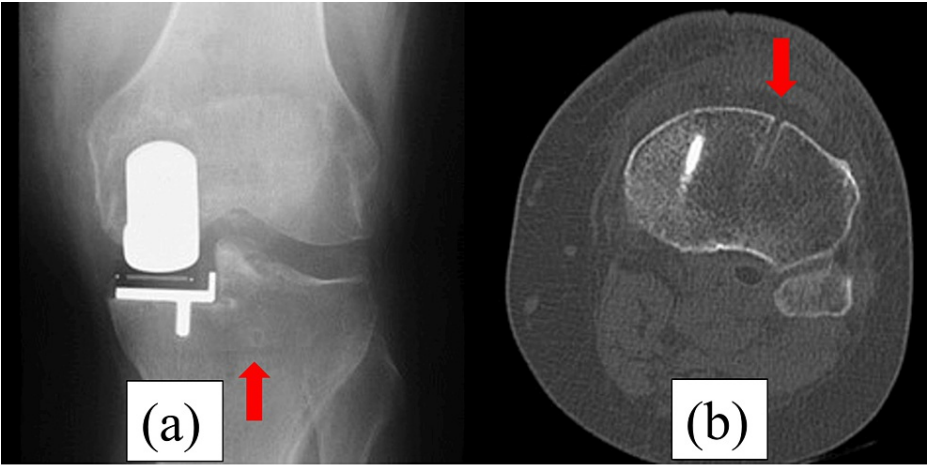
FIGURE 5: Immediately postoperative radiography and CT.

(a) Postoperative radiography shows no fracture line.

(b) Postoperative CT shows the level of a pinhole.

The red arrows show the place of the pin. The pin was placed outside the tibial mechanical axis.

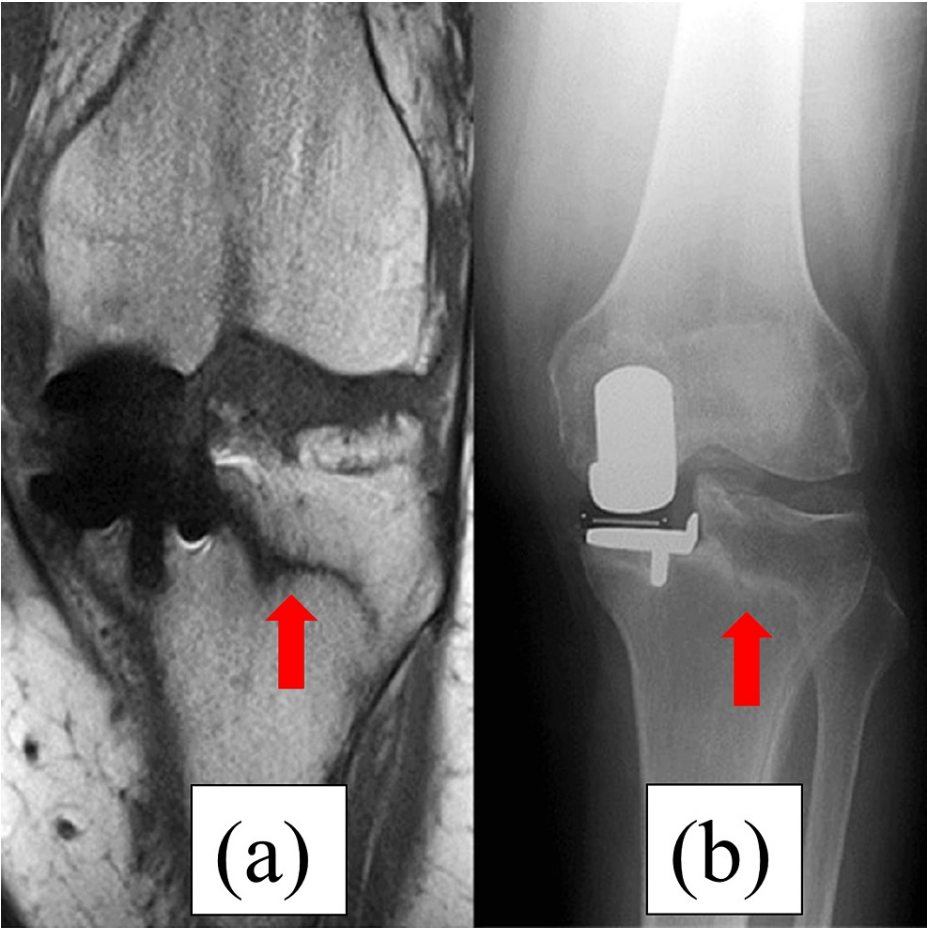
FIGURE 6: MRI and radiography at five weeks postoperatively.

- (a) The red arrow of the MRI shows the same fracture line as Case 1.
- (b) The red arrow of radiography shows the same fracture line as the MRI.

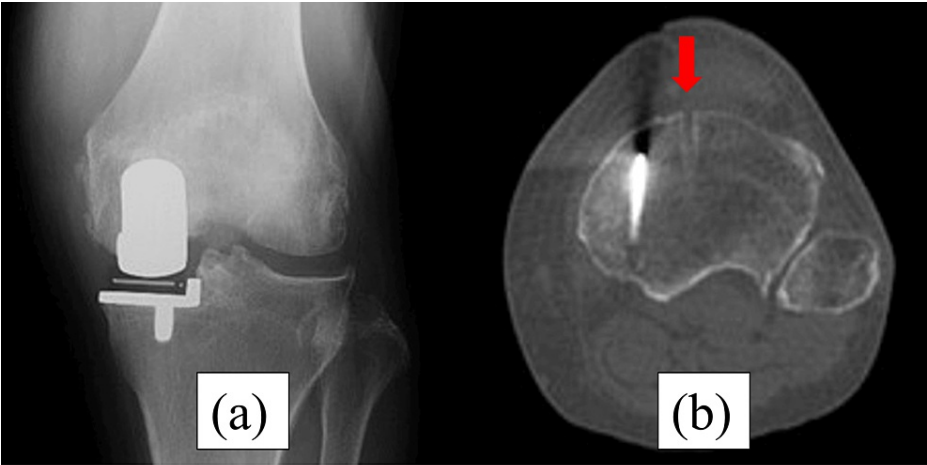
FIGURE 9: Immediately postoperative radiography and CT.

(a) Postoperative radiography shows no fracture line.

(b) Postoperative CT shows the level of a pinhole.

The red arrows show the place of the pin. The pin was placed on the tibial mechanical axis.

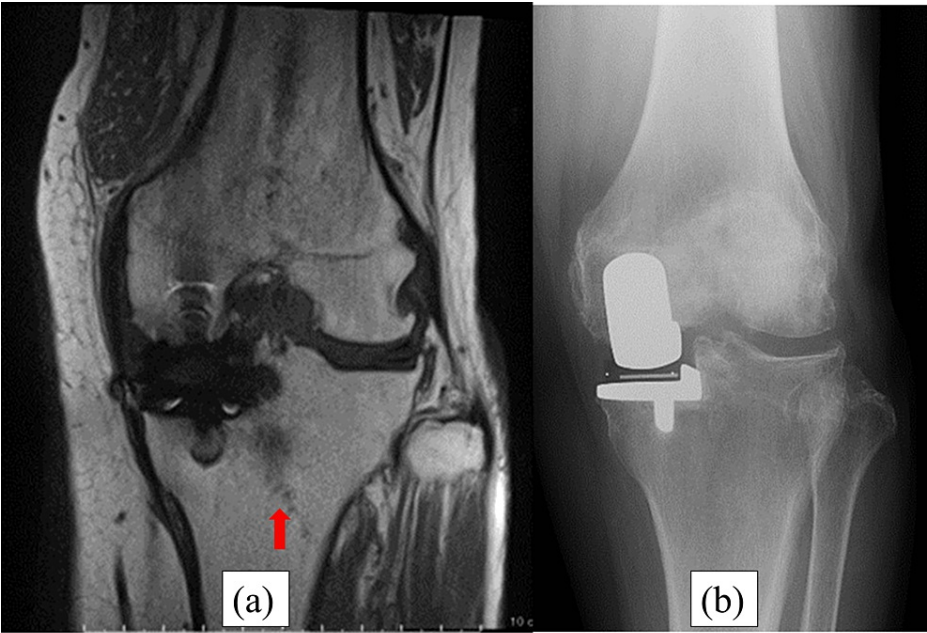
FIGURE 10: MRI and radiography at five weeks postoperatively.

(a) The red arrow of the MRI shows the same fracture line as Cases 1 and 2.

(b) Radiography does not reveal a fracture line.

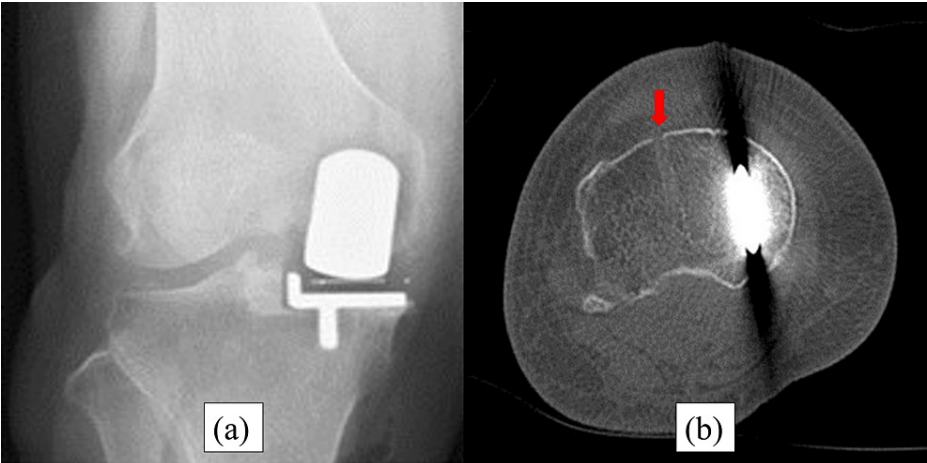
FIGURE 13: Immediately postoperative radiography and CT.

(a) Postoperative radiography shows no fracture line. (b) Postoperative CT shows the level of a pinhole. The red arrows show the place of the pin. The pin was placed on the tibial mechanical axis.

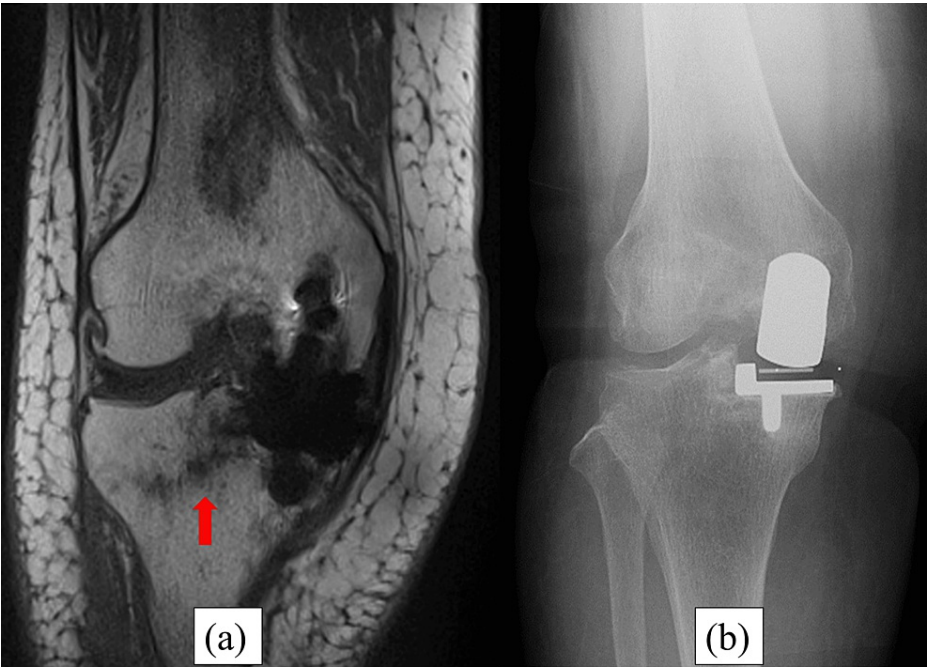
FIGURE 14: MRI and radiography at five weeks postoperatively.

(a) Postoperative radiography shows no fracture line.

(b) Postoperative CT shows the level of a pinhole.

The red arrows show the place of the pin. The pin was placed on the tibial mechanical axis.
