Patellar Dislocation Masking a Tibial Post Fracture: An Unusual Complication of Posterior Stabilized Total Knee Arthroplasty

Seth A, Buddhapuram P K, Kadwad A, et al. (November 17, 2023) Patellar Dislocation Masking a Tibial Post Fracture: An Unusual Complication of Posterior Stabilized Total Knee Arthroplasty. Cureus 15(11): e48950. DOI 10.7759/cureus.48950

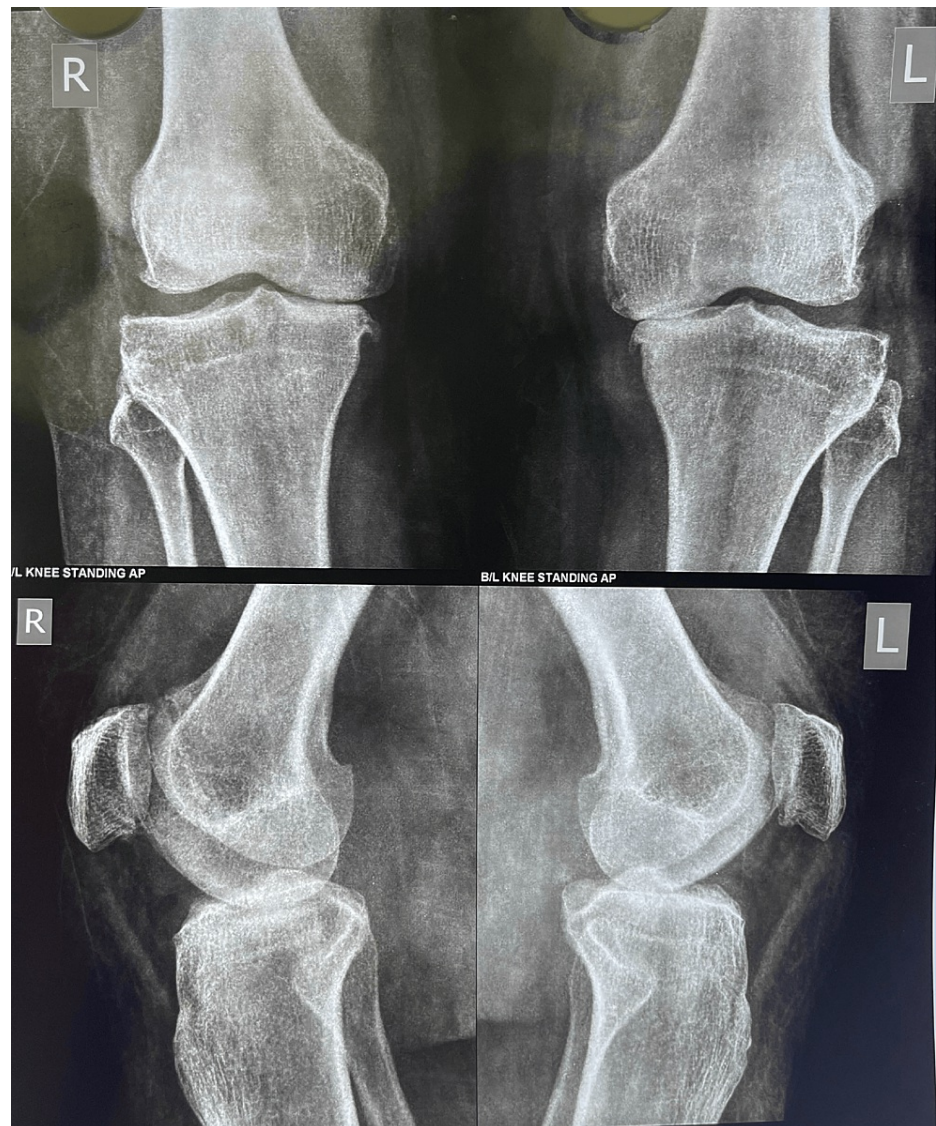
FIGURE 1: Preoperative radiograph showing a varus deformity with severe osteoarthritis over the medial side in both knees

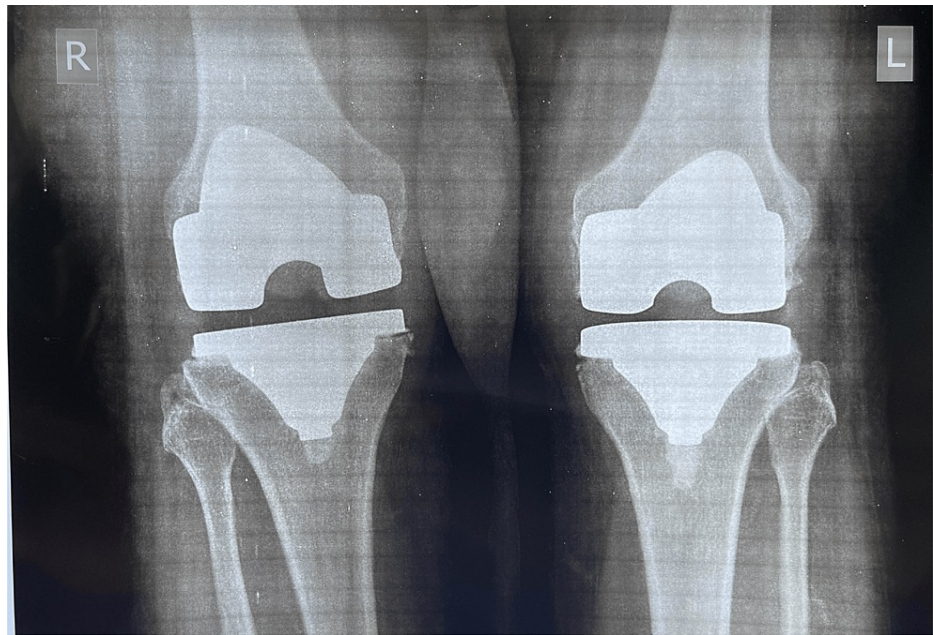
FIGURE 2: Three months postoperative weight-bearing radiograph showing well-balanced knees

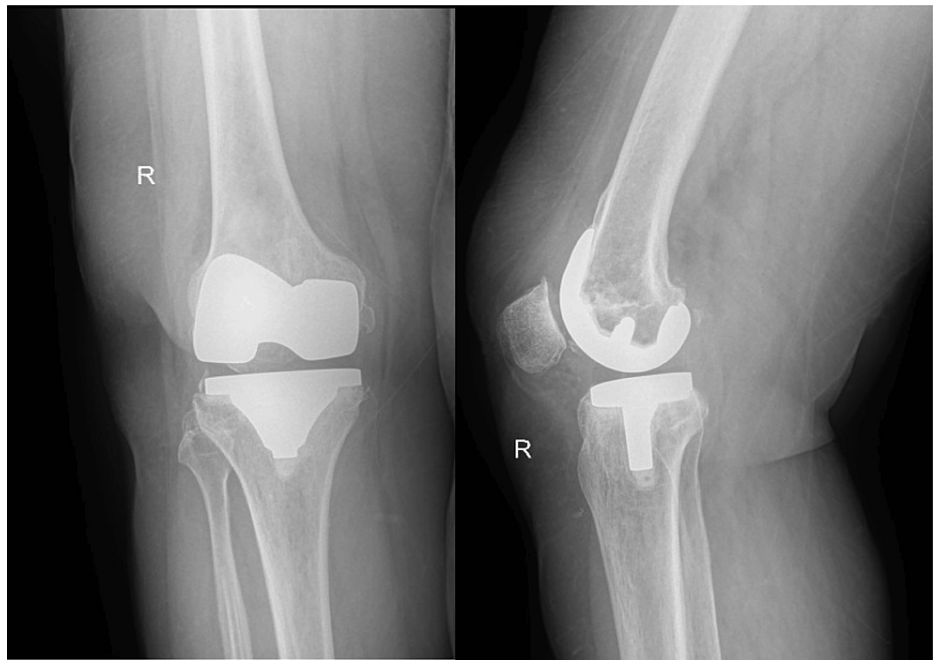
Upon initial examination, the patient's patella exhibited dislocation on the right side. The evaluation revealed grade 2 instability in the anteroposterior plane, with no evidence of varus-valgus instability. Radiographs were obtained, which confirmed the finding as shown in Figures 3, 4.

FIGURE 3: The anteroposterior and lateral views of the knee in the standing position

These radiographs show a well-balanced knee; however, the patella position couldn't be commented on in these radiographs.

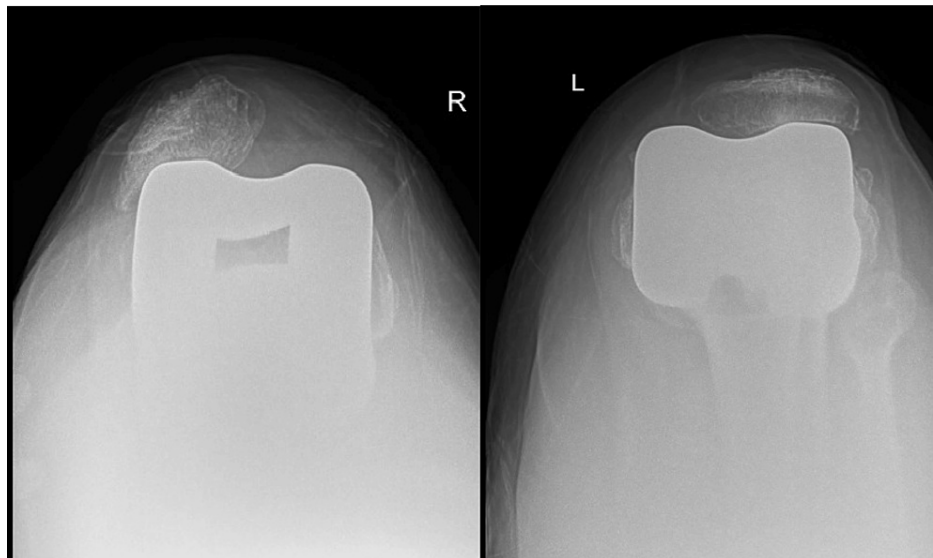
FIGURE 4: Skyline view of the knee with a patellar dislocation on the right side

In our presented case, a significant observation was the chronic patella dislocation on the patient's right side and subluxation of the patella on the left side. This is further corroborated by the evident contouring of the lateral facet, which, when analyzed in conjunction with the femoral component on the skyline view, offers a clear indication of the dislocation's chronic nature as shown in Figure 3. Such findings emphasize the importance of thorough radiographic examinations in assessing the nuances of knee pathologies and understanding their potential implications.

In the course of the clinical assessment, the clicking sounds were linked to the patellar dislocation, which was also evident in the radiographs taken at the time of presentation. This prompted the decision to schedule a surgical procedure for patellar realignment.

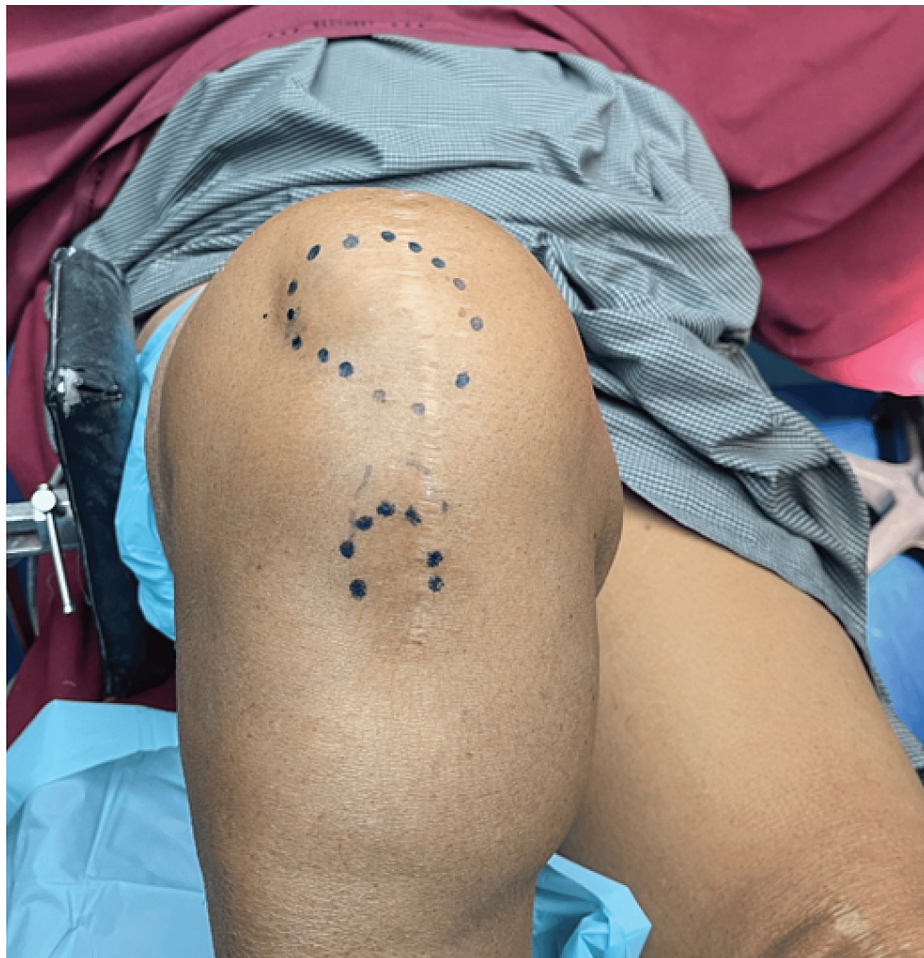
Following the administration of anesthesia, flexion of the knee patellar dislocation was evident as shown in

FIGURE 5: Dislocation of the patella upon flexion of the knee after the administration of anesthesia

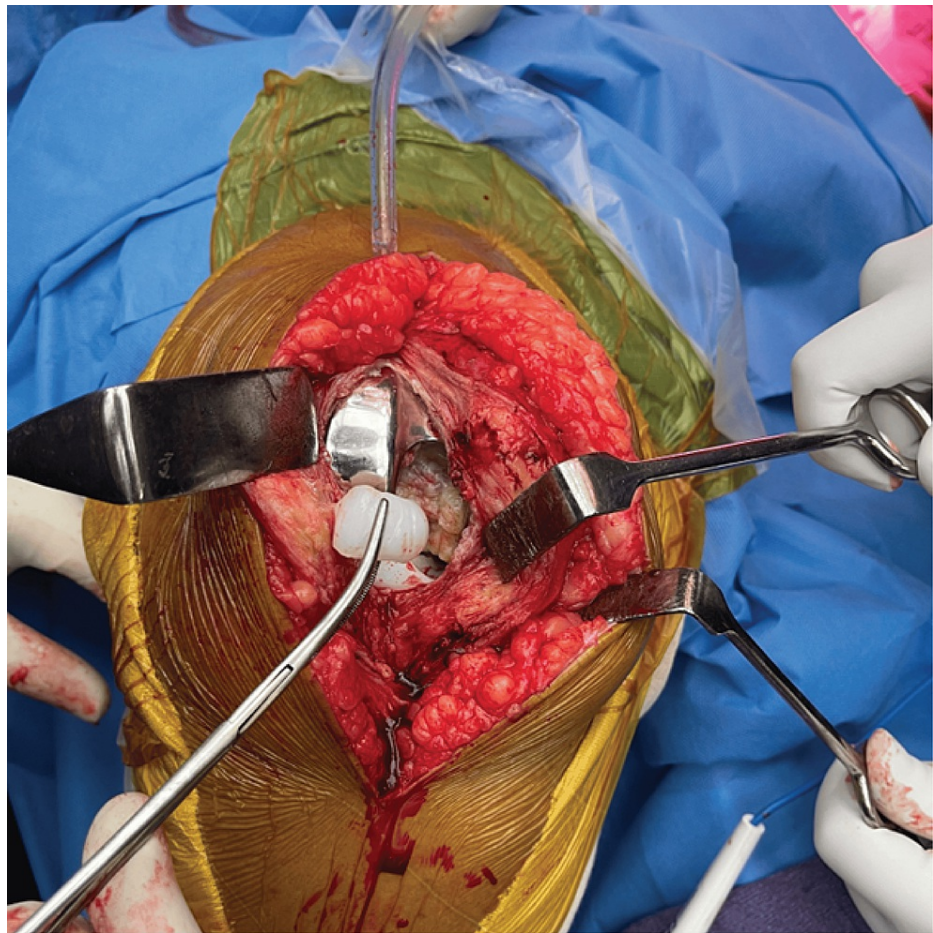
However, upon conducting an arthrotomy, an unforeseen complication emerged, as the tibial post was identified as fractured, as seen in Figure 6, concomitant with an increase in the flexion and extension gaps.

FIGURE 6: Tibial post fracture

As depicted in the case report, it becomes evident that tibial post failure following TKA can occur in the absence of any obvious history of trauma or falls. In our case, it happened after hyperflexion of the knee. However, in our case, the evident patellar dislocation masqueraded as the tibial post fracture. To the best of our knowledge, no such case report has been previously reported in the literature.

The polyethylene insert was replaced with a larger 15mm size from 12mm due to an increase in both flexion and extension gaps. Additionally, debulking of the patella along with the removal of osteophytes followed by lateral retinaculum release and double-breasting technique was employed for the quadriceps tendon.

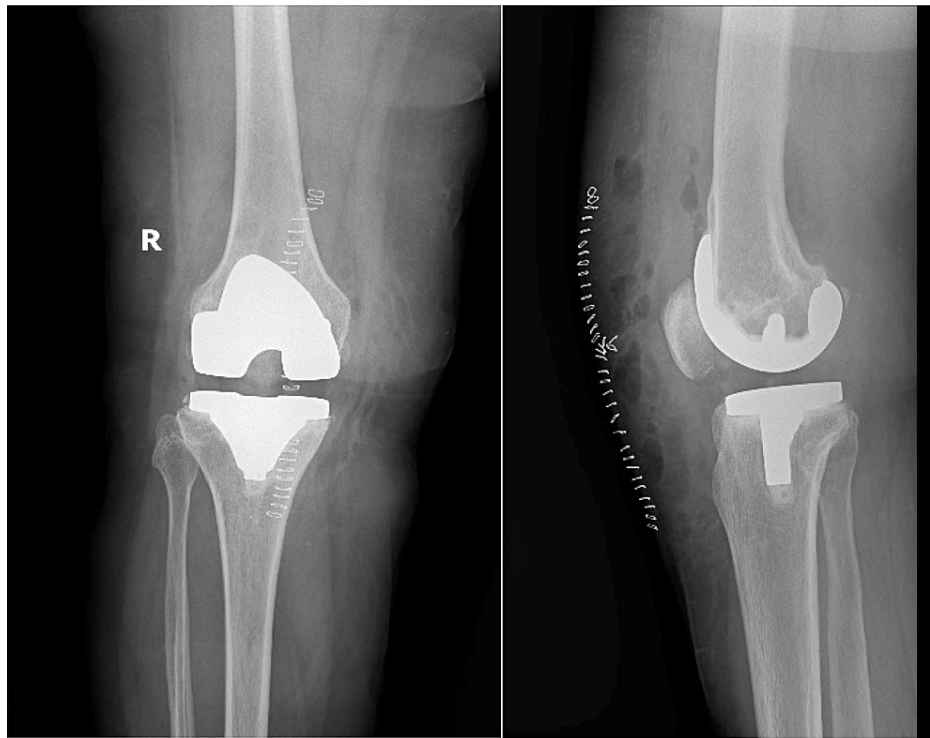
FIGURE 7: Postoperative radiograph of the right knee in the supine position

Subsequent to the surgical procedure, a radiograph was taken postoperatively as shown in Figure 7 and the patient received post-operative instructions, advising a range of motion of up to 30 degrees, with the prescription of a long knee brace to facilitate full weight-bearing. This comprehensive approach aimed at restoring the patient's knee functionality and mitigating her symptoms effectively.
