Dissociation of Modular Total Hip Arthroplasty at the Neck-stem Interface: A Unique but Possible Complication

Abstract

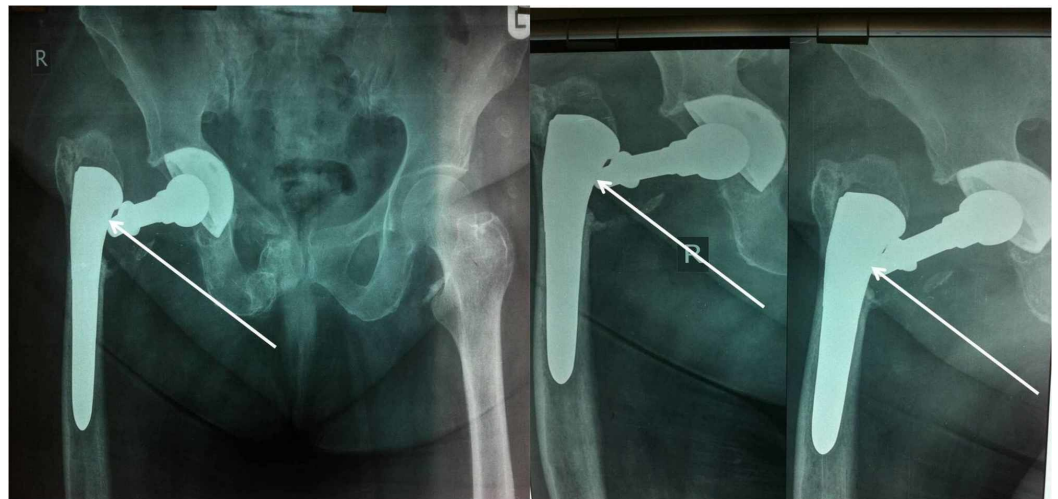
The radiographic follow-up during the first and the third month indicated no problem and the patient was counseled to walk without restrictions. Eight years postoperatively, she presented to our department reporting a fall of own height three months ago. She was unable to bear weight and walking without support was impossible. She complained of a very painful operated hip. Radiographs showed dissociation between the stem and the neck interface without dislocation of the head (Figure 1). A complete laboratory testing was performed and infection was ruled out.

FIGURE 1: Radiographs show the dissociation of the femoral neck-stem interface after the fall (white arrows).

Subsequently, an open reduction was decided as the appropriate treatment. The same posterior approach was utilized and the same neck system was used. The stability test in the neck-stem junction of the modular stem revealed that the prosthesis was stable (Figure 2). Radiographs that were obtained during the first and six months postoperatively showed no signs of instability of the stem. Additionally, the patient declared satisfied with the function of her operated hip.

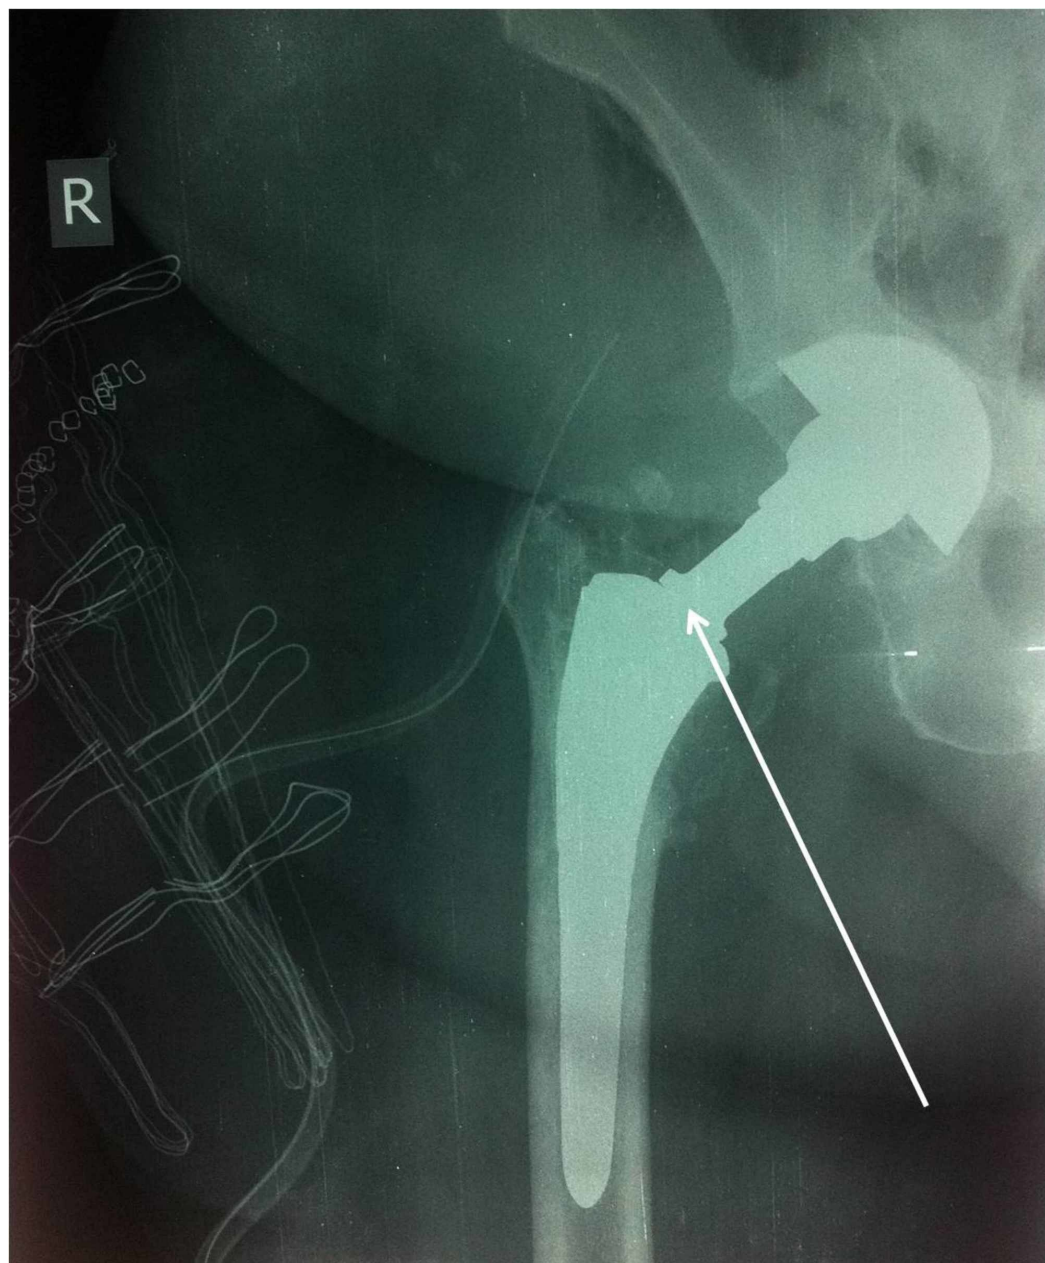
FIGURE 2: Radiograph after open reduction. Stability test in the neck-stem junction (white arrow) of the modular stem revealed that the prosthesis was stable.
