Extensive Metallosis in a Primary Knee Arthroplasty as a Result of Polyethylene Wear: Is It Avoidable?

Anas Bara¹, Abhimanyu Singh², Kuntal Patel², Deepak Herlekar²

Case Presentation

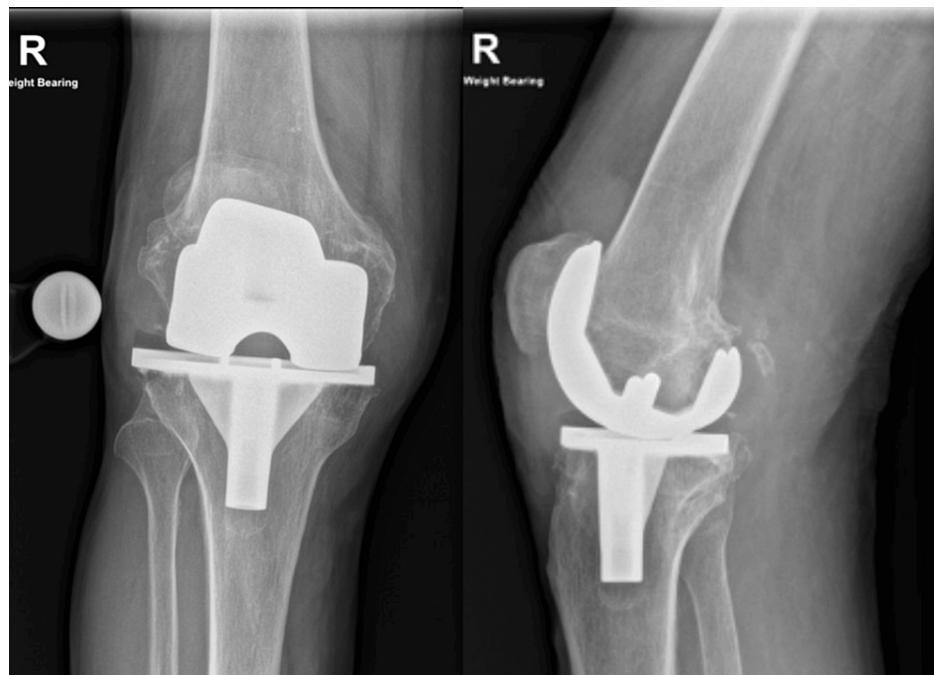
An 85-year-old man, without any comorbidities, who underwent a TKA in 1996, presented to his General Practitioner in 2021 with knee pain and swelling. An X-ray showed PE wear and narrowing of the artificial joint space (Figure 1).

FIGURE 1: Anteroposterior and lateral X-rays of the right knee showing narrowing of the joint space.

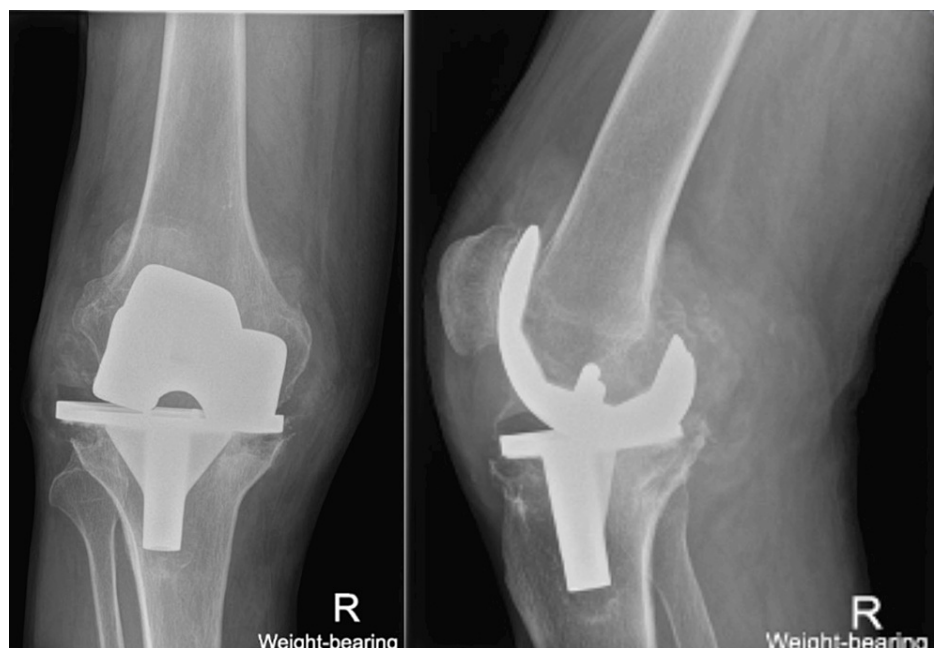
However, due to the COVID-19 pandemic, follow-up and treatment were delayed. Two years later, the patient presented to us with increased knee pain, stiffness, swelling, decreased range of motion (ROM), crepitations, and having to rely on a stick for ambulation. Further imaging showed progressing PE wear, increased loss of joint space, and metal-on-metal articulation of the femoral and tibial components along with osteolysis (Figure 2).

FIGURE 2: Anteroposterior and lateral X-rays of the right knee showing further wear of the polyethylene liner along with osteolysis.

On clinical examination, the patient's knee had a flexion deformity of about 15 degrees with further flexion to 90 degrees and no distal neurovascular deficit. The management plan involved conducting a revision surgery, during which all the implants would be removed from the right knee, followed by radical

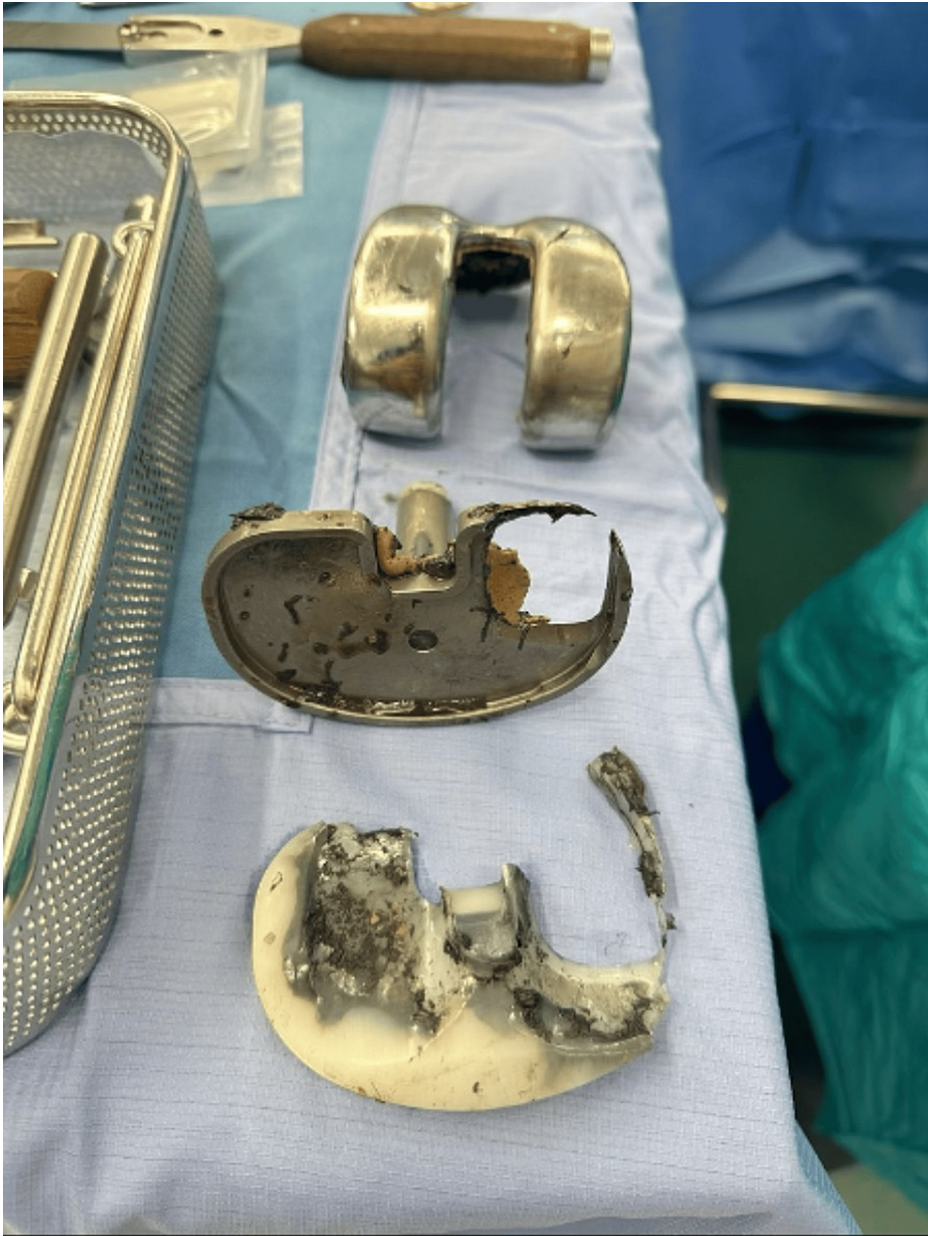
FIGURE 4: Knee prostheses of the right knee showing polyethylene wear with tibial tray defect.

After extensive debridement of stained tissue, the prosthetic components were removed (Figure 4), the knee was washed out, and a new semi-constrained modular revision knee prosthesis (Attune revision system, Depuy) was implanted (Figure 5) using sleeves and cones to achieve good fixation. The extracted prosthesis was a PFC (Press Fit Condylar, Depuy) Sigma fixed bearing, in which the femoral component was made of cobalt-chromium and the tibial tray was made of titanium with a matte articulating surface. The extracted insert was deficient posteromedially and resulted in a large defect in the corresponding area of the tibial tray (Figure 6). Because of bone loss and poor metaphysis, the sleeves and long stems were used on both the femoral and tibial sides. The patient had an uneventful postoperative recovery and was allowed to fully weight-bear. At his six-week follow-up, the scar had healed well and he was walking without any support with an ROM of 0 to 100 degrees.

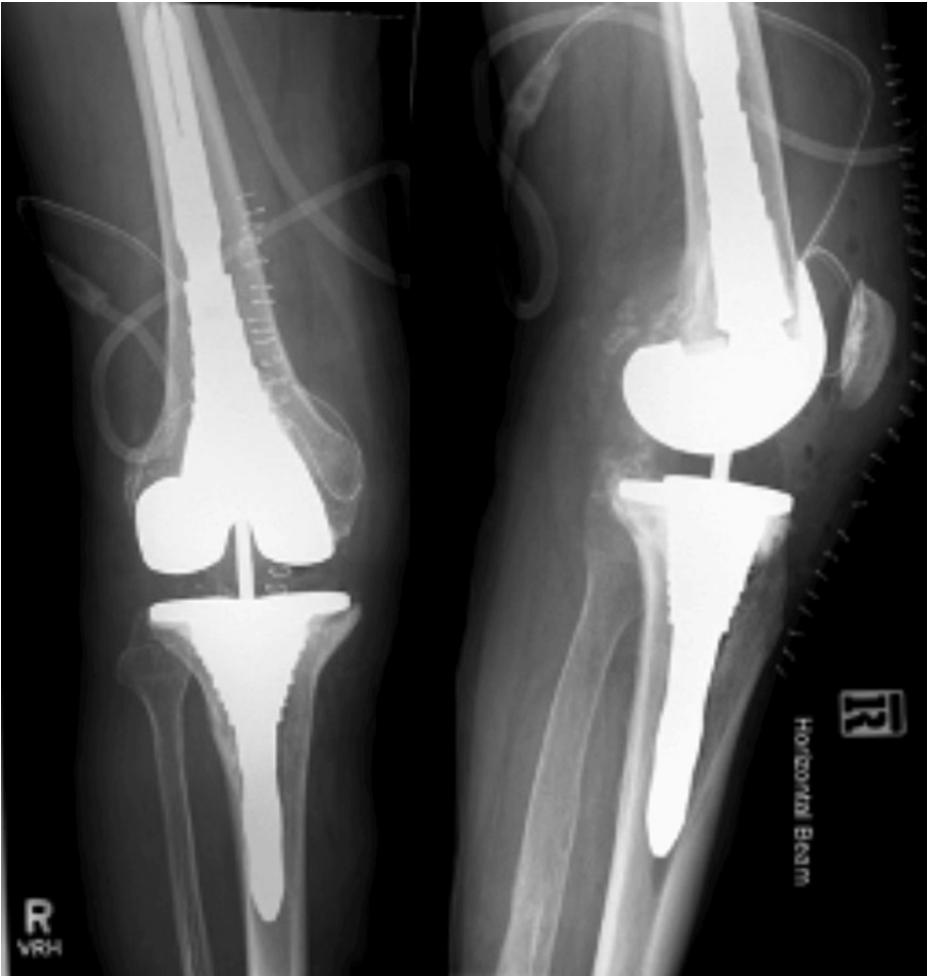
FIGURE 5: Postoperative anteroposterior and lateral X-rays.

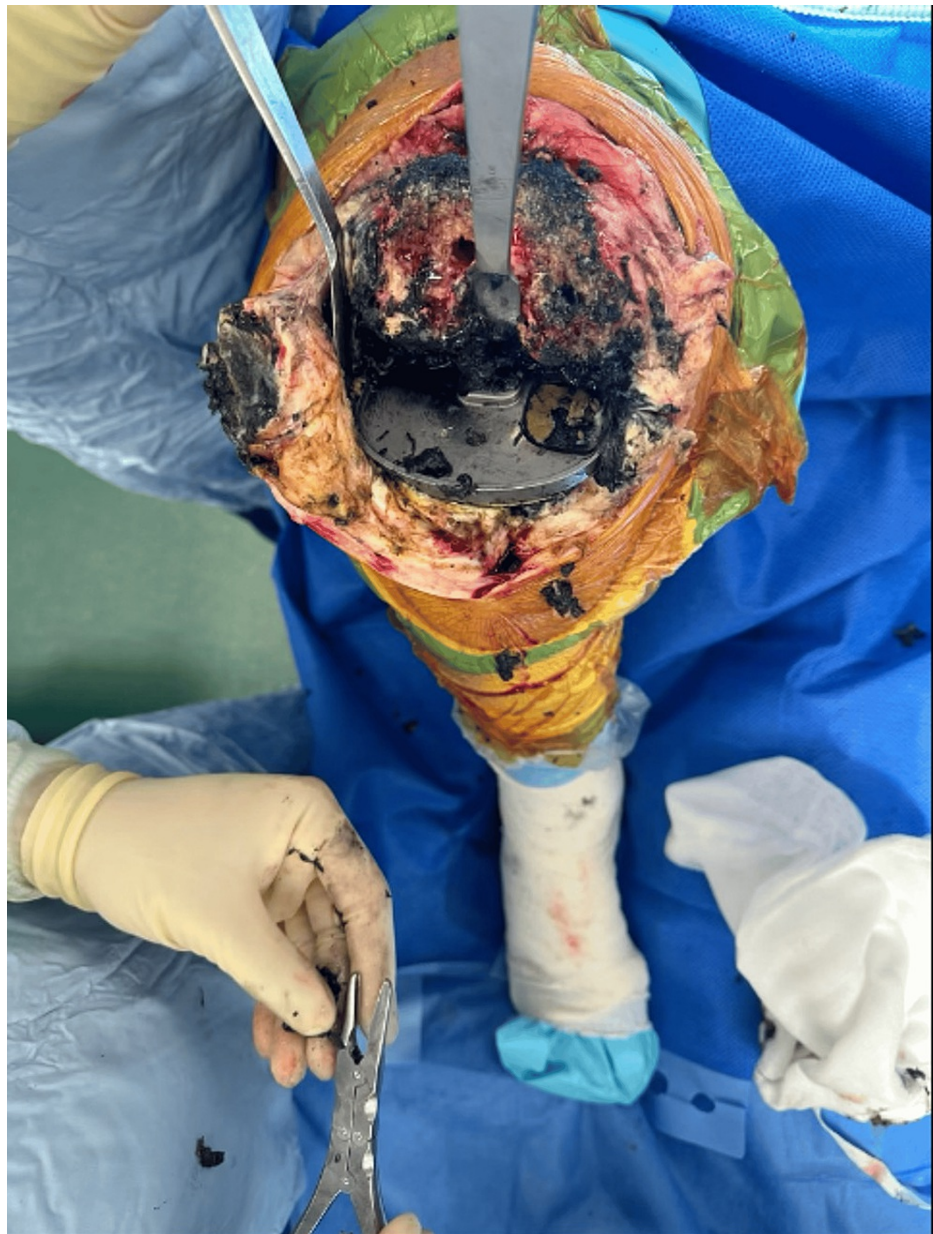
FIGURE 6: Tibial tray defect posteromedially.
