Paravalvular Leak Closure After Transcatheter Tricuspid Valve-in-Ring Implantation: A Case Report

Assaad W, Iskandarani D, Gharzuddine W, et al. (May 25, 2024) Paravalvular Leak Closure After Transcatheter Tricuspid Valve-in-Ring Implantation: A Case Report. Cureus 16(5): e61059. DOI 10.7759/cureus.61059

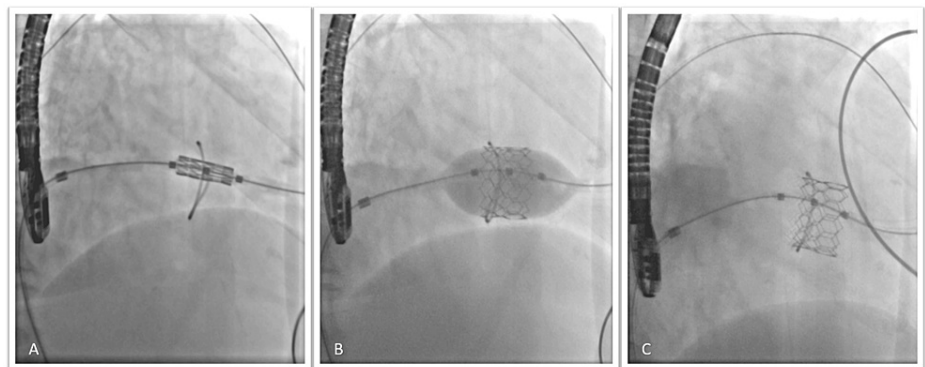
FIGURE 1: Fluoroscopic images show the positioning of the 26 MyVal transcatheter heart valve via a transcutaneous approach (A), its balloon dilation (B), and the final result (C).

The patient's symptoms were initially treated with aggressive diuresis and abdominal paracentesis, with the successful removal of 15 L of fluid. Despite the unfavorable anatomy of the ring, it was decided that transcatheter TVIR implantation was the only viable option. Under conscious sedation and via transfemoral access, the patient underwent a percutaneous transcatheter TVIR with a 26 mm MyVal (Meril Life Sciences Pvt Ltd., Vapi, GJ, IND) (Figure 1), which was delivered via an Amplatz extra stiff wire (Boston Scientific, Marlborough, MA, USA). However, the TEE revealed a residual PVL, resulting in persistent severe TR at the incomplete portion of the ring on the septal side (Figure 2, Videos 1-2).

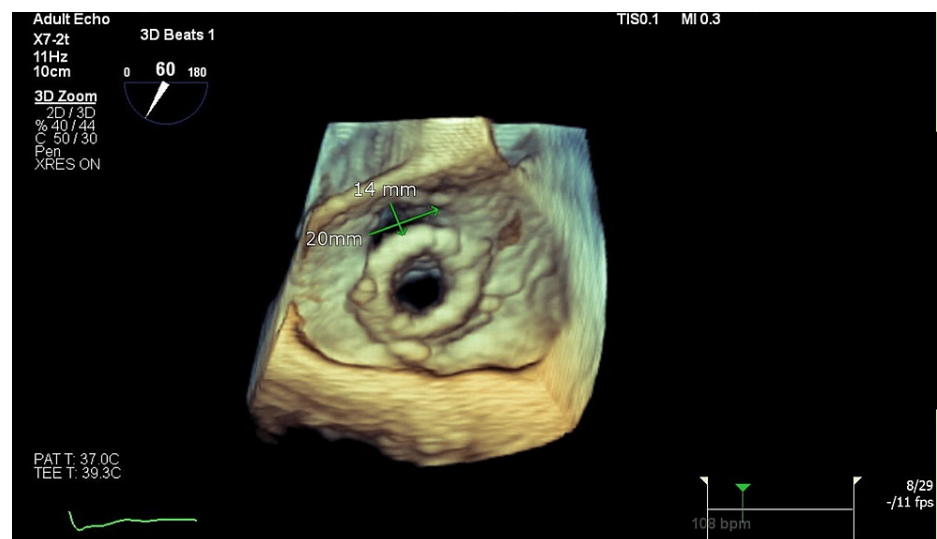
FIGURE 2: The 3D TEE shows the PVL (20 x 14 mm) defect around the bioprosthetic valve causing severe TR.

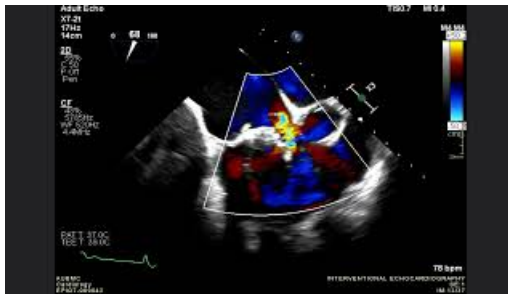
VIDEO 1: The 2D TEE of the PVL on color Doppler.

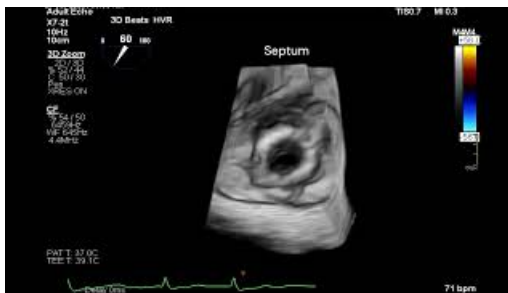
VIDEO 2: The 3D TEE of the PVL defect with regurgitation as seen by color Doppler imaging.

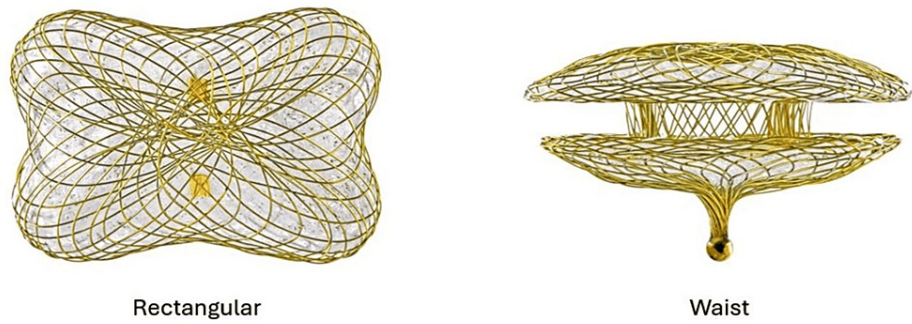
FIGURE 3: The Occlutech PVL device (18 mm x 10 mm) that was used to close the defect.

We attempted to close the PVL using ventricular septal defect (VSD) plugs measuring 14 mm x 5 mm, the largest plug available in our lab at that time, but the gap was larger than expected. Therefore, we decided to reschedule the closure until we had the appropriate size. Two weeks later, the PVL was scheduled for closure under general anesthesia from a right femoral access. An Agilis catheter (Abbott, Green Oaks, IL, USA) mounted on a JR 4.0 (Medtronic) guiding catheter was used to guide the Terumo wire (Terumo Medical Corp., Tokyo, Japan) through the PVL. A dedicated large rectangular PVL device plug (Occlutech) measuring 18 mm x 10 mm (Figure 3, Videos 3-5) was used to close the leak, reducing the regurgitation from severe to trivial (Videos 6-7).

Data regarding PVL closure post-TVIR is limited to some case reports where vascular plugs or VSD occluders were used [10–13]. Here, we demonstrated the successful closure of a large PVL using a dedicated rectangular Occlutech PVL device measuring 18 mm x 10 mm. The key to a successful closure is adequate sizing of the defect, which can be done using 3D TEE or a CT scan. Our patient developed a transient asymptomatic complete AV block after a few hours from the procedure. This is most likely related to local edema at the location of the deployed PVL device towards the septum in proximity to the AV node. However, the heart block resolved in less than 24 hours without any intervention. There is no data in the literature regarding the best time to close a PVL. The decision is case-dependent, taking into consideration the severity of the leak, the size of the defect, the stability of nearby tissue, including the TV, the risk of complication, and the availability of an appropriate PVL occluding device size. In our case, we opted to delay the procedure until we had the right size to ensure adequate closure and minimize complications.

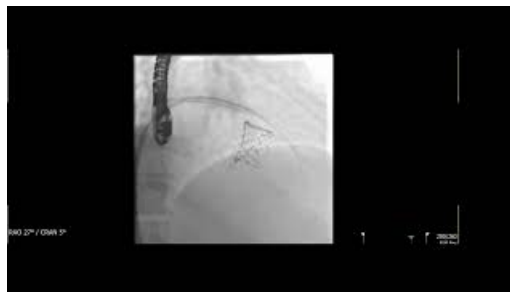
VIDEO 3: Fluoroscopic image shows the deployment of an 18 mm x 10 mm plug to close the large PVL defect.

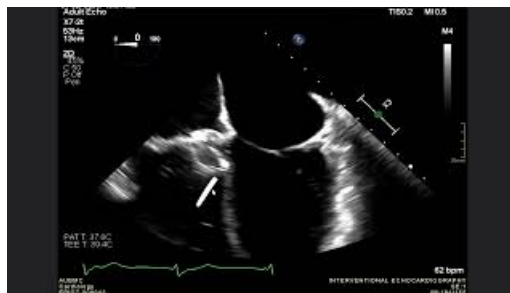
VIDEO 4: The 2D TEE view of the deployment of the plug at the site of the defect.

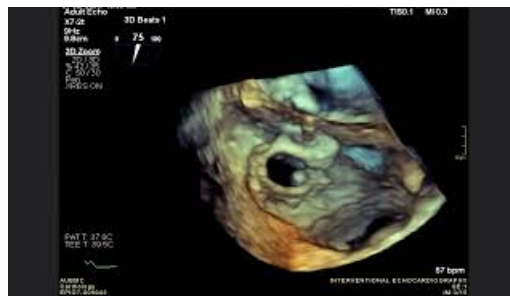
VIDEO 5: The 3D TEE view of the deployment of the plug at the site of the defect.

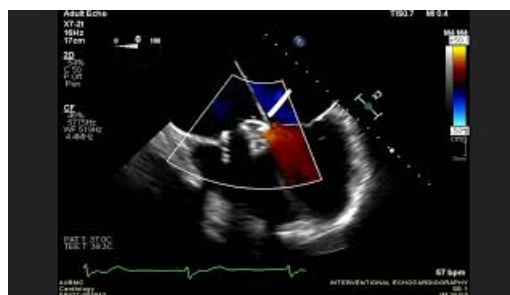
VIDEO 6: The 2D TEE view with color Doppler shows the deployment of the plug at the site of the defect.

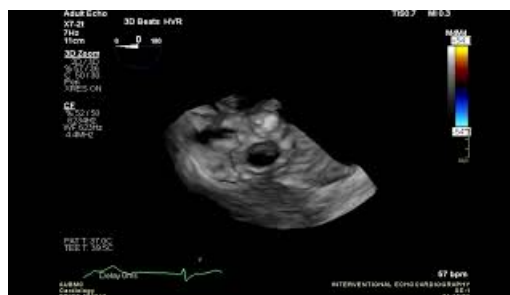
VIDEO 7: The 3D TEE view with color Doppler shows the deployment of the plug at the site of the defect.
