A Case of a Failed Hemiarthroplasty of the Hip Treated by an Extended Trochanteric Osteotomy

Abhishek Nair ¹, Archit Gupta ¹, Mukesh O. Phalak ¹, Shubhankar Chopra ¹

1. Orthopaedics, Dr. D.Y. Patil Medical College, Hospital and Research Centre, Pimpri, Pune, IND

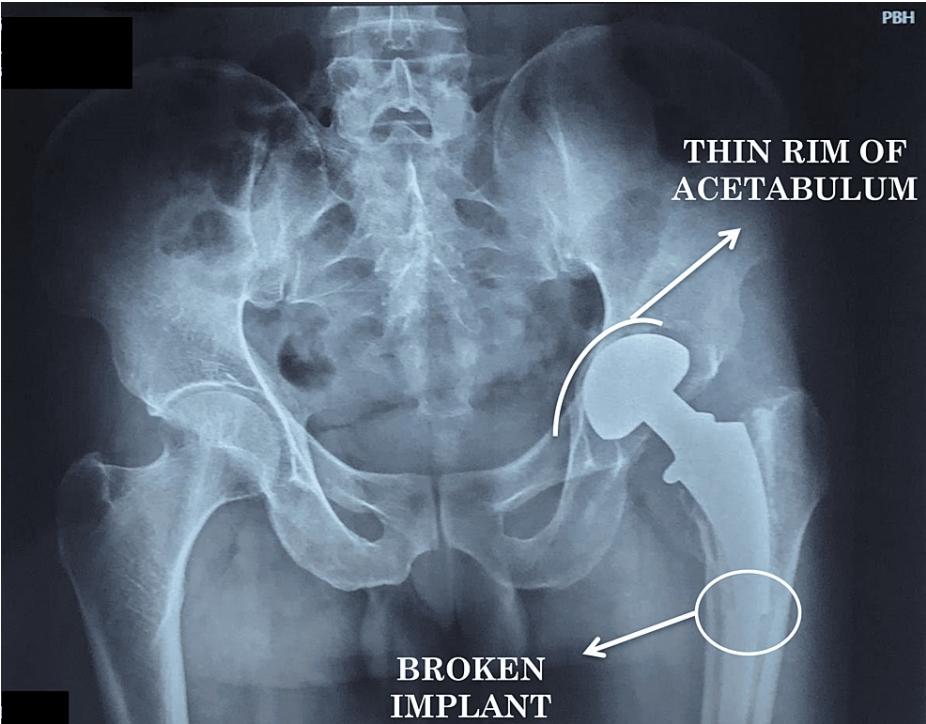
Preoperative radiographs (Figure 1, 2, 3) showed the following features: (1) thin rim of acetabulum and broken implant (Figure 1); (2) broken implant, osteolysis, and thick cement mantle (Figure 2); and (3) lateral view of the broken implant (Figure 3).

FIGURE 1: Plan radiograph of the pelvis with both hips showing the thin rim of the acetabulum and the broken implant

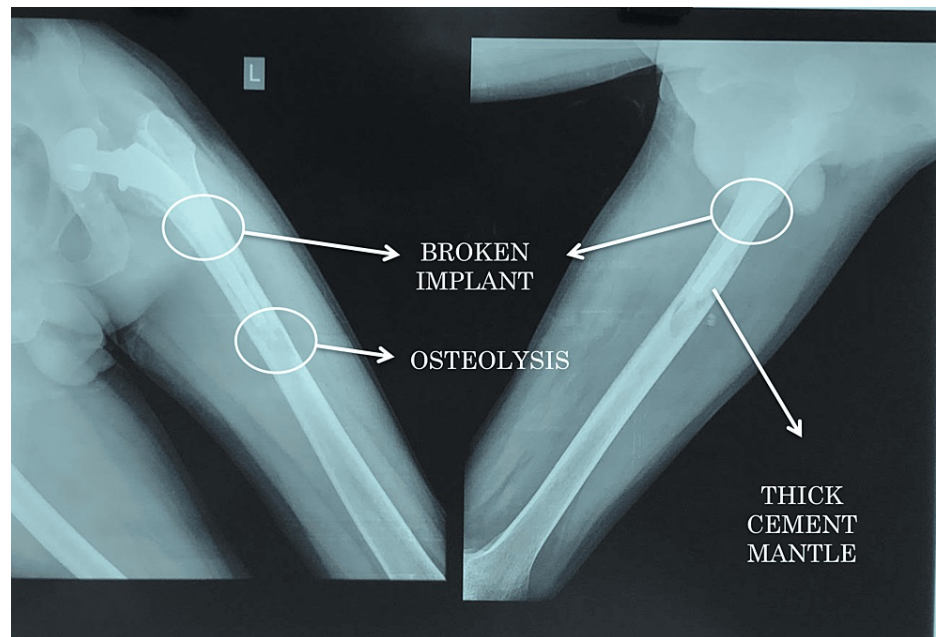
FIGURE 2: Plain radiograph of the left femur showing the broken implant, osteolysis, and thick cement mantle

The incidence of implant breakage is around 9% in previously published data [5]. Fatigue fracture of the stem in hemiarthroplasty is sparsely reported in the literature [6,7]. Distal bonding of the stem, varus alignment of the stem, obesity, and lack of proximal support at the calcar femorale causing cantilever effect and bending mode of failure are cited as the causes for fatigue fracture of the stem. Broken stems are extracted by endo-femoral or transfemoral approach [8]. In the endo-femoral approach, the stems are extracted using an extraction hook, long disc punch, or hollow mill under fluoroscopy guidance, but it is time-consuming.

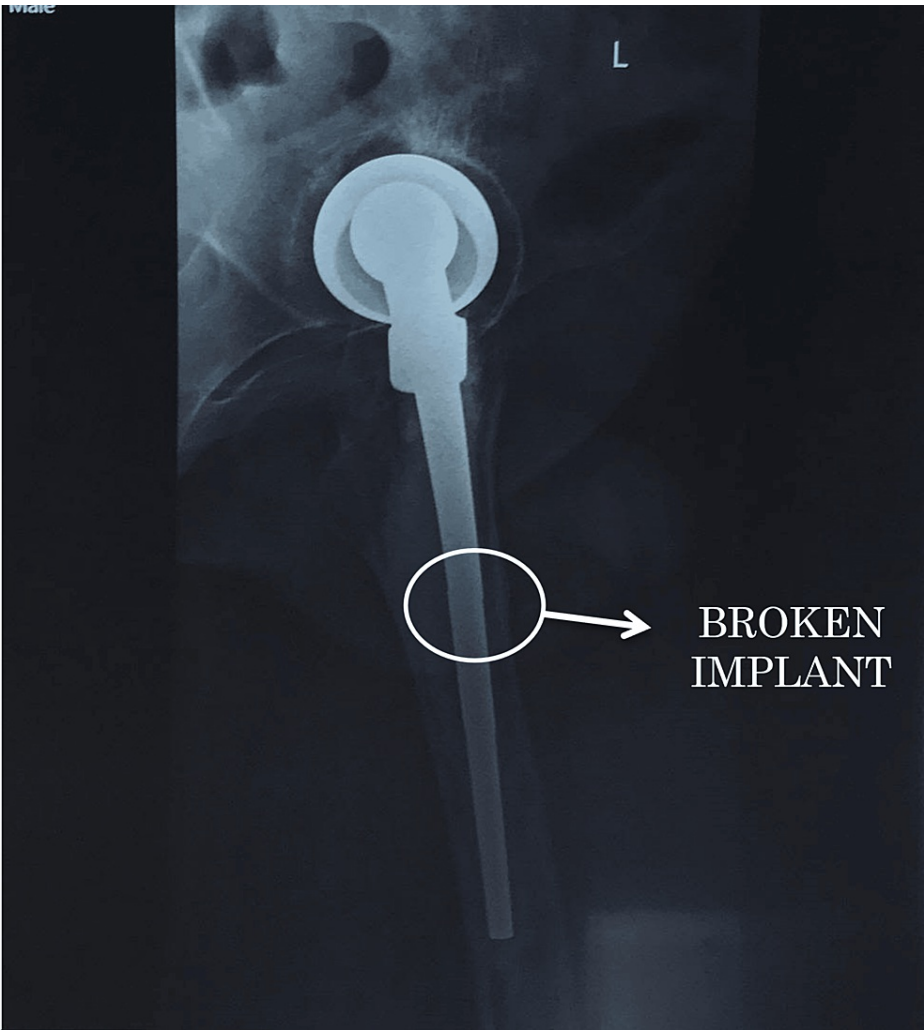
FIGURE 3: Plain radiograph of the left hip lateral view showing the broken implant

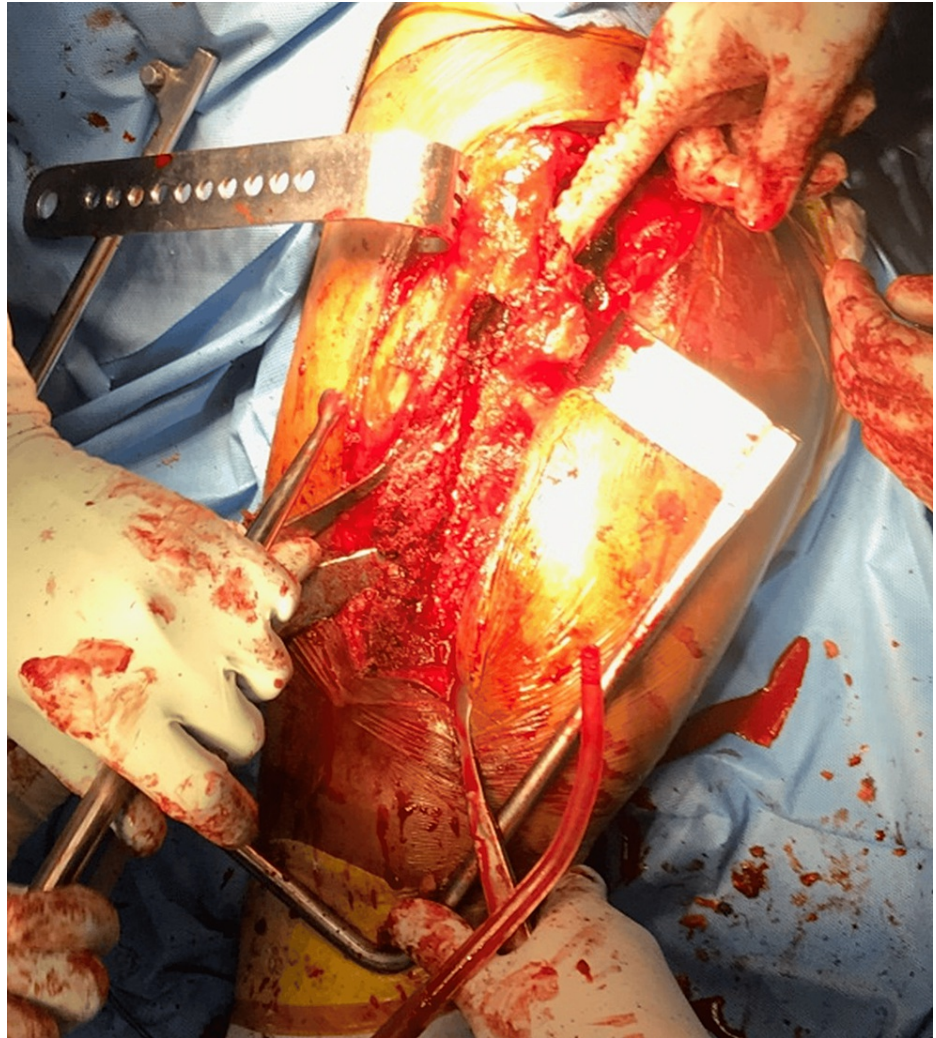
FIGURE 4: Intraoperative photograph depicting the exposure of the femoral shaft with the greater trochanter being pointed out

After all necessary preoperative evaluation, the patient was given spinal anesthesia. The patient was then placed in a right lateral position and a standard posterolateral approach was used. An ETO was planned, and a 20 cm incision was made [2]. The sciatic nerve was identified and protected during dissection. Osteotomy was marked longitudinally just lateral to the linea aspera and extending till about 4 cm proximal to the distal extent of the broken stem. The osteotomy fragment was reflected anteriorly along with its soft tissue attachments, and the lateral portion of the stem was visualized. Through manipulation, the head along with the proximal portion of the stem was extracted. The existing cement mantle and the surrounding metallosis were removed piece meal, and the distal fragment of the stem was loosened. Distal fragment was extracted, and any remaining metallosis was removed. After giving a thorough wash, an hydroxyapatite (HA)-coated Wagner stem was placed by standard procedure. Synthes cables were used to augment the femoral shaft.

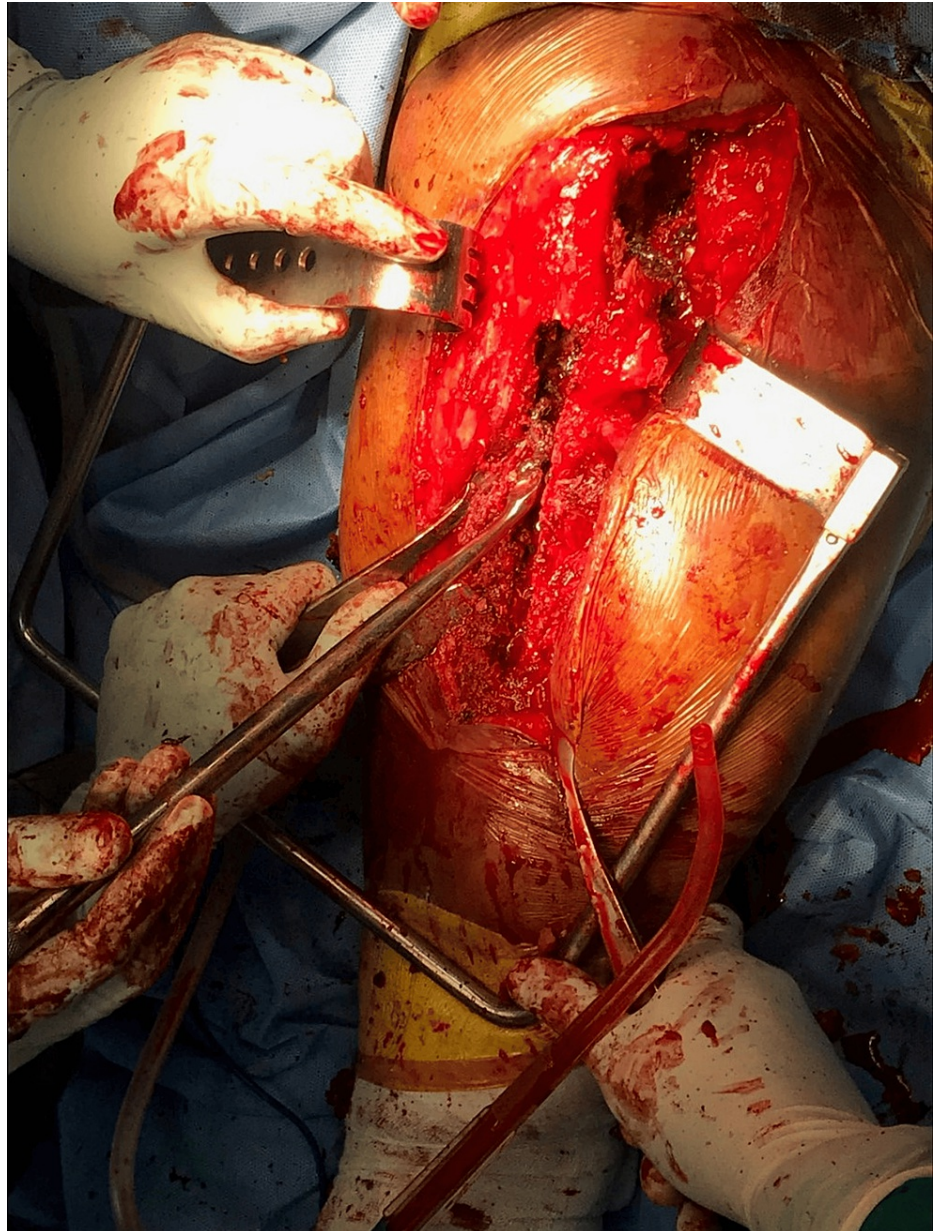
FIGURE 5: Intraoperative photograph showing the extended trochanteric osteotomy

Extended trochanteric osteotomy was done to remove the cement

ETO was necessitated in our case due to the broken stem and long interval from index surgery. ETO provides several advantages such as providing superior visualization of the acetabulum and proximal femur, facilitating meticulous removal of existing implants, and thorough assessment of the bone quality. ETO allows for easier extraction of well-fixed implants, reducing the risk of intraoperative fractures and minimizing soft tissue damage. In cases of severe bone loss or malpositioned components, ETO enables precise restoration of the hip center, optimizing biomechanics and implant stability. By providing greater access to the femoral canal and acetabulum, ETO facilitates accurate placement and fixation of revision components, thereby improving long-term outcomes. Careful handling of the trochanteric fragment during ETO preserves the integrity of surrounding soft tissues, promoting faster rehabilitation and reducing the risk of postoperative complications.

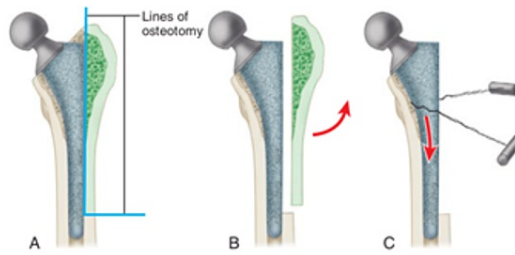
FIGURE 3-149 Extended trochanteric osteotomy for difficult stem removal. **A**, Longitudinal portion of osteotomy follows lateral border of stem and extends distally to predetermined level. **B**, Anterior cortex is divided, and entire lateral cortical segment, with trochanter, is retracted anteriorly, exposing lateral surface of stem. **C**, Bone ingrowth is disrupted with Gigli saw passed down medial side of stem. **SEE TECHNIQUE 3-12.**

FIGURE 6: Description of an extended trochanteric osteotomy

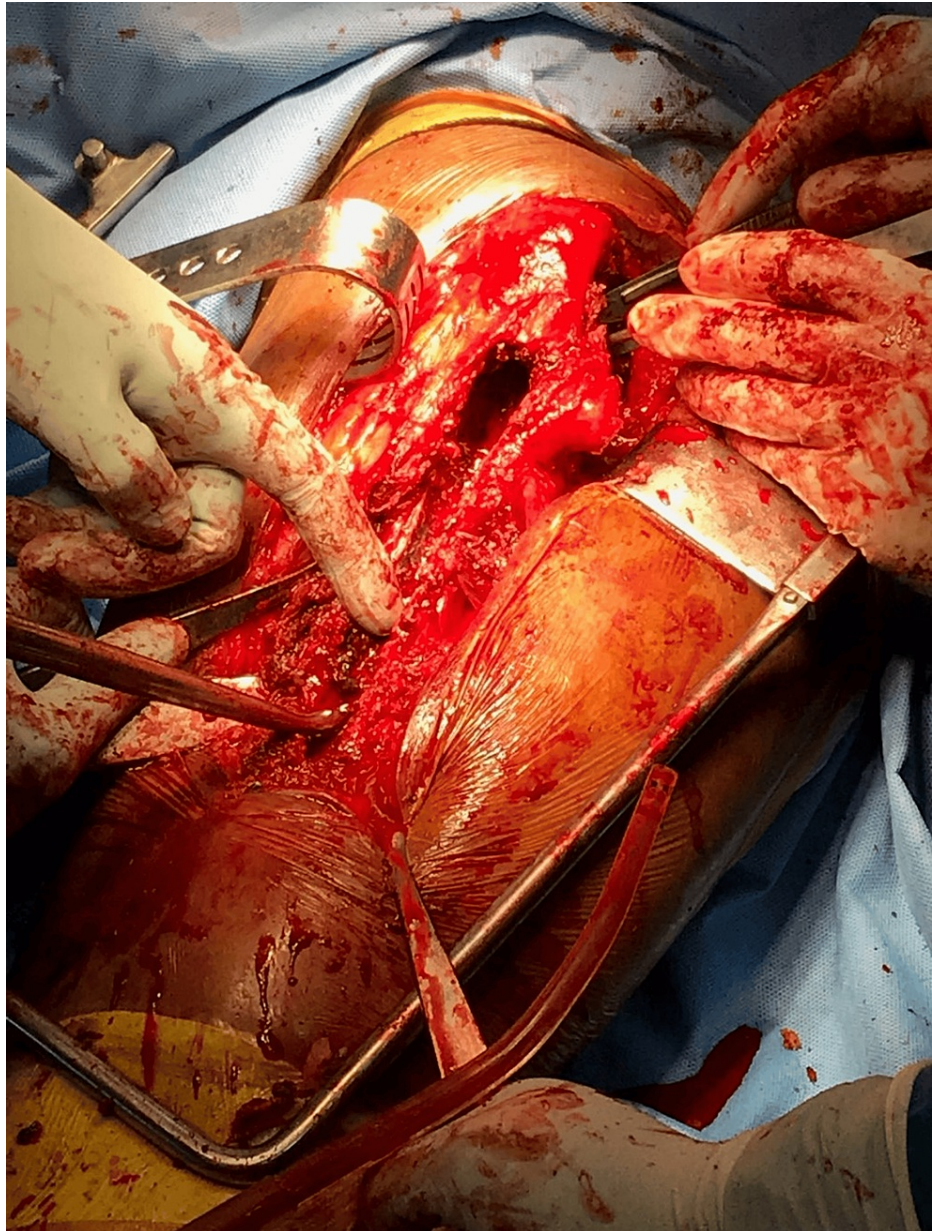
FIGURE 7: Intraoperative photograph showing the femoral canal after clearing all the cement debris

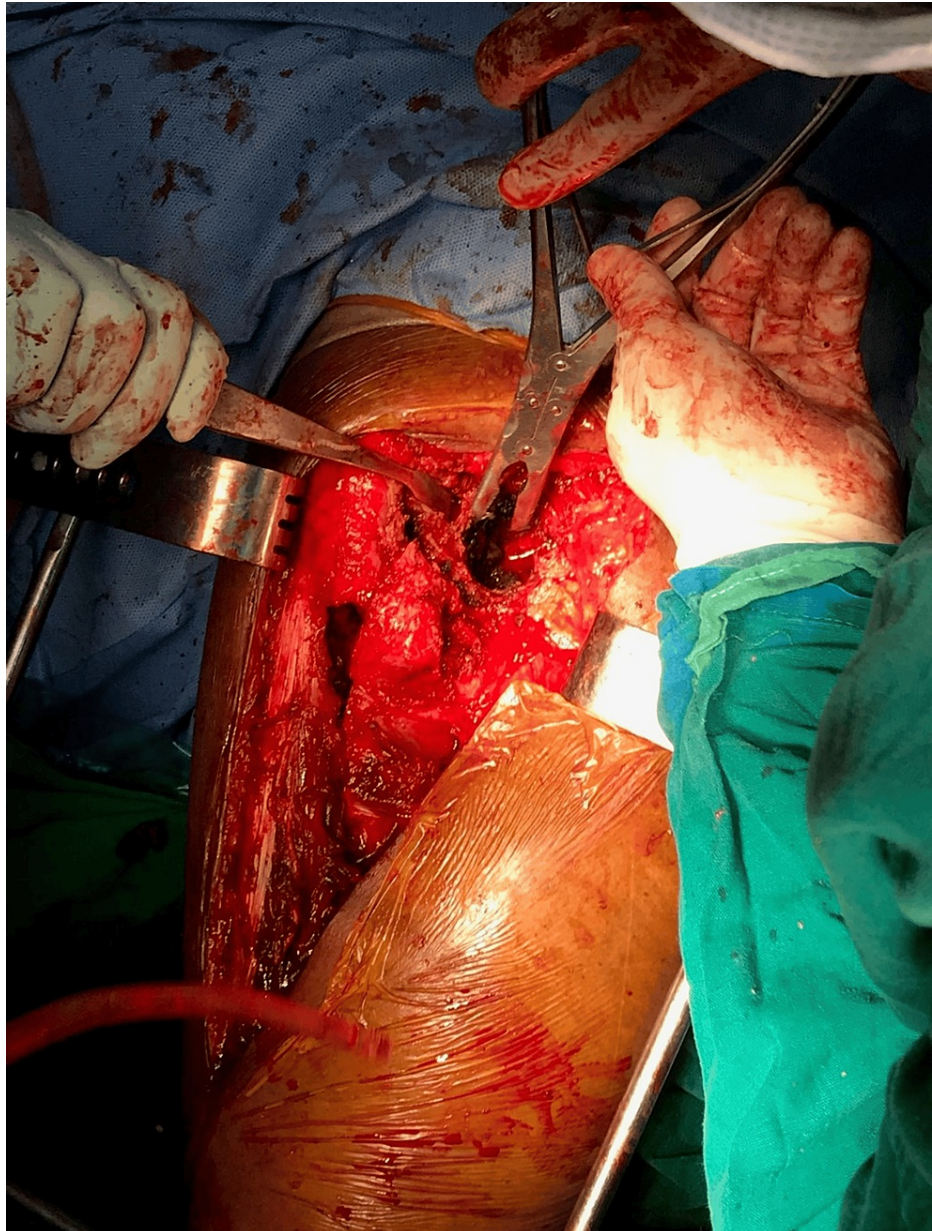
FIGURE 8: Intraoperative photograph showing the removal of the metallosis

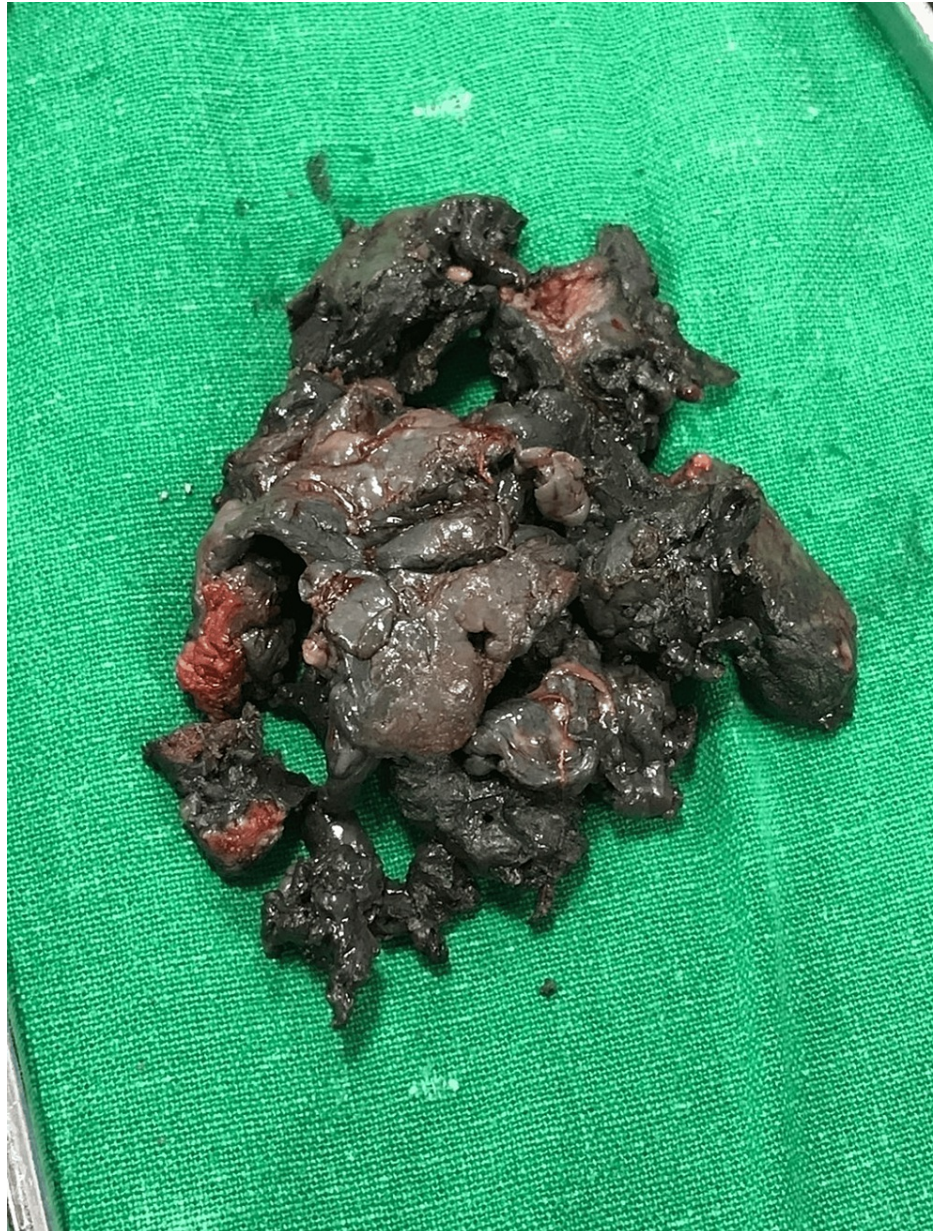
FIGURE 9: Clinical photograph of the metallosis that was removed

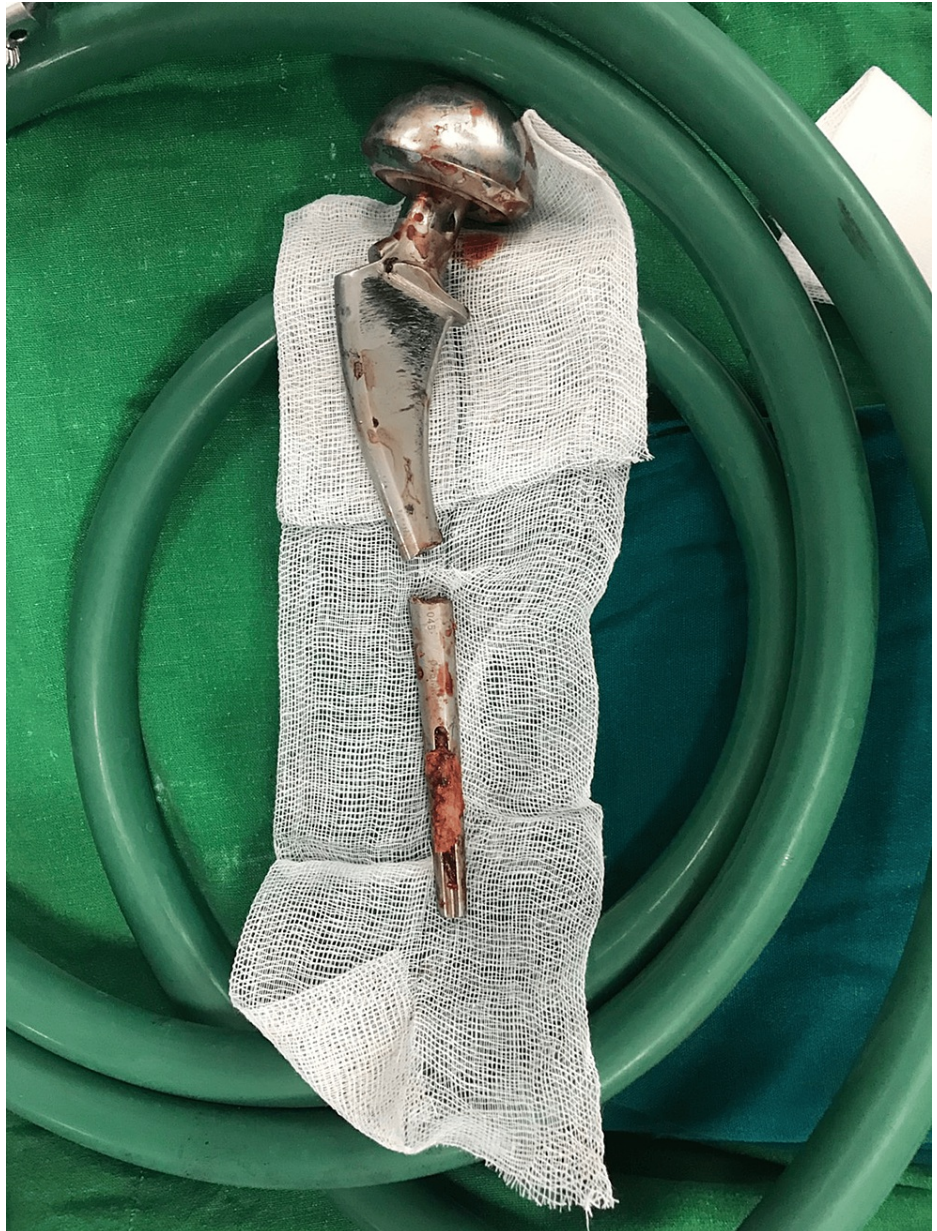
FIGURE 10: Clinical photograph of the original bipolar implant after removal

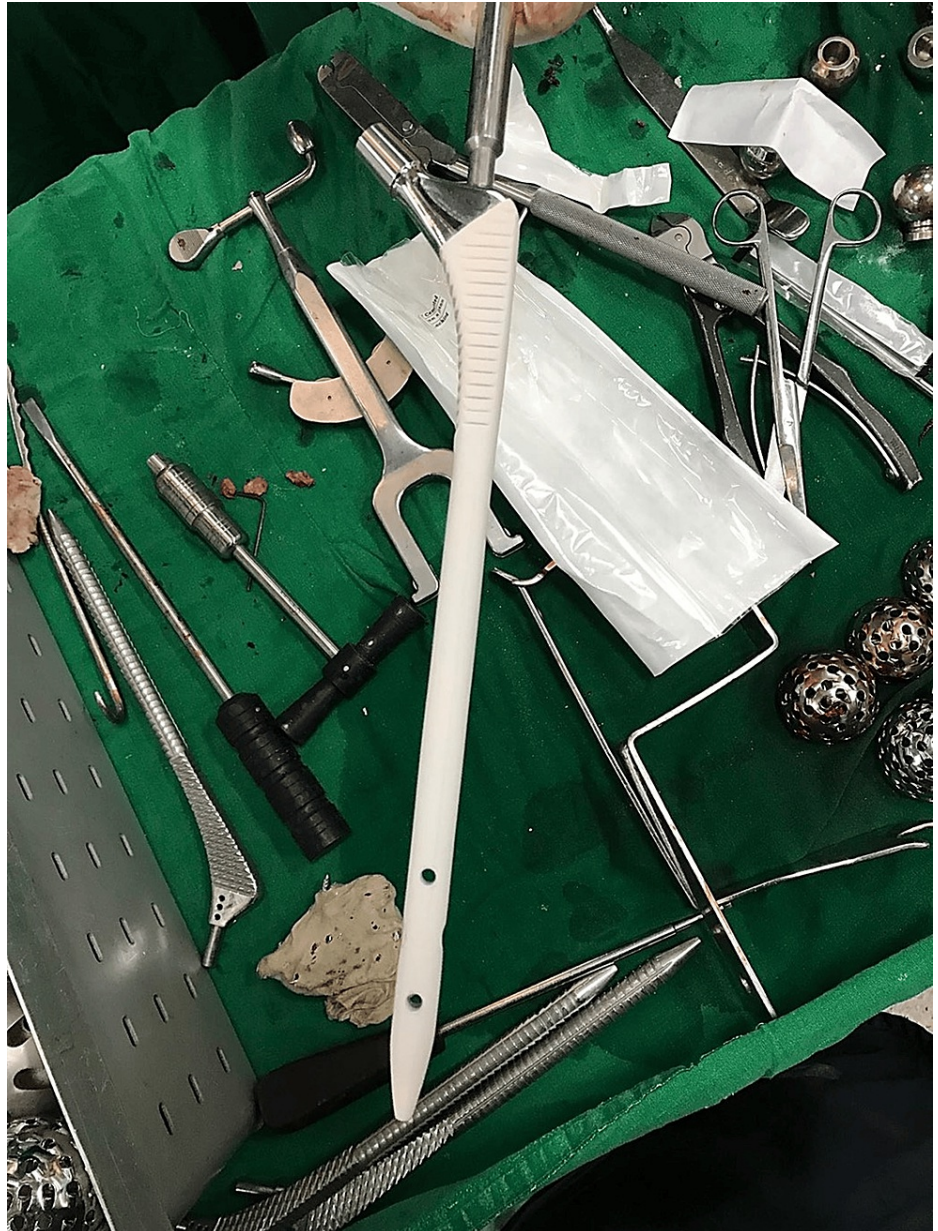
FIGURE 11: Clinical photograph of the new implant

Gen-X long stem, stainless steel

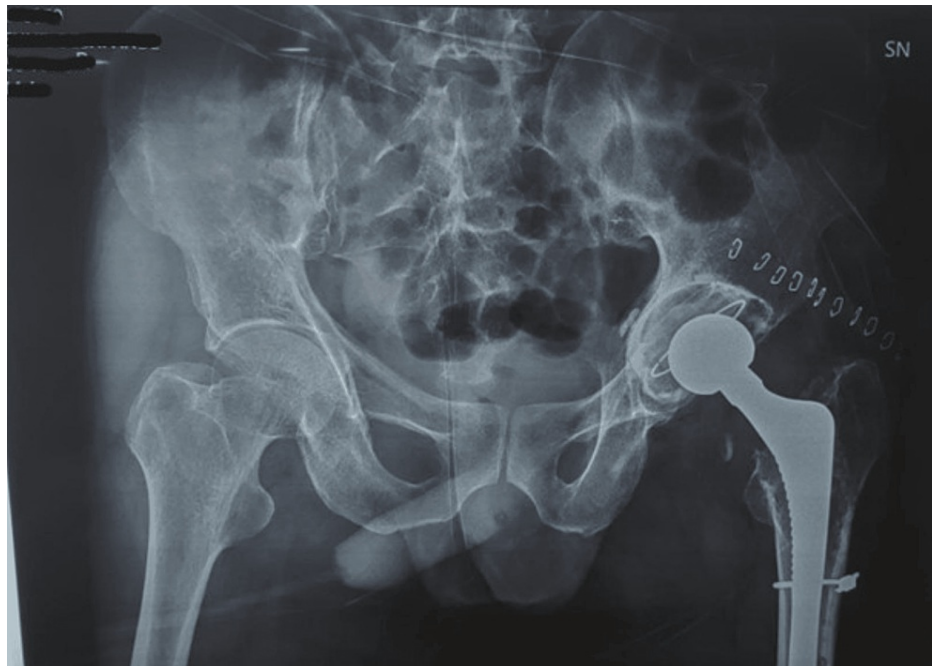
FIGURE 12: Postoperative plain radiograph of the pelvis with both hips

Anatomical reduction was achieved, and the osteotomy flap was fixed in place with DePuy Synthes Cables

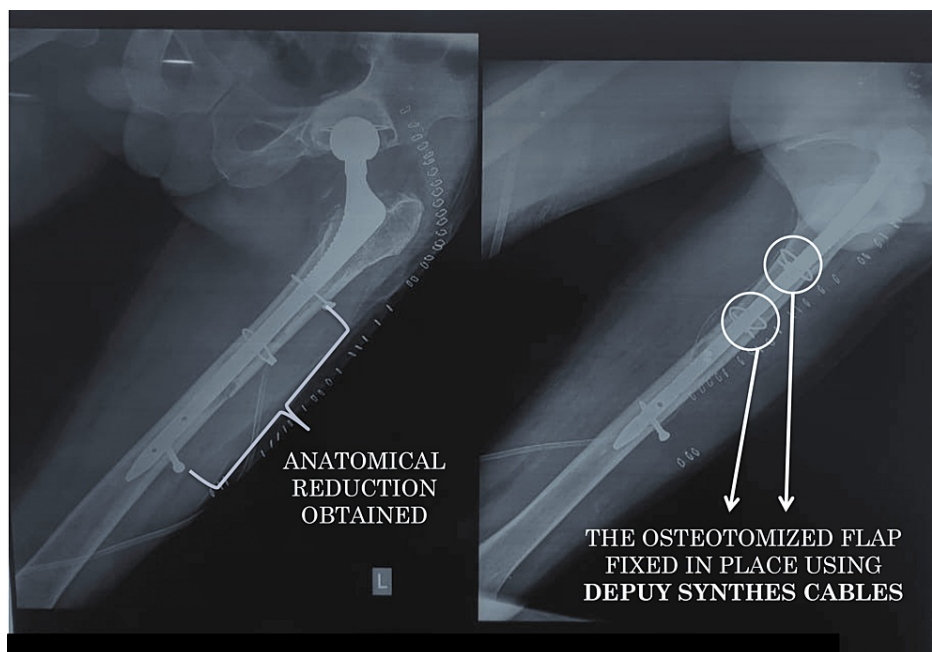
FIGURE 13: Postoperative plain radiograph of the left femur
