Delayed Bladder Perforation Resulting From Large Bladder Stone and Gluteal Abscess Caused by Pelvic Plate Loosening: A Case Report

Categories: Orthopedics, Trauma

Keywords: bridge plate, gluteal abscess, plate loosening, delayed bladder perforation, pelvic ring injury

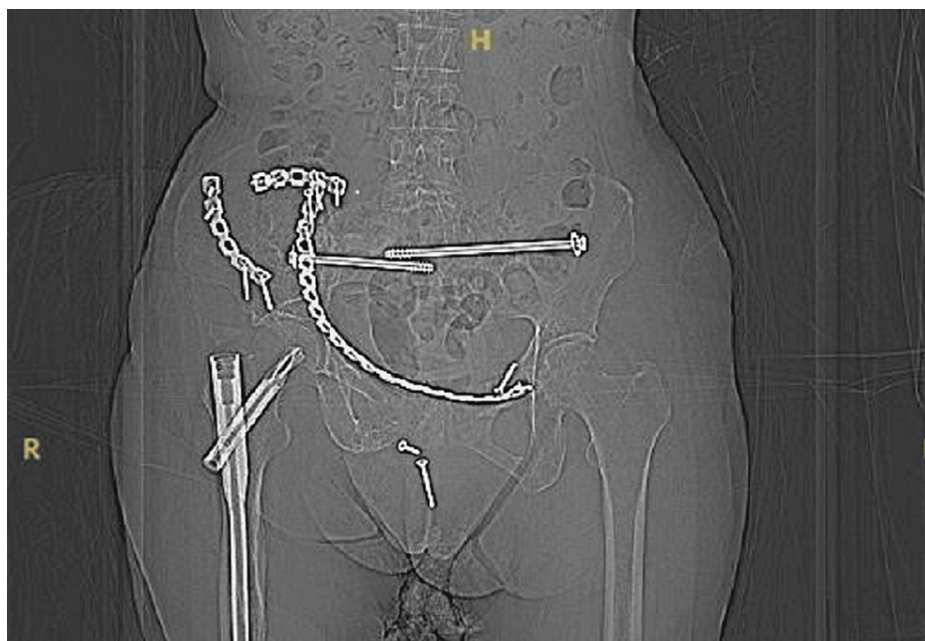
FIGURE 1: Radiograph upon admission showing the anterior pelvic bridge plate extending from the right ilium to the left pubic region, two reconstruction plates over the right iliac fossa, and three sacral screws inserted to fix bilateral sacral fractures.

Three migrated screws were detected in the pelvic region.

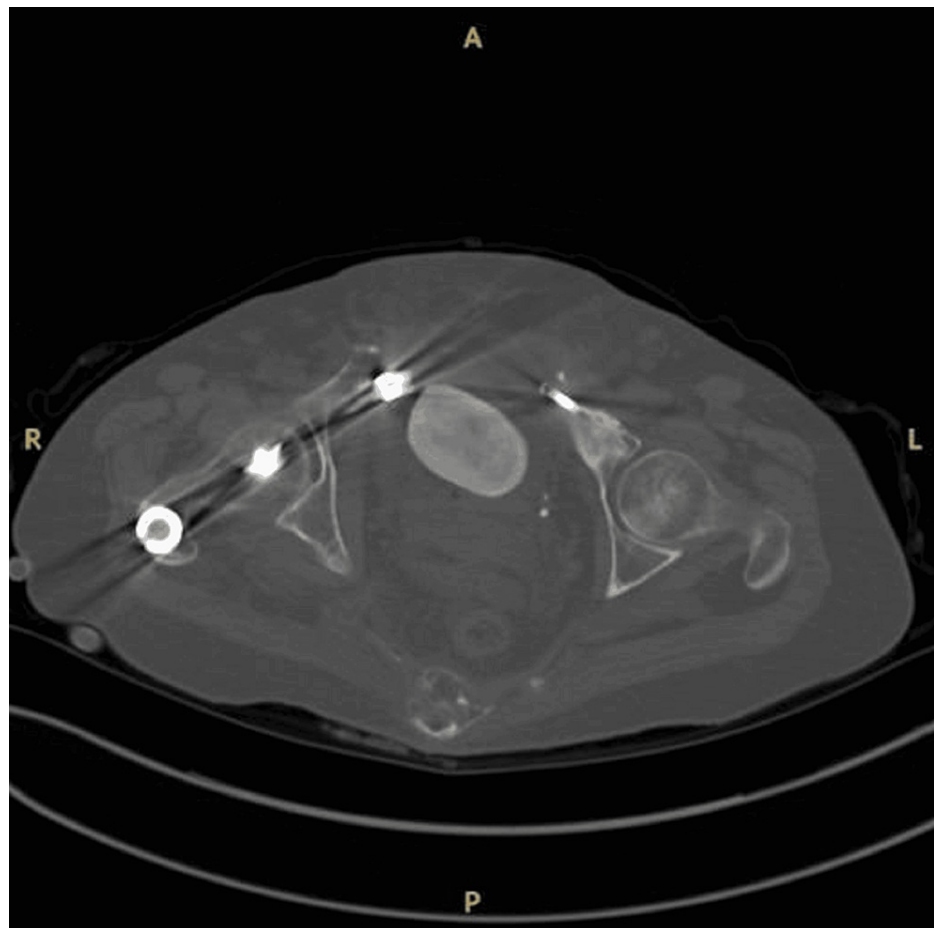
FIGURE 2: Abdominal computed tomography showing a 5-6 cm bladder stone.

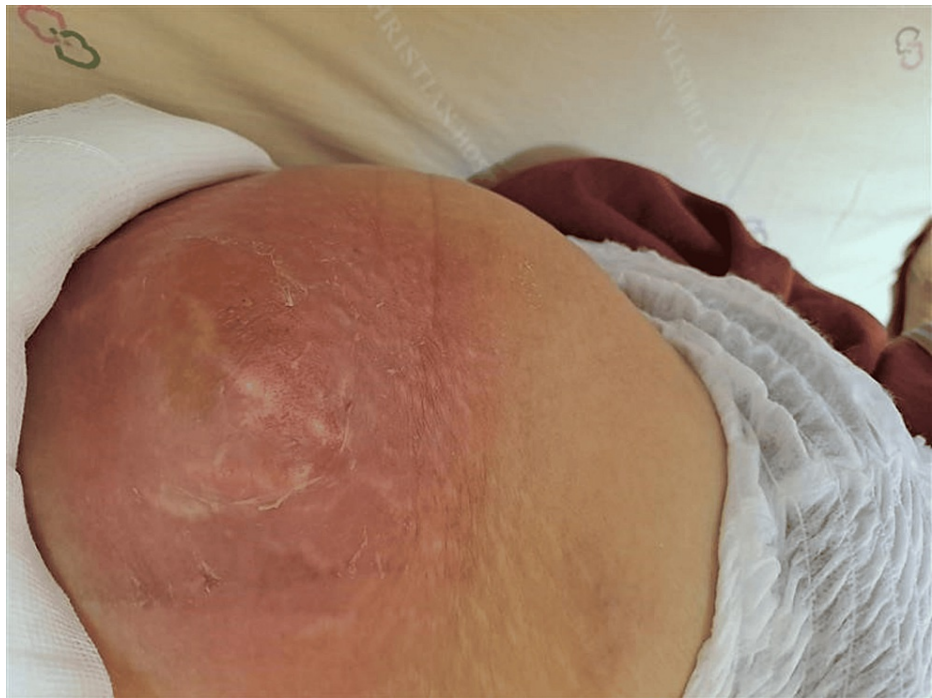
FIGURE 3: The abscess over the left gluteal region.

Six months later, the patient noticed local swelling with redness in the left gluteal region, which enlarged progressively. Moreover, her lower abdominal pain persisted. She thus visited our outpatient department and underwent aspiration for the left hip mass (Figure 3). However, her symptoms persisted, and she again visited our orthopedic outpatient department. Laboratory tests revealed elevated C-reactive protein levels (7.055 mg/dL) and leukocytosis resulting from a left gluteal abscess. The patient requested the removal of the three migrated screws around her pelvic area; accordingly, she was admitted to the orthopedic ward for surgical screw removal and abscess debridement. However, during the surgery, a 5-cm bladder rupture was noted. Moreover, one segment of the bridge plate was detected in the bladder cavity and was covering the stone. The bridge plate had multiple bladder stones attached and was removed. Furthermore, one reconstruction plate and two of the three cannulated screws were removed sequentially (Figure 4). The bladder wall defect was debrided and closed using two layers of 3-0 catgut and Vicryl sutures. The abscess over the left gluteal region was also debrided. Subsequent wound culture revealed the presence of oxacillin-resistant *Staphylococcus aureus*. The patient underwent another debridement of the abscess 10 days later because of poor healing.

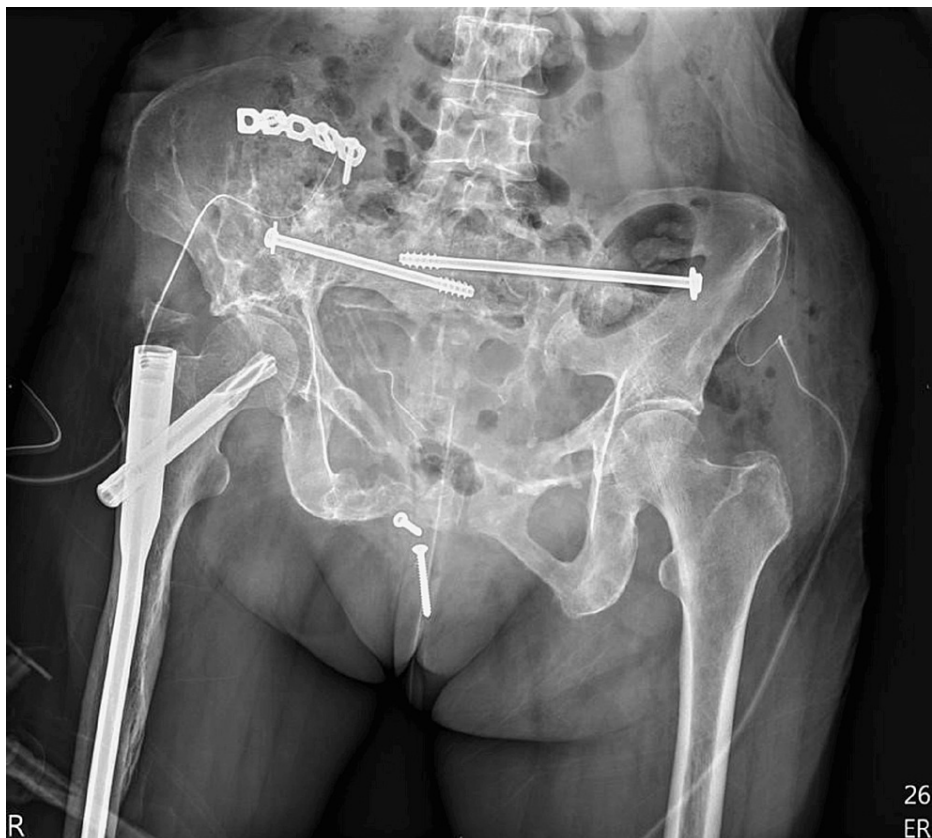
FIGURE 4: The loosening plate extending from the right ilium to the left pubic region and one reconstruction plate were removed.

After the surgery and 14 days of antibiotic treatment, the patient was discharged in stable condition. During two-month follow-up, the abscess region recovered almost completely. Moreover, the patient's lower

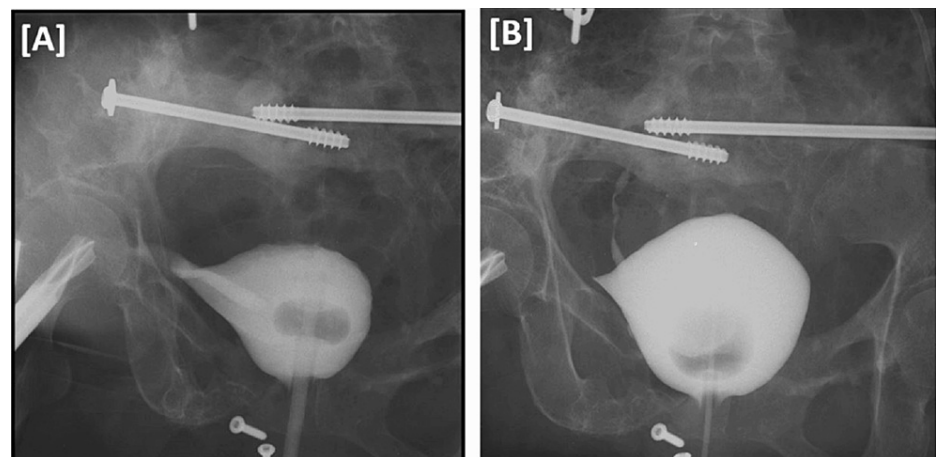
FIGURE 5: Cystogram performed.

(A) Cystogram performed two weeks after hardware removal and bladder repair showing the tract formed by the bridge plate from the bladder to the retroperitoneal space. (B) Cystogram performed one month after surgery showing a decrease in the tract with no significant leakage.

abdominal pain and dysuria were resolved. Follow-up cystograms revealed good healing of the bladder rupture (Figures 5A, 5B).
