# Rare Central Venous Catheter Malpositions: A Case Series

**Categories:** Anesthesiology, Medical Education, Radiology

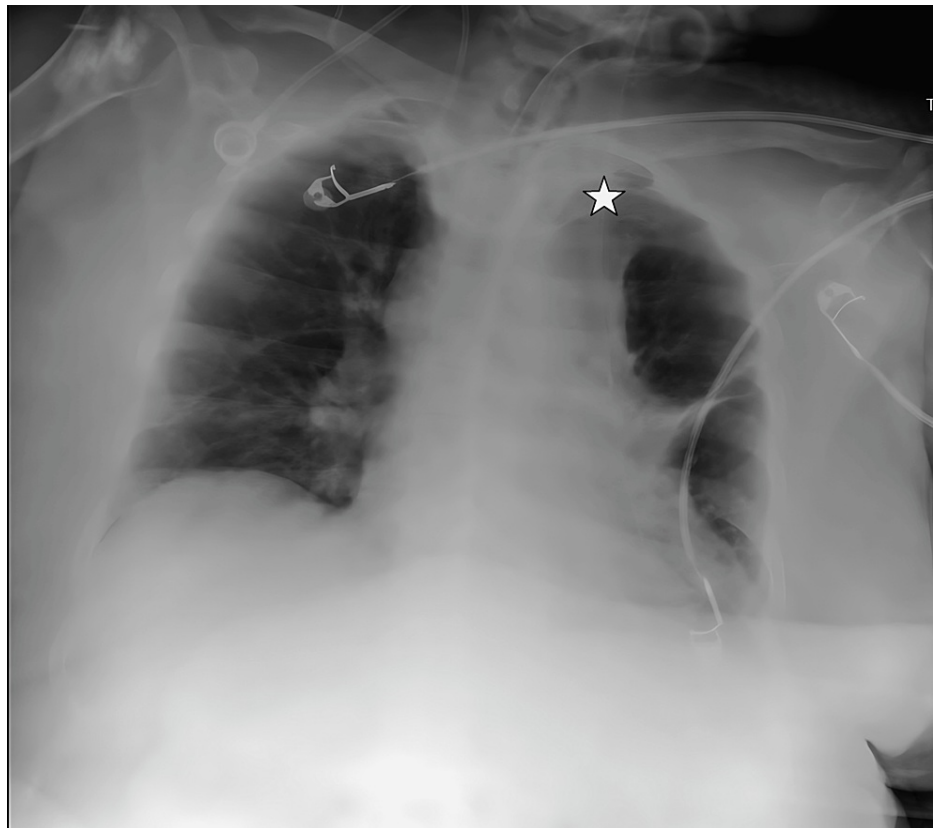
**FIGURE 1: CVC transition from the right subclavian vein to the left brachiocephalic vein on chest radiograph imaging.**

The star symbol shows the tip of the catheter.

The catheter was fixed at 12 cm. Blood was taken from all three lines of the catheter. Postprocedural evaluation of posteroanterior chest radiograph imaging revealed that the catheter was placed on the opposite side of the brachiocephalic vein (Figure 1).

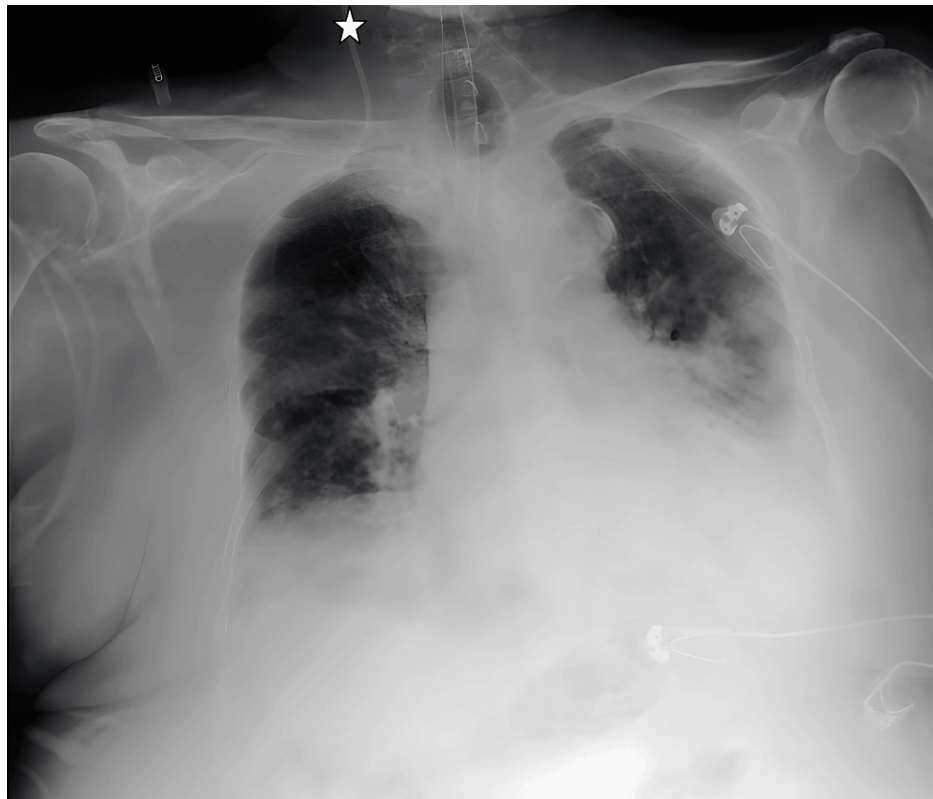
**FIGURE 2: CVC transition from the right subclavian vein to the right internal jugular vein on chest radiograph imaging.**

The star symbol shows the tip of the catheter.

A 90-year-old female patient with hypertension, hypothyroidism, obesity (BMI 37), and dementia was admitted to the intensive care unit as a result of COVID-19 pneumonia. On the 23rd day of the patient, who was still hospitalized due to pneumonia, a 7-French triple lumen catheter was placed in the right SCV using the Seldinger technique, without USG guidance, for CVC replacement. The catheter was fixed at 13 cm. Blood was taken from all three lines of the catheter. Postprocedural evaluation of posteroanterior chest radiograph imaging revealed that the catheter was inserted into the right IJV (Figure 2).

Another factor that makes it difficult to insert the central catheter using a blind technique is the difficulty in determining the patient's BMI and anatomical intervention areas [8]. In Case 2, the patient's obesity may be the cause of malposition.

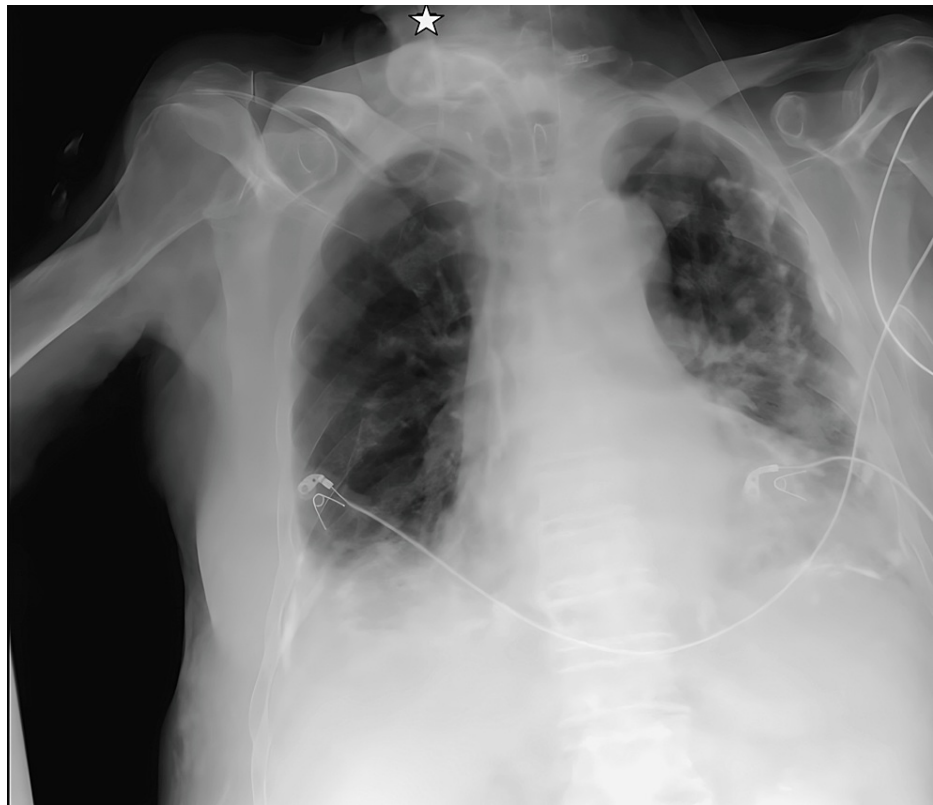
**FIGURE 3: Transition from the right subclavian vein to the right internal jugular vein on chest X-ray imaging.**

The star symbol shows the tip of the catheter.

An 88-year-old male patient was admitted to intensive care with a diagnosis of septic shock. The patient was planned to have a CVC catheter inserted on the 27th day for inotropic treatment and high-volume fluid replacement. A 7-French triple-lumen catheter was placed in the right SCV using the Seldinger technique under USG guidance. The catheter was fixed at 12 cm. Blood was aspirated from all three lines of the catheter. When the posteroanterior chest radiograph was evaluated, the catheter was seen to move from the right SCV to the right IJV (Figure 3). The intervention was repeated from the left SCV. After the procedure, posteroanterior chest radiograph imaging was evaluated, and this time it was observed that the catheter was placed in the left IJV (Figure 4).

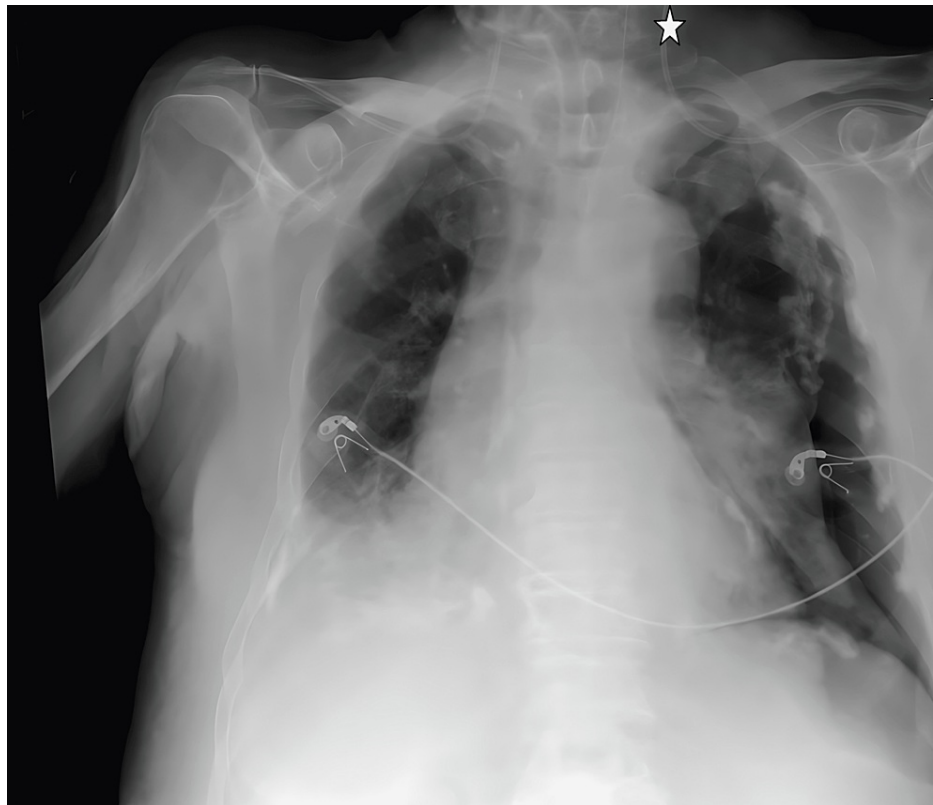
**FIGURE 4: Transition from the left subclavian vein to the left internal jugular vein on chest X-ray imaging.**

The star symbol shows the tip of the catheter.

Bedel et al. stated that malposition cases can be minimized by guidewire localization guided by transesophageal echocardiography (TEE) [9]. If this technique had been used in the third case, in which the central catheter procedure was tried twice in the treatment of the patient, the same complications could have been prevented in the second attempt. It is possible that rotation towards the ipsilateral IJV is due to anatomical problems. The patient is 88 years old and age-related osteoporosis, changes in anatomical structures and vascular changes can cause this.

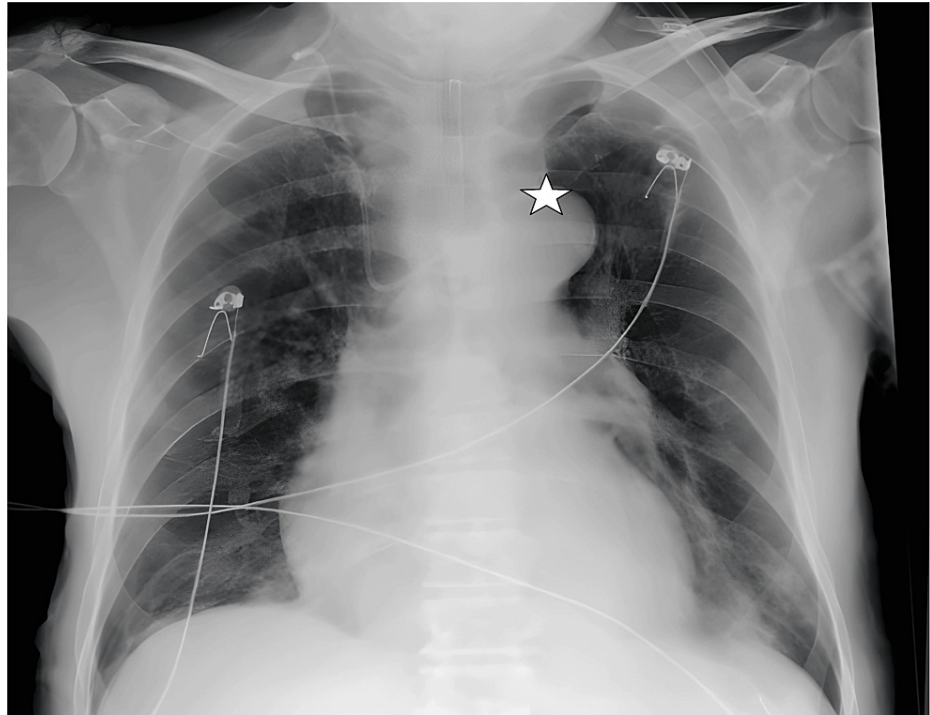
**FIGURE 5: Kink of the catheter in the internal jugular vein on chest X-ray imaging, return from the right brachiocephalic vein to the left brachiocephalic vein.**

The star symbol shows the tip of the catheter.

A 71-year-old male patient with diabetes mellitus, coronary artery disease, and hypertension was admitted to the intensive care unit due to diabetic ketoacidosis. On the 43rd day of hospitalization, the patient developed acute renal failure and peripheral arterial circulation disorder during his treatment in the intensive care unit. A 7-French triple lumen catheter was placed in the right IJV using the Seldinger technique, without USG guidance, for CVC replacement. The catheter was fixed at 14 cm. Blood was extracted from all three lines of the catheter. During the posteroanterior chest radiograph imaging following the procedure, we observed that the catheter kinked in the right IJV and passed from the right brachiocephalic vein to the left brachiocephalic vein (Figure 5).

During the CVC placement process using the Seldinger technique, it is critical to ensure that blood can flow freely and that no resistance occurs when placing the guidewire [2]. During CVC placement, in our fourth case, there was a sticking sensation during guidewire placement.

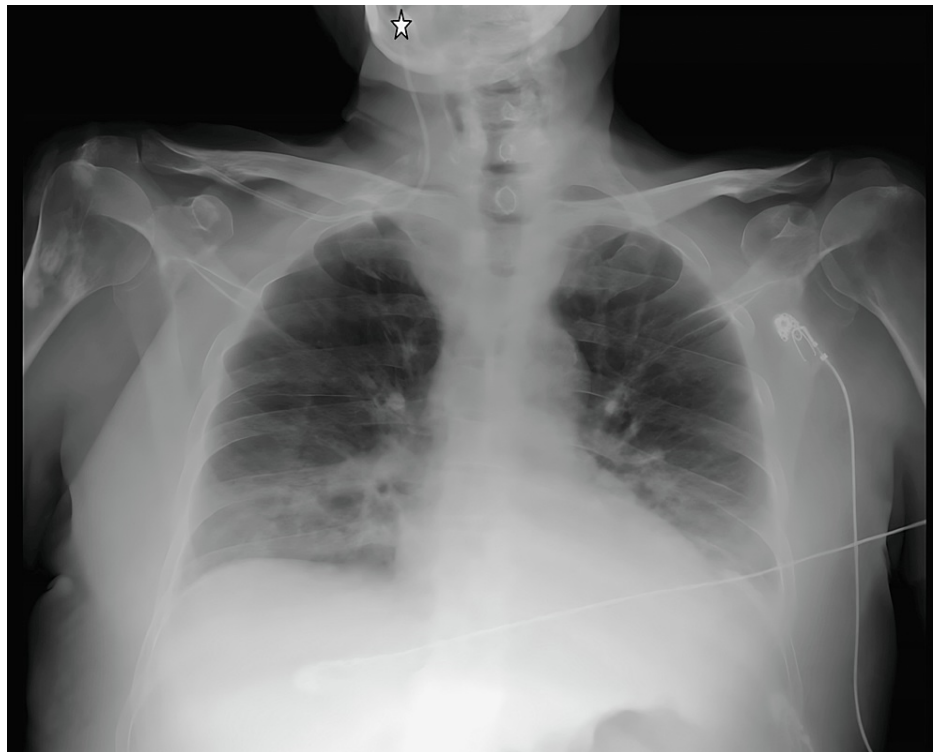
**FIGURE 6: Transition of the catheter from the right subclavian vein to the right internal jugular vein on chest X-ray imaging.**

The star symbol shows the tip of the catheter.

A 66-year-old male patient with coronary artery disease and hypertension was admitted to the intensive care unit after cardiopulmonary resuscitation. On the 12th day of the patient, who was hospitalized due to pneumonia, a 7-French triple lumen catheter was inserted into the right SCV using the Seldinger technique, without USG guidance, for CVC replacement. The catheter was fixed at 13 cm. Blood was extracted from all three lines of the catheter. After the procedure, the posteroanterior chest radiograph imaging revealed the placement of the catheter in the right IJV (Figure 6).
