Ventriculoperitoneal Shunt Malfunction Due to a Fibrous Capsule Obstructing the Peritoneal Catheter

Categories: Neurosurgery, Healthcare Technology

Keywords: ventriculoperitoneal shunts, obstruction, fibrous capsule, peritoneal catheter

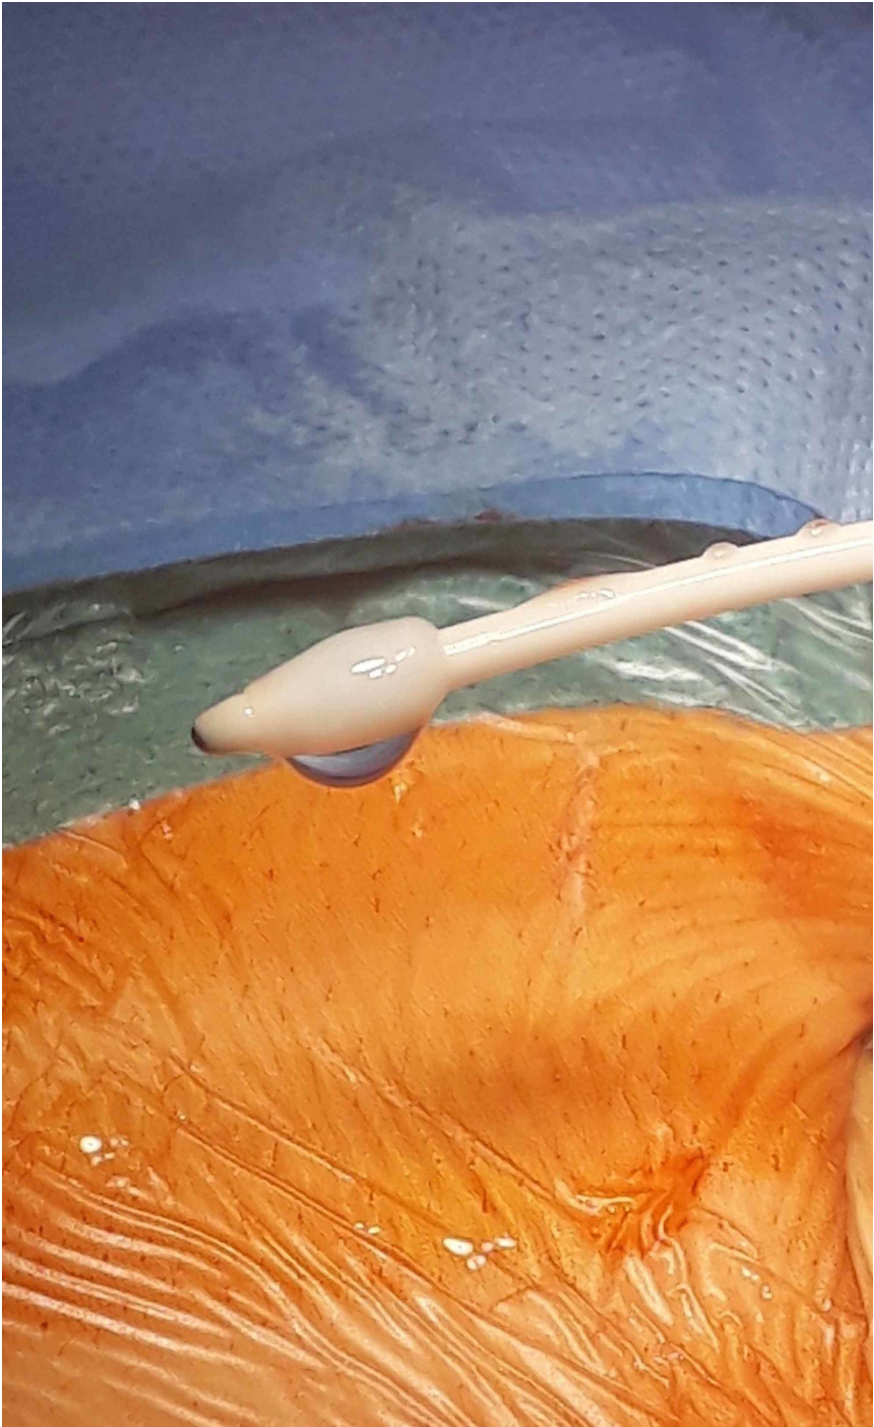
FIGURE 2: Peritoneal catheter with fibrous sheath encasing the side slits at the distal end of the catheter but not the tip itself

He was taken to the theatre where his previous abdominal incision was reopened and the peritoneal catheter located. During delivery of the peritoneal catheter from the peritoneal cavity, resistance was encountered at the peritoneum. The peritoneum was opened further to allow delivery of the distal tip of the peritoneal catheter. The distal end (around the side slits in the catheter, but not the tip itself), was found to be encased in a 1 cm long bulbous fibrotic sheath (Figures 2-3). Clear fluid (subsequently confirmed to be sterile CSF) was dripping from the catheter tip, albeit very slowly. Upon removal of this bulbous fibrotic sheath, CSF began to flow at a greater rate through the catheter (Figure 4). Additional perforations were cut into the side of the catheter, which was then placed back inside the peritoneal cavity. The cranial wound was not opened and as such, the ventricular catheter and valve were not exposed.

A pathophysiological foreign body response to the peritoneal catheter involving mesothelial cells has been proposed to be the cause of the development of these fibrous capsules; however, this does not explain why the fibrotic capsule was limited to, and only encased the side slits at the distal end of the catheter (Figure 2) [8]. Alternatively, progressive debris accumulation in the dead space beneath the side slits may also lead to the formation of granulomatous nodules [9]. Additionally, Del Bigio et al. showed that graphite, used to coat the side slits in peritoneal catheters in order to keep them patent during storage, incites a chronic inflammatory response with subsequent deposition of granulomatous tissue which blocks the slits alone and leads to obstruction [10]. This would explain why the fibrous sheath encased only the side slits and not the remainder of the peritoneal catheter in our case.

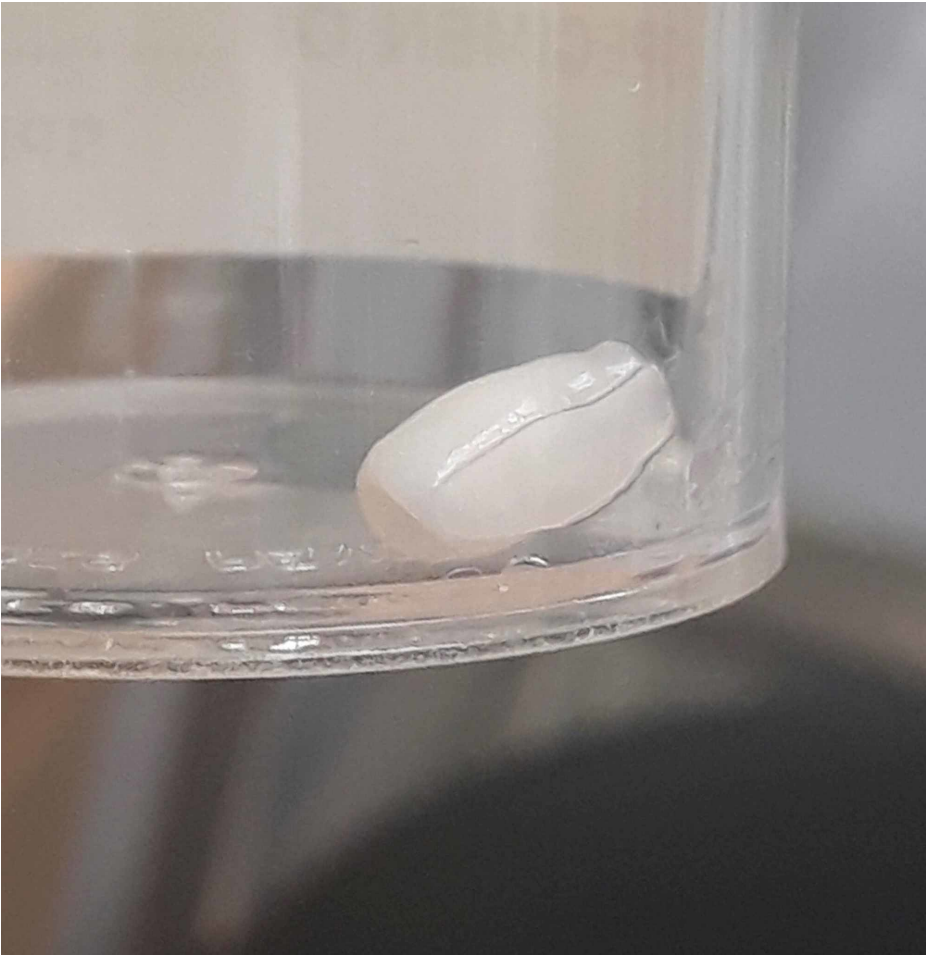
FIGURE 3: Fibrous capsule after removal

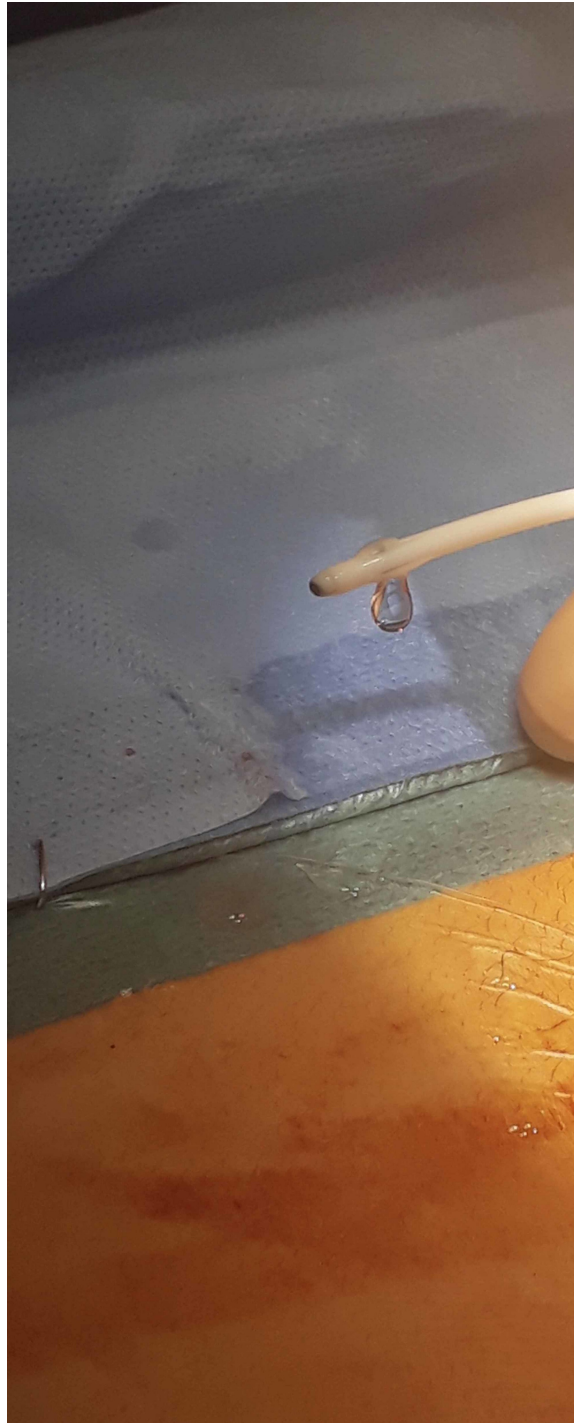
FIGURE 4: Distal catheter tip after removal of fibrous capsule, with patent slits visible

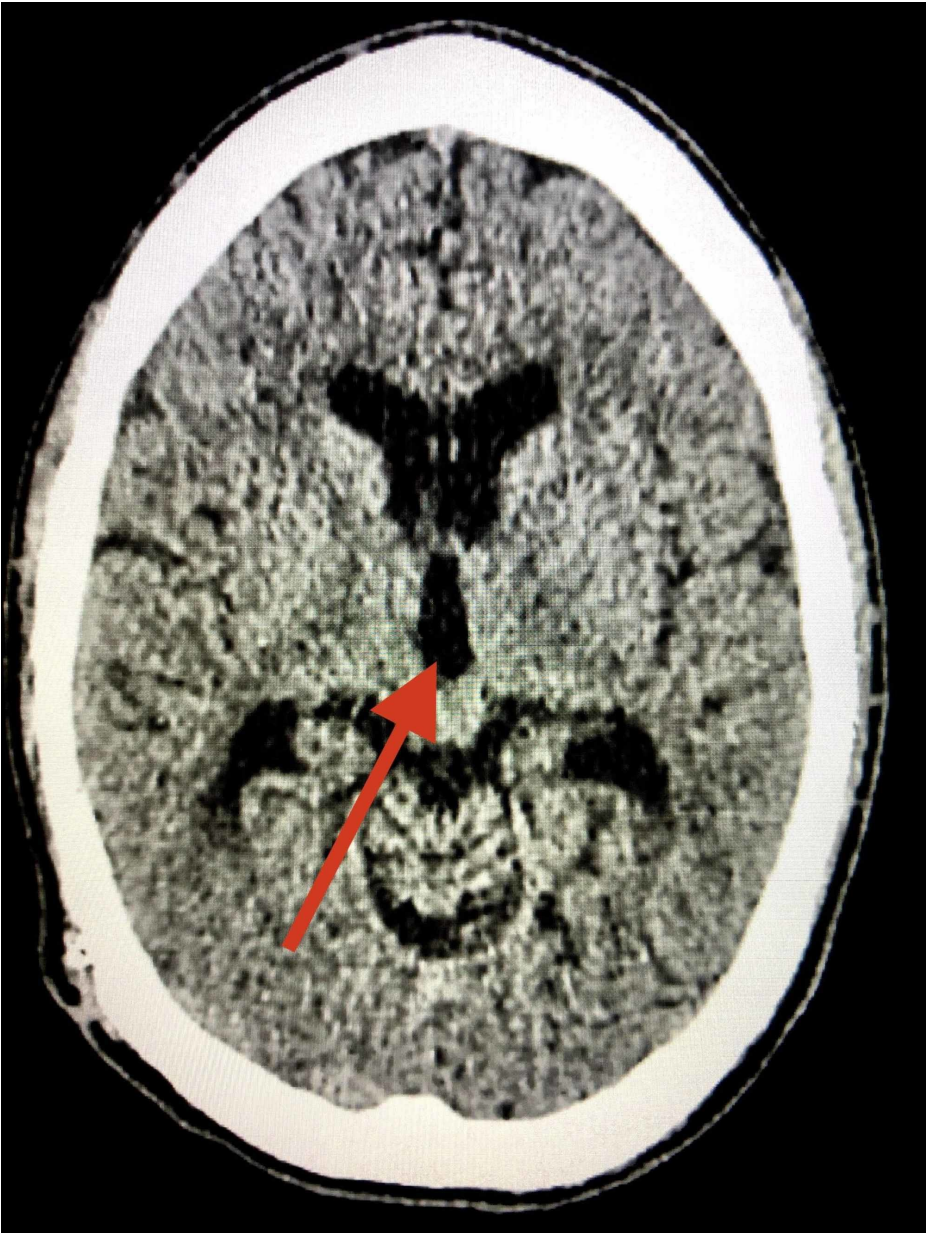
FIGURE 5: Post-operative axial computed tomography of the head demonstrating resolution of hydrocephalus; arrow indicating reduction in size of third ventricle

The patient made a full recovery and post-operative CT head demonstrated resolution of his hydrocephalus (Figure 5). Histological analysis revealed the encasing sheath to be comprised of non-inflammatory, dense, mostly acellular hyalinised fibrous tissue (Figure 6).

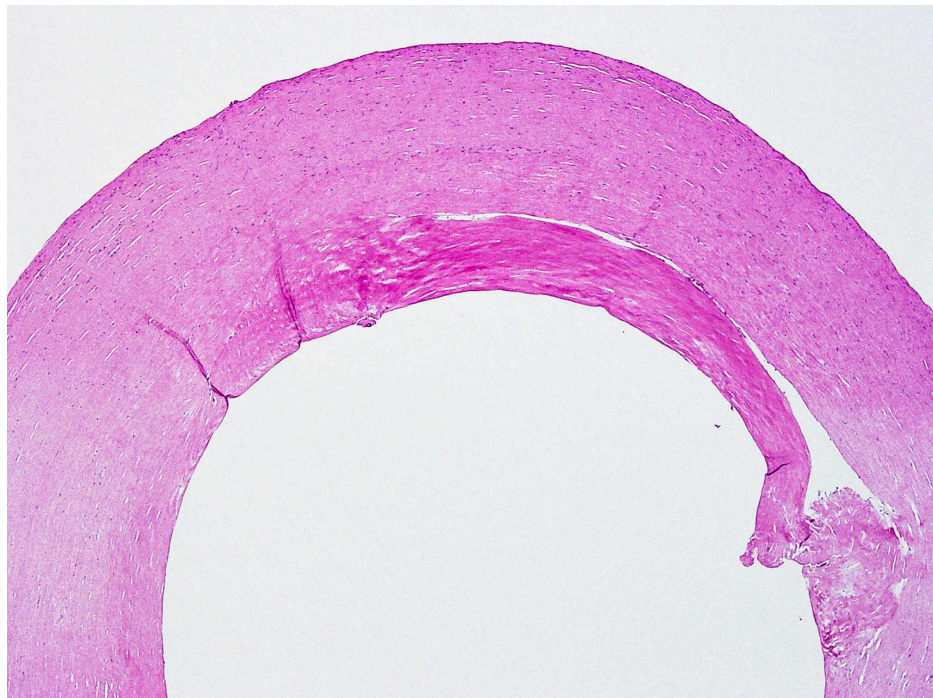
FIGURE 6: Haematoxylin and eosin stain of fibrous capsule showing mostly acellular hyalinised fibrous tissue
