Cystoscopic Management of the Intravesical Migration of an Intrauterine Device Complicated by Bladder Stone Formation: A Video Case Report

Gupta E, Prabhudesai M, Halarnakar R, et al. (June 16, 2024) Cystoscopic Management of the Intravesical Migration of an Intrauterine Device Complicated by Bladder Stone Formation: A Video Case Report. Cureus 16(6): e62467. DOI 10.7759/cureus.62467

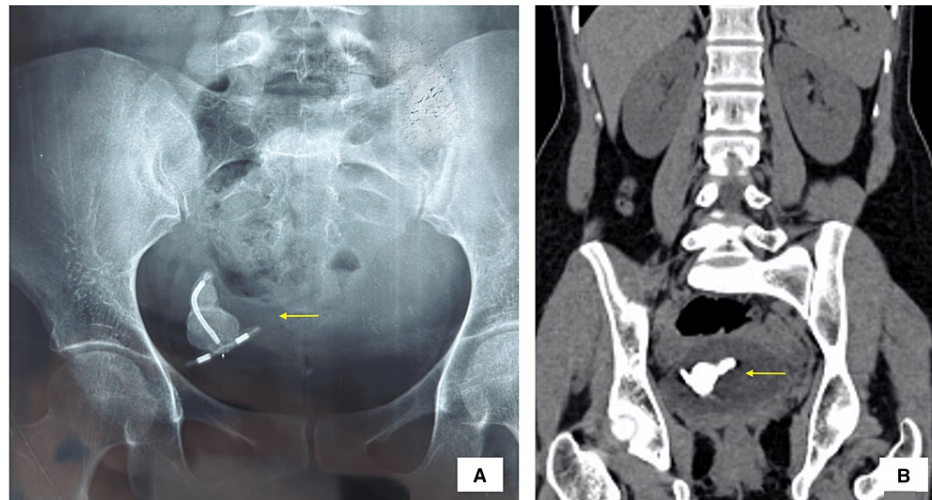
FIGURE 1: Radiological images (X-ray (A) and computed tomography scan (B)) showing the migrated IUD

Arrow: Encrusted intravesical IUD

A 32-year-old lady presented to the Department of Obstetrics for antenatal care, following pregnancy due to contraceptive failure. She had undergone a medically induced termination of pregnancy seven years ago, following which IUD insertion was done at a local healthcare center. The post-IUD insertion period was uneventful, and the patient reported feeling the IUD threads for a few months before she stopped feeling them in the vaginal canal. Due to a lack of symptoms, she did not seek any further medical assistance. Following her delivery, she was referred to the Department of Urology in view of X-ray and sonographic findings suggestive of a displaced IUD, suspiciously located in the bladder. Subsequent computed tomography scanning revealed an intravesical calculus (~3 cm in size), with no evidence of upstream hydroureteronephrosis on either side (Figure 1).

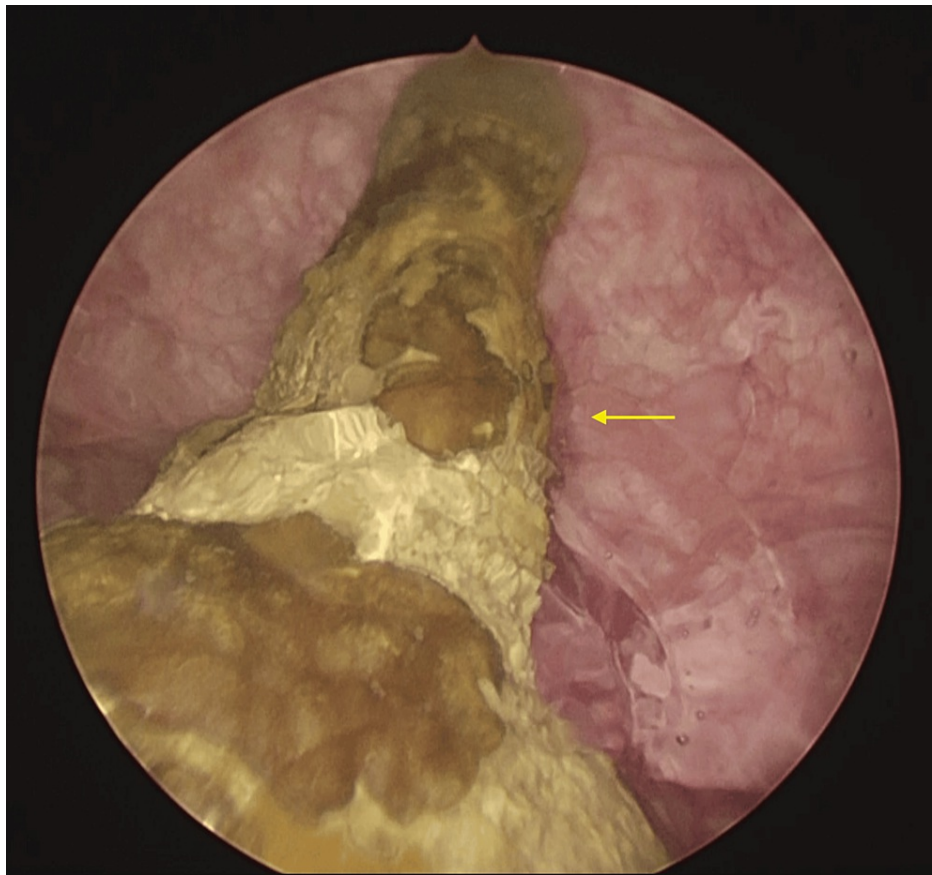
FIGURE 2: Cystoscopic view of the encrusted IUD

Arrow: Encrusted intravesical IUD

After a thorough preoperative workup, the patient was then taken up for the cystoscopic evaluation of the bladder along with the extraction of the encrusted IUD (Figure 2, Video 1).

Intraoperative evaluation revealed a completely encrusted IUD (bladder stone), along with normal ureteric orifices and occasional trabeculations over the bladder wall. There was no breach in the bladder mucosa by the encrusted IUD, and no fistulous opening could be appreciated in the bladder wall. Using a pneumatic lithotripter, the stone was broken down to expose the IUD, which was then held from the tail end and retrieved through the cystoscope sheath. The patient reported no significant pain/dysuria/hematuria or bladder discomfort following the procedure and was discharged after an uncomplicated postoperative period.

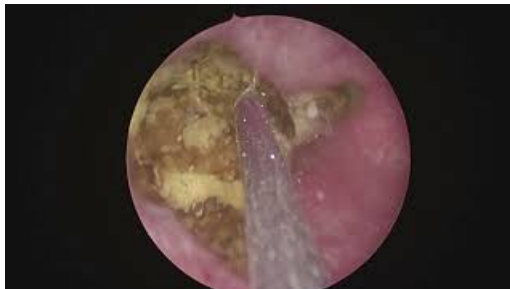
VIDEO 1: Cystoscopic management of the intravesical migration of IUD

IUD: intrauterine device
