# Pseudotumor in Ceramic-on-Ceramic Total Hip Arthroplasty: A Case Report

DOI: 10.7759/cureus.71518

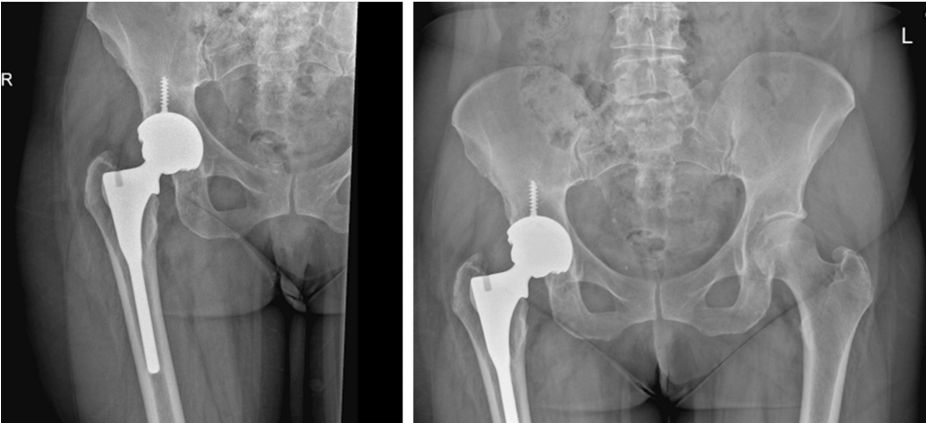
FIGURE 1: Pre-revision radiographic images.

Radiographs demonstrate a right primary THA with a JRI Furlong cementless stem, a 32 mm ceramic head, and a JRI cementless CSF shell with a ceramic liner.

In 2010, a 57-year-old woman underwent a right primary THA for osteoarthritis at a satellite orthopedic surgical center. The patient received a JRI R Furlong cementless stem with a 32 mm ceramic head and a JRI cementless CSF shell with a ceramic liner, as depicted in the radiographic images in Figure 1.

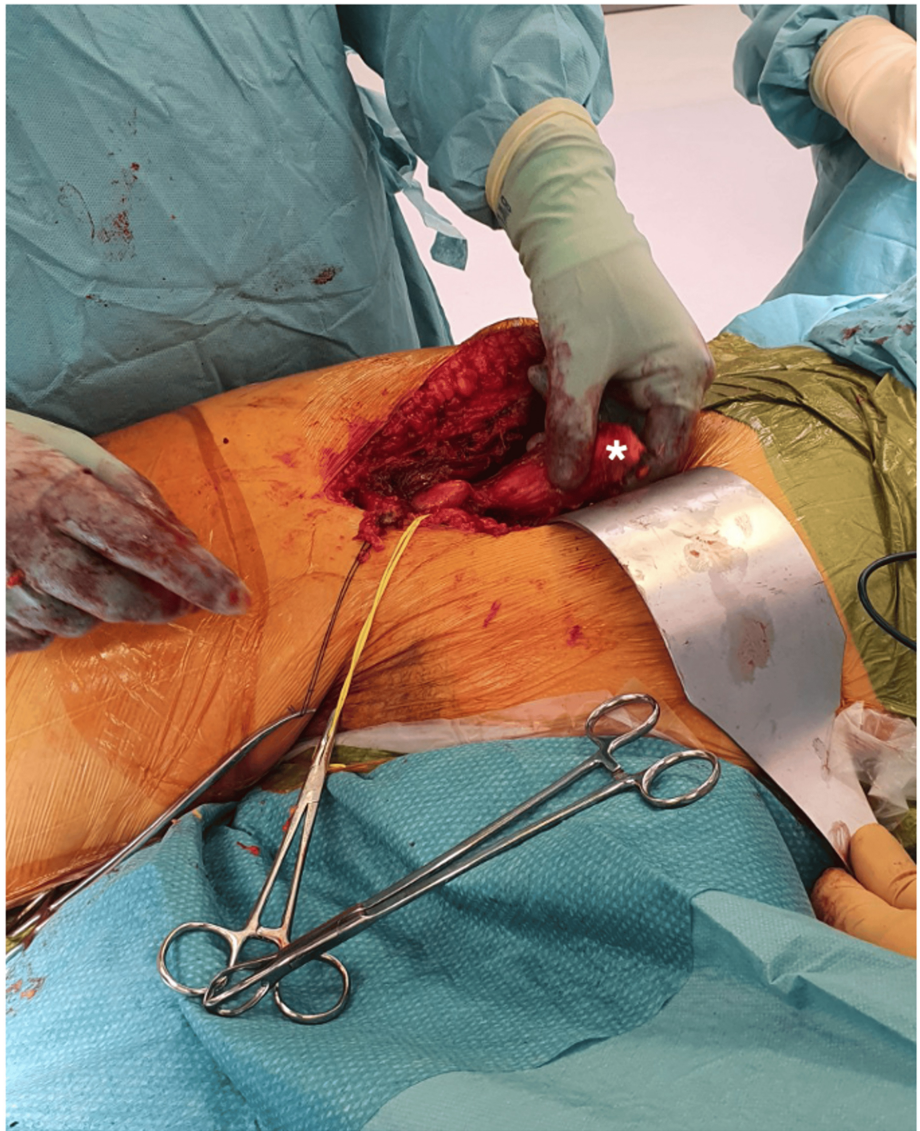
**FIGURE 3: Intraoperative pseudotumor.**

The pseudotumor is located on the ilioinguinal aspect of the patient's right thigh, indicated by the asterisk (\*).

The pseudotumor was excised through an ilioinguinal approach and was located in the first compartment, within the psoas and iliacus muscles, extending inferior to the inguinal ligament. The pseudotumor in situ and post-excision are depicted in Figure 3 and Figure 4, respectively. Complete dissection and excision of the macroscopic lesion were successfully achieved.

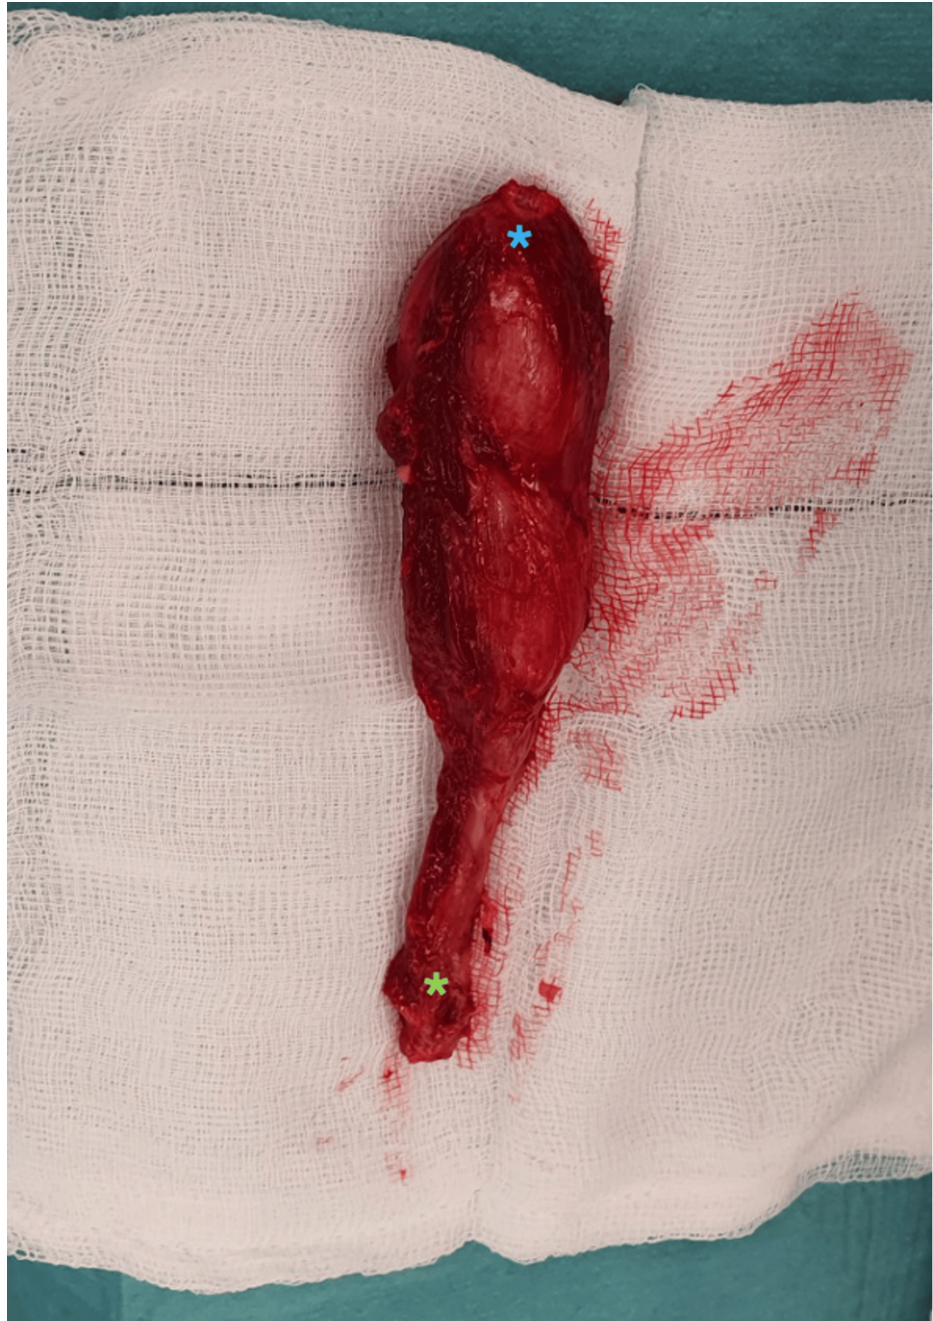
**FIGURE 4: Excised pseudotumor.**

The pseudotumor was removed from the patient through the ilioinguinal approach. On MRI, it measured 7.5 cm × 3.3 cm × 10 cm. The blue asterisk indicates the proximal pole, while the green asterisk marks the distal pole of the pseudotumor.

Histopathology results of the excised specimen revealed a macroscopic appearance of irregular, multilobulated tissue. Upon dissection, the cut surface exhibited multiple cream, slightly mucinous soft tissue areas. Microscopically, the sections showed fibrous tissue with underlying infiltration of macrophages accumulating wear debris. Additionally, foamy macrophages, hemosiderin deposition, and multinucleated giant cells were observed. Throughout the lesion, there were areas of large cysts with central necrosis. Overall, the report was consistent with a diagnosis of a pseudotumor.
