# Management of Strip Perforation on the Upper Front Tooth and Tooth Rehabilitation Using Flexible Glass Fiber Post: A Case Report

A 26-year-old female patient requested crowning on her upper front tooth. The patient had a history of a root canal treatment on tooth 11 due to pulp necrosis performed by an undergraduate student. A post and crown restoration was scheduled for this tooth, but strip perforation occurred when the student was preparing the post space. The case was then referred to a conservative postgraduate clinic for further management. On the first visit, the patient claimed the referred tooth was free of signs and symptoms and

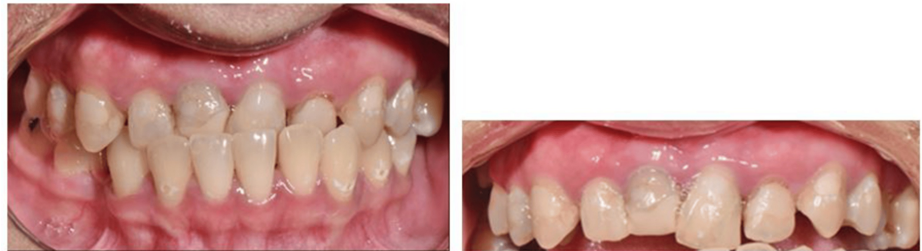
Upon clinical examination, extensive composite and temporary restoration was observed in the patient's tooth 11. The tooth was asymmetrical and irregular in shape and size compared to the adjacent upper central tooth. The tooth demonstrated grayish discoloration, but the surrounding soft tissues appeared normal. The clinical photograph of tooth 11 at the initial presentation is shown in Figure 1, while the radiograph of the tooth at the initial presentation is illustrated in Figure 2. The periapical radiograph demonstrated a well-condensed and apical root canal filling of tooth 11 with periapical radiolucency. Radiolucency was observed at the middle third level, mesial to the root canal. The restoration was evident at the coronal of tooth 11 due to the presence of radiopaque material. Meanwhile, radiolucency beneath the restoration margin indicated defective restoration.

**FIGURE 1: Clinical photographs of tooth 11 at initial presentation**

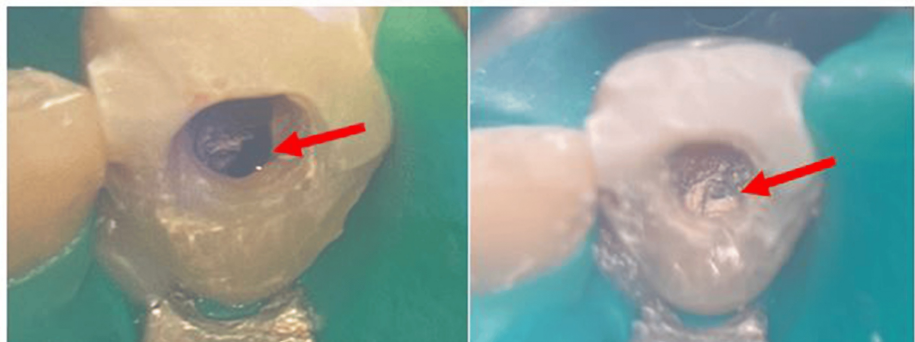
**FIGURE 4: Clinical photograph of bleeding at the perforated site, mesial to the gutta-percha (GP) (left) and perforated site repaired using Biodentine™ (Septodont, France) (right)**

The existing restoration on tooth 11 was first removed with the aid of an operating microscope (Zeiss OPMI Pico, Carl Zeiss, Germany), followed by perforation repair under rubber dam isolation. When bleeding was detected at the tip of paper points (Figure 4), the perforation site was cleaned and irrigated with caution using diluted sodium hypochlorite with less concentration (2.5%) and normal saline. The perforated area was dried with paper points (size 50) before repairing the site with tricalcium silicate-based cement, Biodentine™ (Septodont, France), using the recommendation by manufacturers (Figure 4). Subsequently, the temporary double seal restoration was performed using Cavition (GC Corporation, Japan) and glass ionomer cement Fuji VII (GC Corporation, Japan). At the end of this procedure, the post-operative periapical radiograph illustrated that the perforated site had a well-condensed Biodentine™ with slight extrusion (Figure 5).

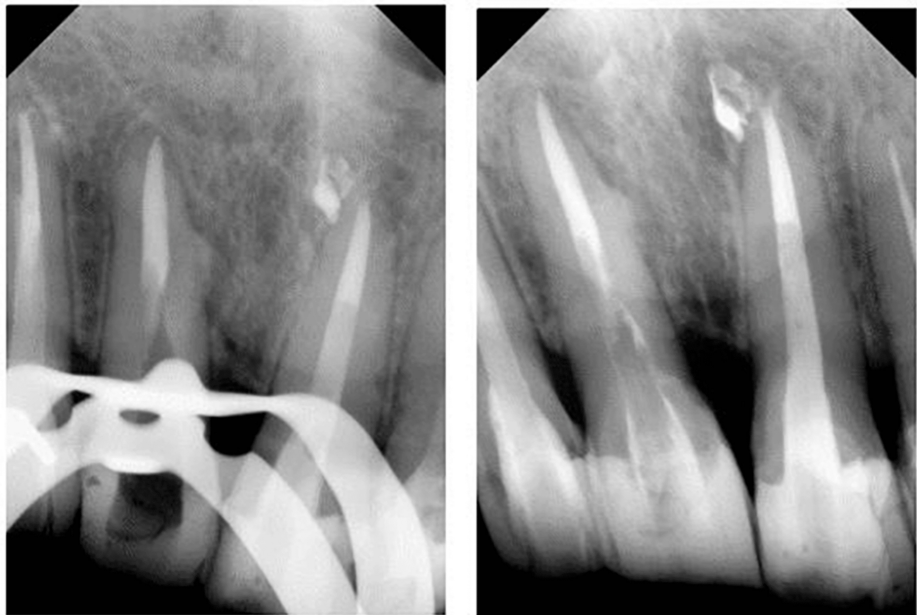
**FIGURE 6:** Periapical radiograph showing gutta-percha (GP) removal (left) and everStick post-cementation of tooth 11 (right)

Once the perforation was successfully repaired, the post-placement was planned for tooth 11 using the soft, flexible glass fiber everStick Post™ (GC Corporation, Tokyo, Japan) under rubber dam isolation. First, the temporary restoration and gutta-percha (GP) were removed under the operating microscope (Zeiss OPMI Pico), leaving 4 mm of GP apically followed by the preparation of the post space using the Gates Glidden bur (Figure 6). An ultrasonic instrument (Satelec ultrasonic scaler, Suprasson P5 Newtron XS, Aceton, USA) and Hedstrom files (Dentsply Maillefer, Baillage, Switzerland) were then utilized to remove the remaining Biodentine™ at the canal wall carefully. Finally, 2.5% sodium hypochlorite was used to clean and irrigate the canal, and the post length was measured using a K-file.

After the measurement was obtained, 15 mm of the everStick Post™ (1.5 mm) was cut and fitted into the root canal. An additional 1.2 mm everStick Post™ was inserted and condensed laterally into the canal until it was completely filled. Subsequently, a periapical radiograph was taken to ensure that the post was appropriately fitted into the canal space. The next procedure was then performed by injecting a dual-cured, glass-reinforced composite system (ParaCore, Coltene/Whaledent, USA) into the post space, followed by the insertion of the prepared everStick Post™ and light-cured for 40 seconds. The post-cementation radiograph is presented in Figure 6. Figure 7 is a clinical photograph of the prepared everStick Post™ before cementation. The core was built using composite resin (3MTM Filtek™ Z350 XT Universal Restorative, 3M ESPE) and polished.

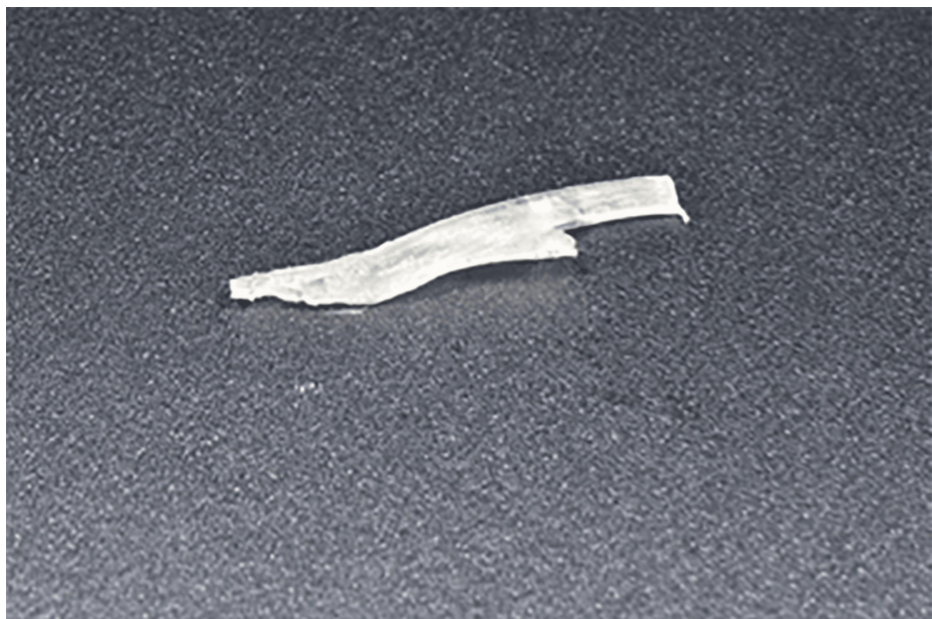
**FIGURE 7:** Clinical photograph of prepared everStick Post prior to cementation

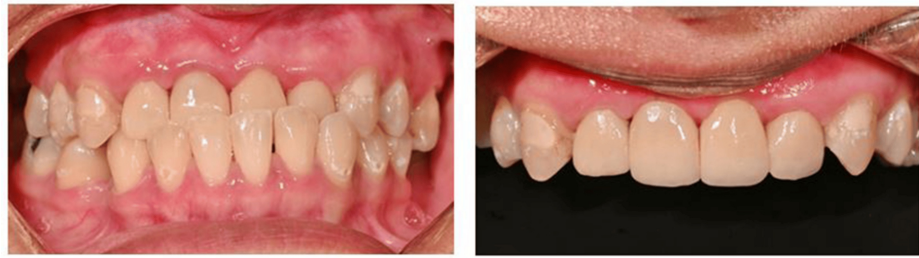
**FIGURE 8: Intra-oral clinical photographs of teeth 11, 12, 21, and 22 at post-treatment**

Tooth 11, together with the adjacent teeth 12, 21, and 22 were prepared for ceramic (IPS e.max Press, Ivoclar, USA) crowns using monolithic lithium disilicate. The secondary impression was established using the light and heavy body polyvinyl siloxane (PVS) (Chromaclone™, Ultradent Products) via a stage double mix impression technique. The crowns were then fabricated in the laboratory. Subsequently, the teeth temporization was done using the putty index (3M ESPE, USA) and bisacryl composite (Protemp™ 4, 3M ESPE, USA). Zinc oxide non-eugenol temporary luting cement (Freegenol™, GC, Japan) was used to cement the temporary crowns. Finally, the finished and polished lithium disilicate crowns were cemented using self-adhesive dual-cure resin (RelyXTM U200, 3M ESPE, Germany). The intra-oral clinical photographs of the teeth at post-treatment are presented in Figure 8.
