# Atraumatic Fracture of Newer Generation Ceramic Head Three Days Post-op: A Case Report

Herein we present a case of atraumatic ceramic head fracture from right THA in a CoP patient. To our knowledge, this is the first atraumatic case presented in the literature of a newer-generation ceramic head fracture with a polyethylene-bearing surface.

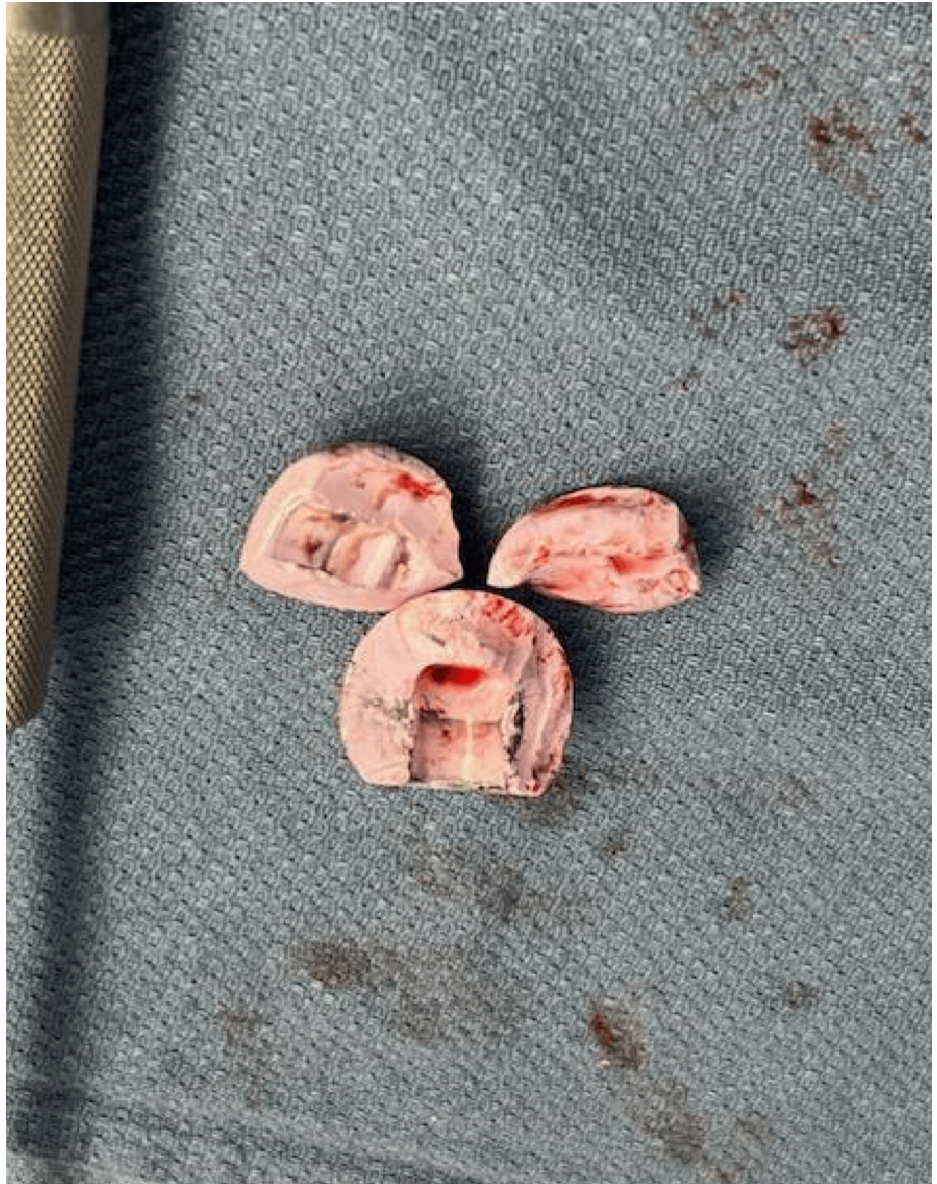
**FIGURE 2: Ceramic head components following removal from the pelvis.**

The literature contains many examples of traumatic ceramic head fractures in THA but does not contain many non-traumatic examples. This case is even more rare since the fracture occurred days following the procedure. In discussion with the company post-implant analysis, it was determined that this was likely a machining defect. There was either a slight defect in the ceramic head or a slight mismatch in the Morse taper leading to catastrophic failure. Another option would be a slight defect in the femoral stem taper but we had no further issues with the new ceramic head so that was excluded. It is also possible that the head was placed malaligned during impaction but there were no complications during surgery and we had a good fit intraoperatively. No other common causes of non-traumatic head fracture seem to be validated due to the paucity of these cases in the literature.

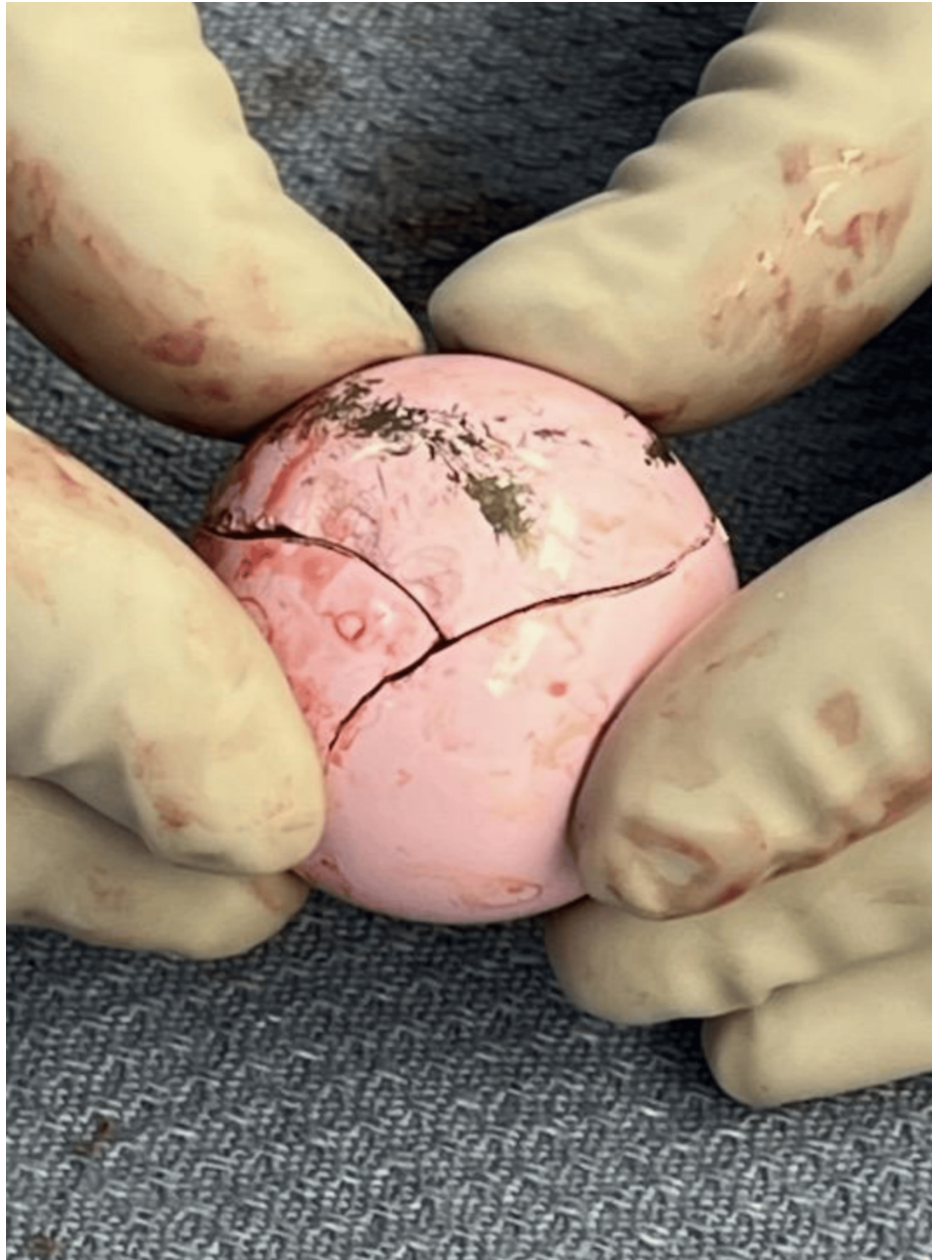
**FIGURE 3: Proximal side of the fractured ceramic head components pieced together following removal.**
