# Nutrient Artery Canal of Femur Masquerading a Fracture Line: A Case Report

Radiographic differentiation between true fracture lines and anatomical structures, such as nutrient artery canals, is crucial for optimal fracture management and postoperative mobilization. We present the case of a 54-year-old male with an AO 31A1.3 (AO/OTA 2018) pertrochanteric femur fracture treated with short trochanteric femoral nailing. Postoperative radiographs revealed an oblique radiolucent line adjacent to the distal part of the nail, raising suspicion of an undisplaced distal fracture extension. However, contralateral femoral imaging and CT scan confirmed the finding to be a nutrient artery canal. The patient was safely mobilized with full weight-bearing without the need for implant revision. Awareness of the radiographic features of nutrient artery canals is essential to avoid misinterpretation, unnecessary surgical modifications, and unwarranted delays in rehabilitation following fracture fixation.

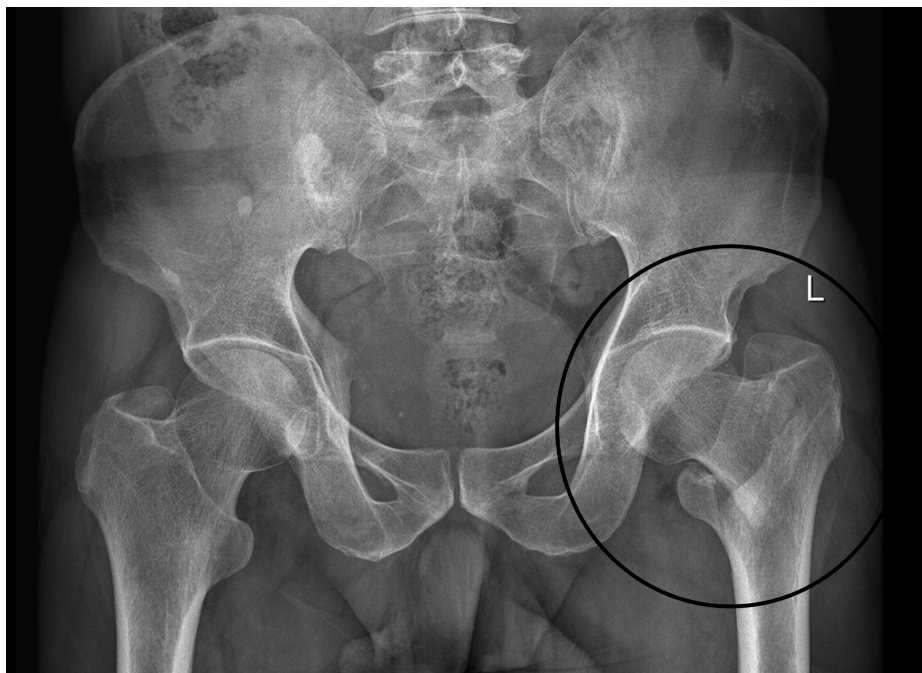
**FIGURE 1: Plain radiograph of pelvis with bilateral hip showing left-sided AO 31A1.2 type of pertrochanteric femur fracture.**

A 54-year-old male was admitted to our hospital following a fall on level ground. Radiographic examination revealed an AO 31A1.3 (AO/OTA 2018) type pertrochanteric fracture of the left femur (Figure 1) [5]. After ruling out other injuries, the patient was planned for closed reduction and internal fixation. As the patient had no comorbidities and the fracture exhibited a stable pattern, a decision was made to proceed with fixation using a short TFN (nail dimensions -10mm x 235mm, TFN-ADVANCED™ Proximal Femoral Nailing System (TFNA) (DePuy Synthes, USA)).

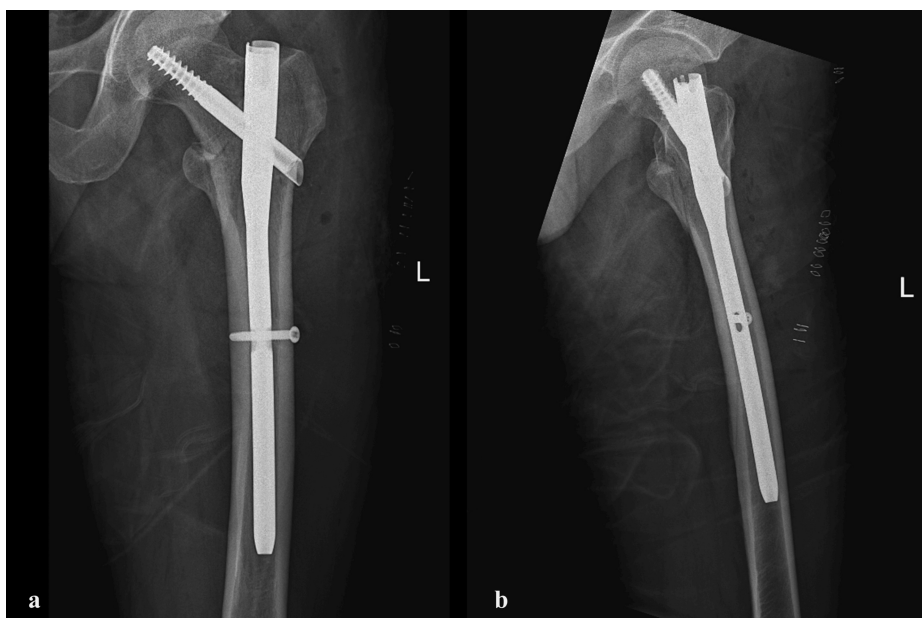
**FIGURE 2: Post-operative (a) anteroposterior and (b) cross-table lateral radiographs showing stable internal fixation with a short TFN.**

The patient was positioned supine on a fracture table, with the affected limb slightly internally rotated and the patella facing upwards. Closed reduction was achieved under fluoroscopic guidance. An incision was made proximal to the tip of the greater trochanter, and entry into the femoral canal was established with a guide pin. Proximal reaming was performed with a 16-mm reamer, and the guide wire was secured within the femoral canal. Sequential reaming was carried out in increments of 0.5 mm up to 11.5 mm and a 10mm x 235mm nail was selected. Following nail insertion, a lag screw was placed in the femoral head and neck proximally and distal locking screw was inserted. The procedure was uneventful (Figures 2a, 2b).

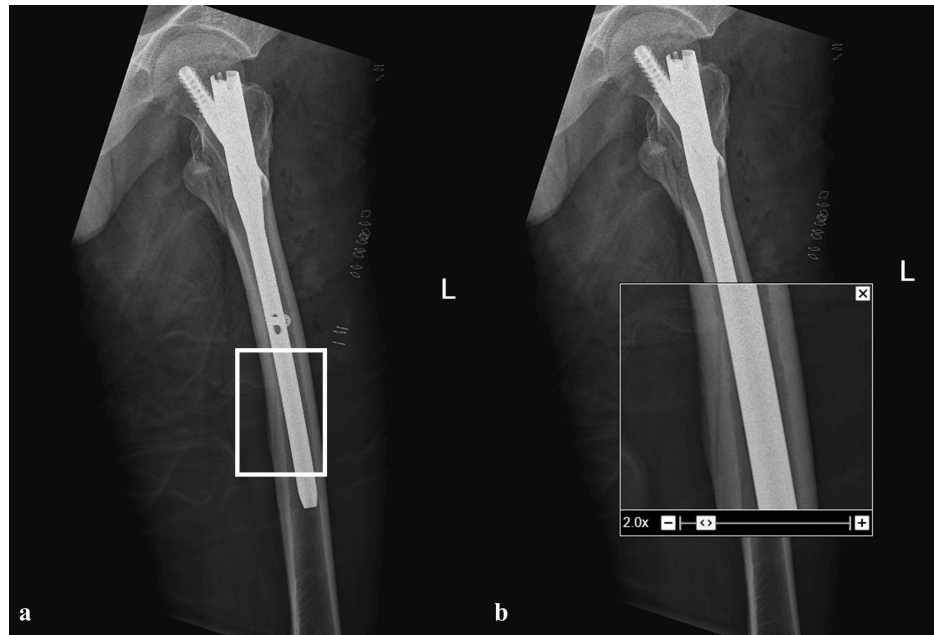
**FIGURE 3: (a, b) Post-operative radiographs revealed presence of an oblique radiolucent line on the posterior cortex of femur adjacent to distal part of the nail in the middle third of femoral diaphysis.**

However, post-operative radiographs revealed the presence of an oblique radiolucent line along the posterior cortex of the femur, adjacent to the distal part of the nail in the mid-diaphyseal region (Figures 3a,

3b). This raised suspicion of a possible undisplaced fracture. A full-length radiograph of the contralateral femur was obtained, which demonstrated a similar radiolucent line along the posterior cortex, suggestive of the nutrient artery canal (Figures 4a, 4b). To further clarify the finding, a CT scan of the femur was performed, which confirmed the presence of a nutrient artery canal without any evidence of a fracture line (Figures 5a-5e).

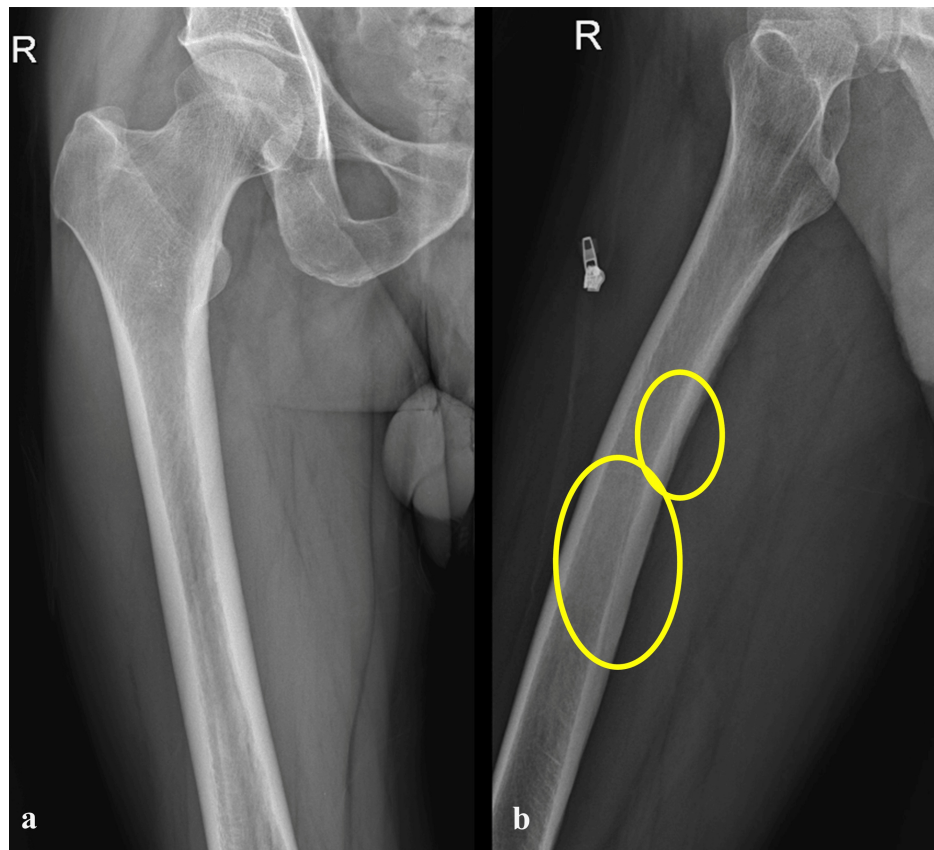
**FIGURE 4:** (a) Anteroposterior and (b) cross-table lateral radiographs of the contralateral side revealing two similar radiolucent lines on the posterior cortex of femur suggesting the shadow of the nutrient artery canals.

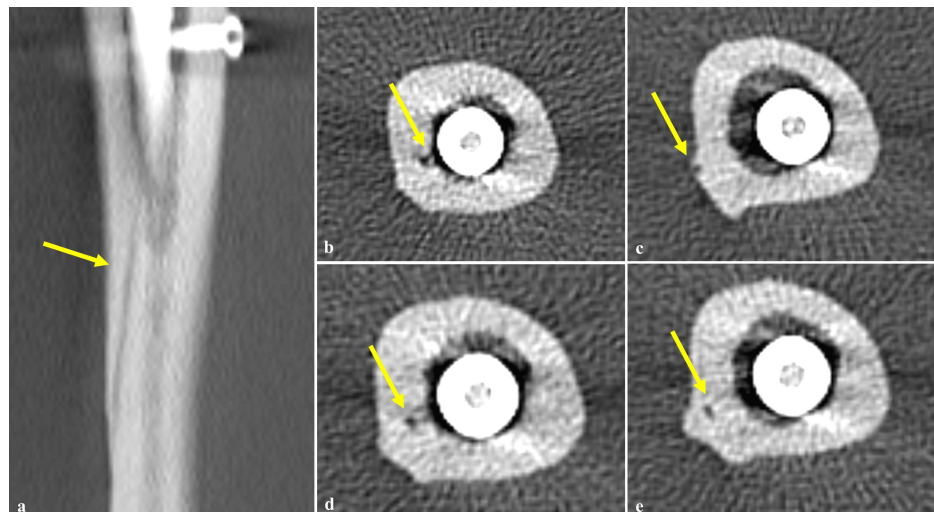
**FIGURE 5:** (a) Coronal and (b-e) axial CT images revealing features suggestive of nutrient artery canal (yellow arrows point at the nutrient artery canal).
