# Artifact Mimicking Mechanical Valve Dysfunction on Intraoperative Transesophageal Echocardiography Following Redo Mitral Valve Replacement

## Abstract

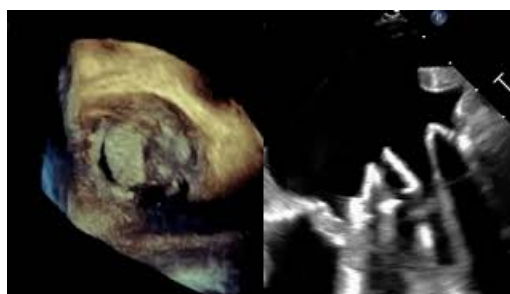
#### **VIDEO 2: Repeat intraoperative TEE after first re-exploration still showing apparent lateral leaflet immobility**

Even after excision of the preserved posterior native leaflet (P2), the same abnormal finding persists, suggesting a possible artifact.

Upon reopening the left atrium, no leaflet entrapment, residual chordae, or suture-related obstruction was noted. Manual inspection confirmed symmetrical leaflet motion and function. Although the P2 leaflet measured 15.6 mm on preoperative transthoracic echocardiography (TTE), we excised the P2 segment intraoperatively due to concern that it might intermittently protrude into the path of the mechanical leaflet. Despite this, repeat TEE still demonstrated apparent lateral leaflet immobility (Video 2). A second re-exploration was then performed, and the P3 segment was also excised.

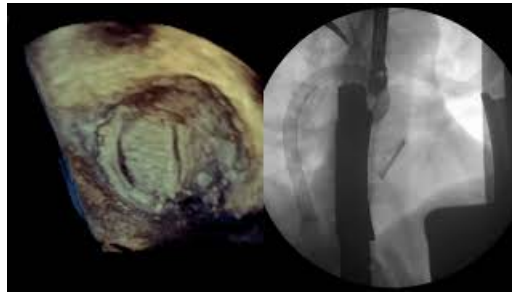
### VIDEO 3: Intraoperative fluoroscopic image (AP view) demonstrating normal bileaflet mechanical valve motion

Both leaflets are seen to open and close symmetrically, confirming that the TEE finding was artifactual and that valve function is preserved.

To resolve the discrepancy, intraoperative fluoroscopy using a mobile C-arm system in the anteroposterior (AP) view was performed. This revealed normal opening and closing of the mechanical leaflets, with no

evidence of restriction or obstruction (Video 3). The echocardiographic findings were therefore attributed to a mirror artifact or reverberation produced by the reflective surfaces of the bileaflet mechanical valve.
