DOI: 10.7759/cureus.101240

Traumatic In-Situ Fracture of an Etonogestrel Implant (Nexplanon®) Presenting as Altered Palpation Without Bleeding: A Case Report and Review of Literature

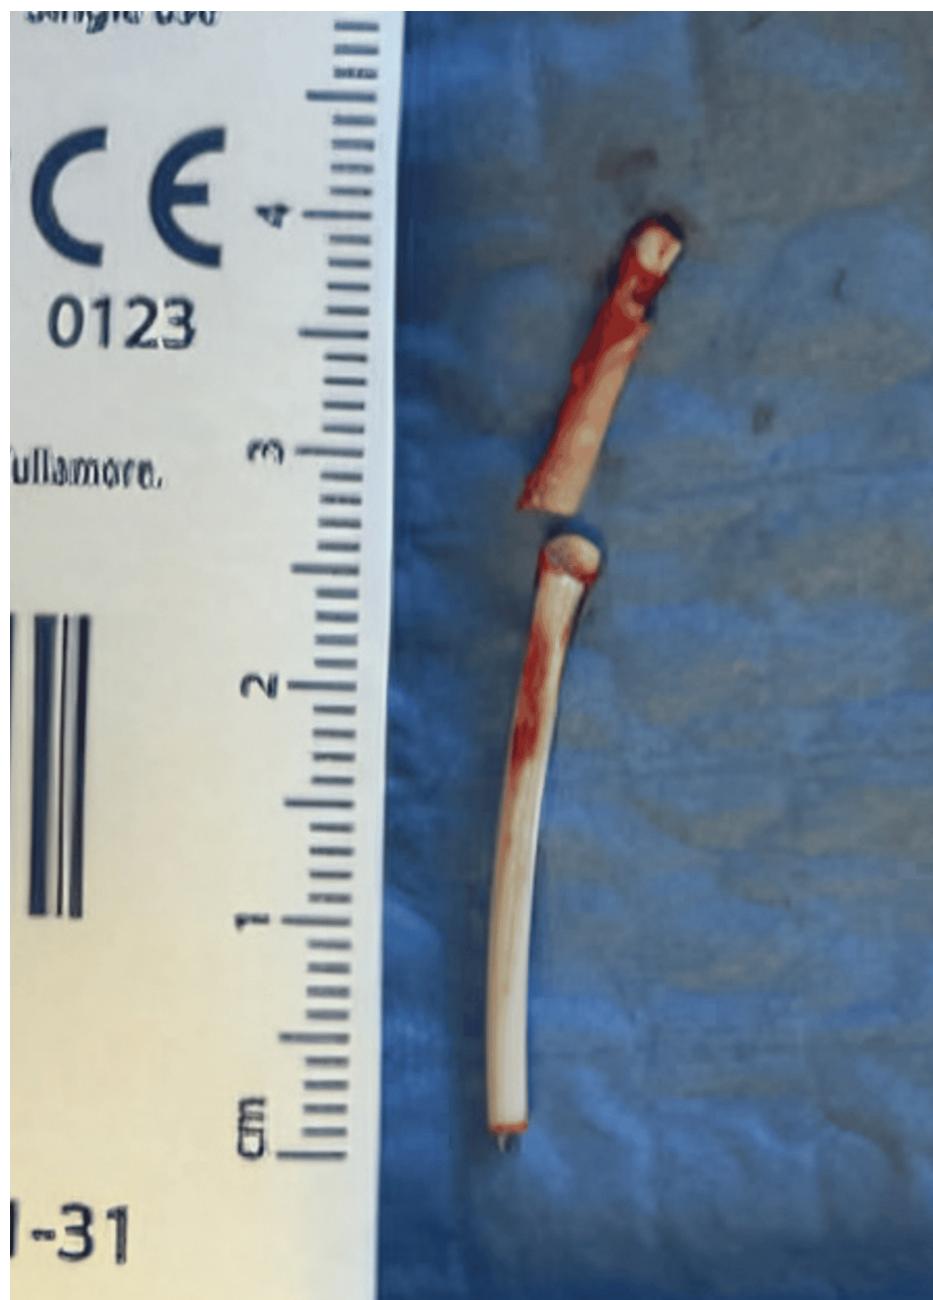
On examination, there was a loss of continuity of the Nexplanon implant noted on palpation. The smaller part was proximal, and the longer part was distal. The patient was counseled on the uncertainty of the outcomes and the available evidence on the chances of migration and changes in hormone release, as well as the associated changes in efficacy. The patient opted for the removal of the implant and declined any other form of birth control. Because the Nexplanon could be palpated, no imaging was required prior to removal. It was removed in its entirety with two small (~5 mm) incisions on each end, after utilizing 4 ml of local anesthetic (1% lidocaine). Each piece was removed from its respective incision, and it was confirmed to be removed in its entirety both by palpation and by measuring the two fragments. The Nexplanon rod was noted to be broken in two pieces, 2.6 cm and 1.4 cm in length (Figure 1). The procedure was tolerated well with no complications.

FIGURE 1: Both parts of the broken Nexplanon implant were removed in their entirety.
