# Metallosis Following Bipolar Hemiarthroplasty Due to Polyethylene Wear: A Case Report

DOI: 10.7759/cureus.118660

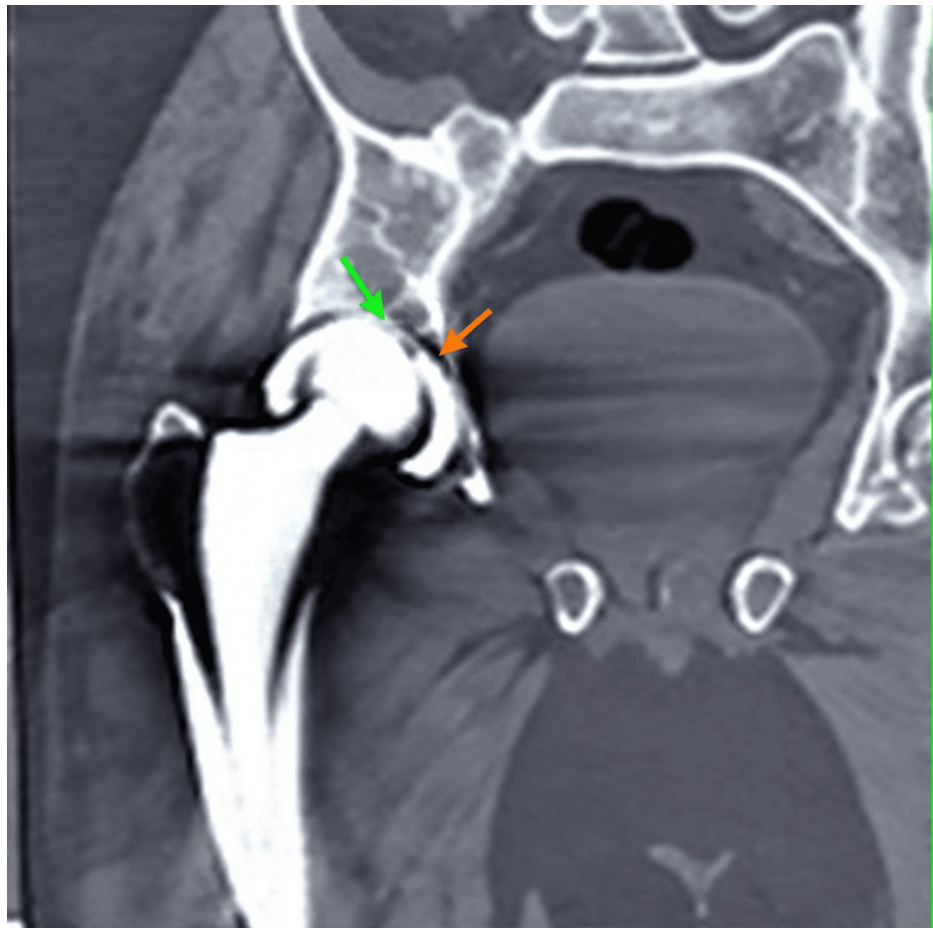
On examination, the previous surgical scar was well healed. Hip movements were painful and restricted. Laboratory investigations, including inflammatory markers, showed no evidence of infection (Table 1). Plain radiography demonstrated eccentric positioning of the femoral head within the bipolar cup (Figure 1). Plain radiography demonstrated osteolysis around the proximal end of the femoral stem (Figure 1). Computed tomography (CT) further demonstrated osteolytic changes around the proximal femoral stem, eccentric position of the femoral head in the bipolar cup, along with a contained supra-acetabular bone defect (Figure 2).

**FIGURE 2: Coronal CT scan showing eccentric position of the femoral head (green arrow) and contained supra-acetabular defect (orange arrow).**

Cross-sectional imaging was particularly useful in our patient because CT demonstrated the extent of the acetabular and peri-trochanteric bone loss and identified the contained supra-acetabular defect. Accurate assessment of bone loss is important when planning revision surgery because extensive osteolysis may influence the choice of reconstruction and the need for bone grafting.

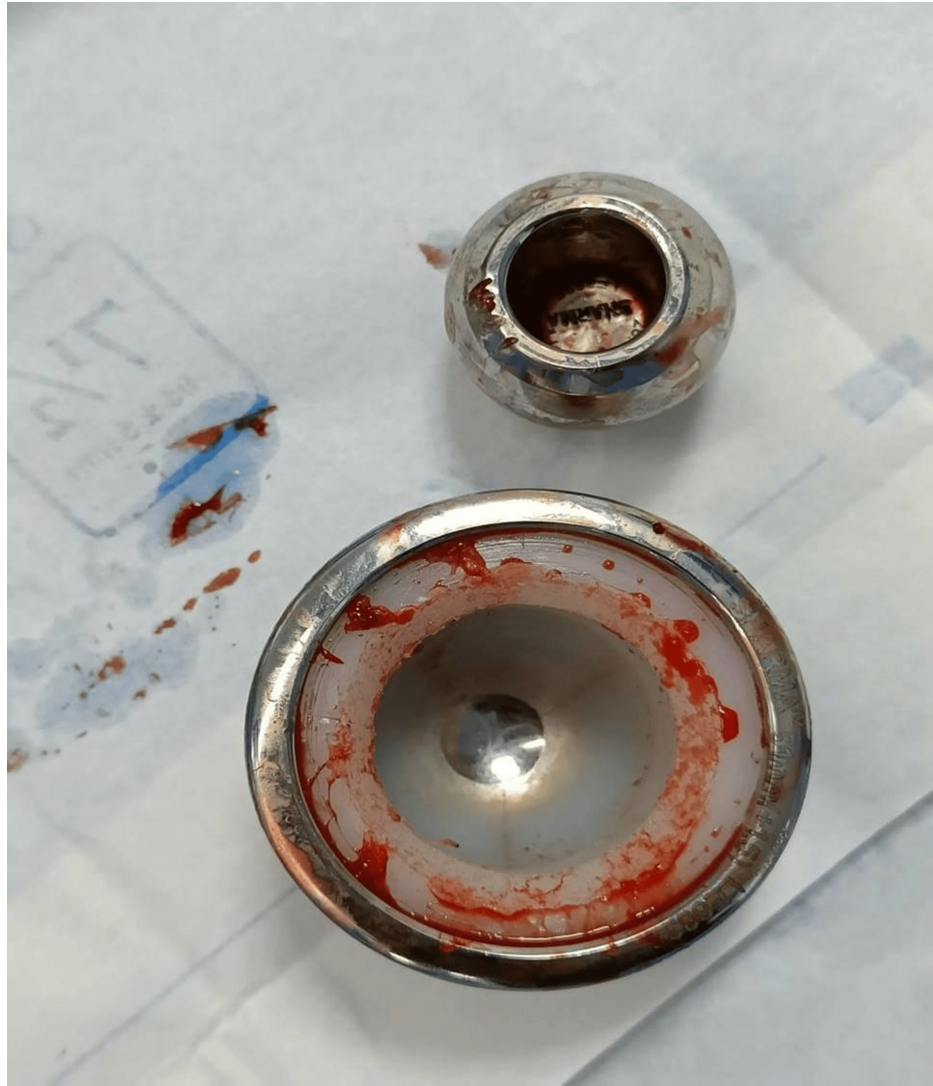
In view of the patient's progressive symptoms, eccentric femoral head positioning, and radiological evidence of osteolysis, revision surgery was planned. Intraoperatively, extensive blackish discoloration of the periprosthetic tissues consistent with metallosis was encountered (Figure 3). The bipolar head was separated and examined. The inner polyethylene liner showed complete wear-through, resulting in direct metal-on-metal contact between the inner femoral head and the outer metallic bipolar shell (Figure 4). This unintended articulation was identified as the source of the extensive metallic debris.

**FIGURE 3:** Retrieved bipolar head assembly after removal, showing complete wear-through of the polyethylene liner within the cup with a resulting metal-on-metal articulation between the inner and outer heads.

In our patient, complete wear-through of the inner polyethylene liner resulted in direct metal-on-metal articulation between the inner femoral head and the outer bipolar shell. This mechanism produced extensive metallic debris and blackish discoloration of the periprosthetic tissues, confirming clinically significant metallosis. Metallosis has been described as a consequence of catastrophic polyethylene failure when the metallic femoral head articulates directly with the metallic shell [5,6].
