# Valvular Hemolysis Masquerading as Prosthetic Valve Stenosis

The evaluation of prosthetic valves can provide a unique challenge, and a thoughtful approach is required. High output states like anemia should be kept in the differential when evaluating elevated gradients across prosthetic valves. We present the case of a 69-year-old man with a Starr-Edwards prosthetic aortic valve who presented with symptoms of congestive heart failure and high transvalvular pressure gradients. These symptoms indicate a potential prosthetic valve stenosis. His laboratory evaluation results were consistent with valve-related hemolysis. Resolving his anemia led to a resolution of the symptoms and lowered the pressure gradient on follow-up.

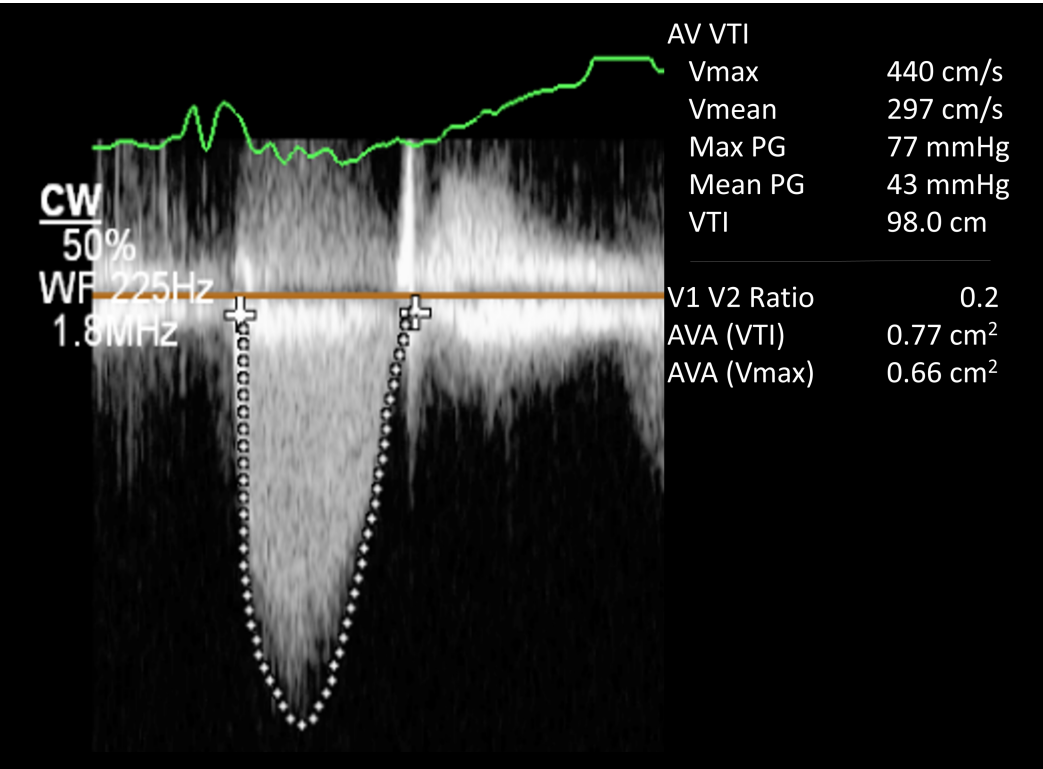
**FIGURE 1: Doppler echocardiogram showing elevated peak and mean gradients across the aortic valve at 77 mm Hg and 43 mm Hg respectively**

ejection fraction; more importantly, it demonstrated a dramatic increase in aortic valve gradients (which had been normal on the previous TTEs). His peak and mean gradient were 77 and 43 mmHg respectively with a dimensionless velocity index of 0.24 (Figure 1). The aortic valve appeared normal in structure and function with a calculated valve area of 0.82 cm<sup>2</sup> (Figure 2). Given the patient's age and the presence of iron deficiency anemia, the gastroenterology department was consulted and a workup for upper and lower gastrointestinal tract that included capsule endoscopy was unrevealing for any source of bleeding. A hemolysis panel was obtained that revealed low haptoglobin levels ( < 10 mg/dL) and elevated lactate dehydrogenase (LDH) levels ( > 1000 U/L) consistent with intravascular hemolysis. He received three units of blood. His symptoms improved considerably and he was discharged on iron supplementation therapy. The patient was evaluated at a six-week follow-up office visit. The follow-up TTE demonstrated gradients at baseline with a peak and mean gradient of 32 and 17 mmHg respectively, which is normal for a Starr-Edwards valve (Figure 3).

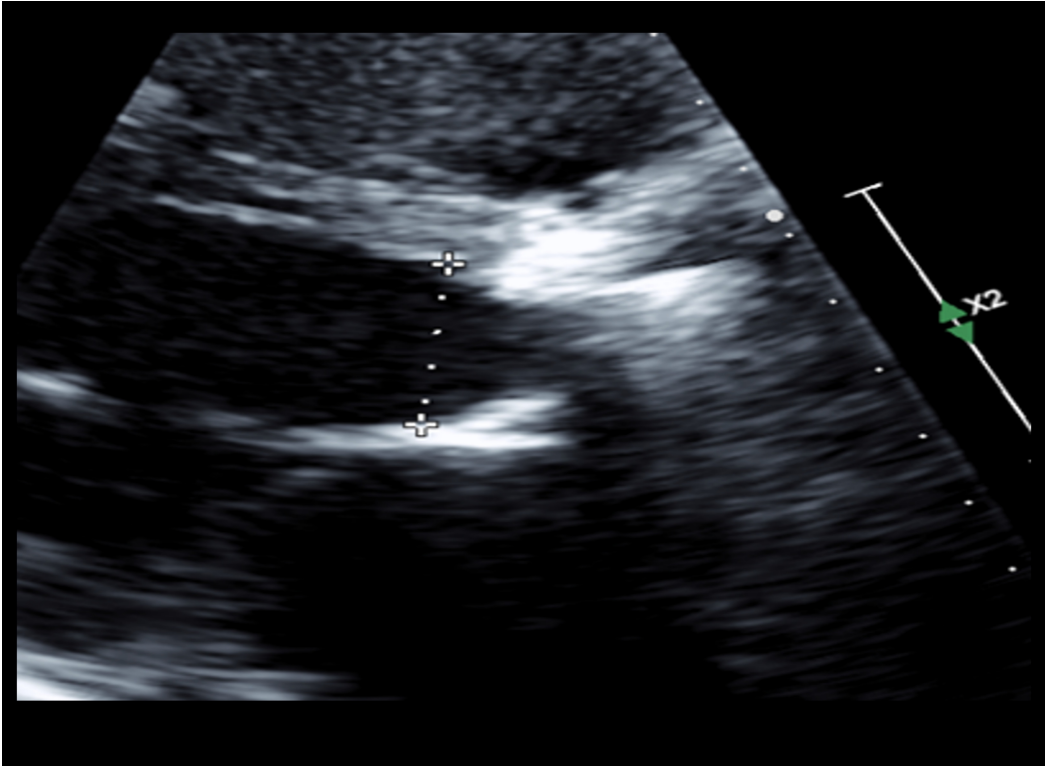
**FIGURE 2: Echocardiogram showing Ball and Cage, and Starr Edwards valve**

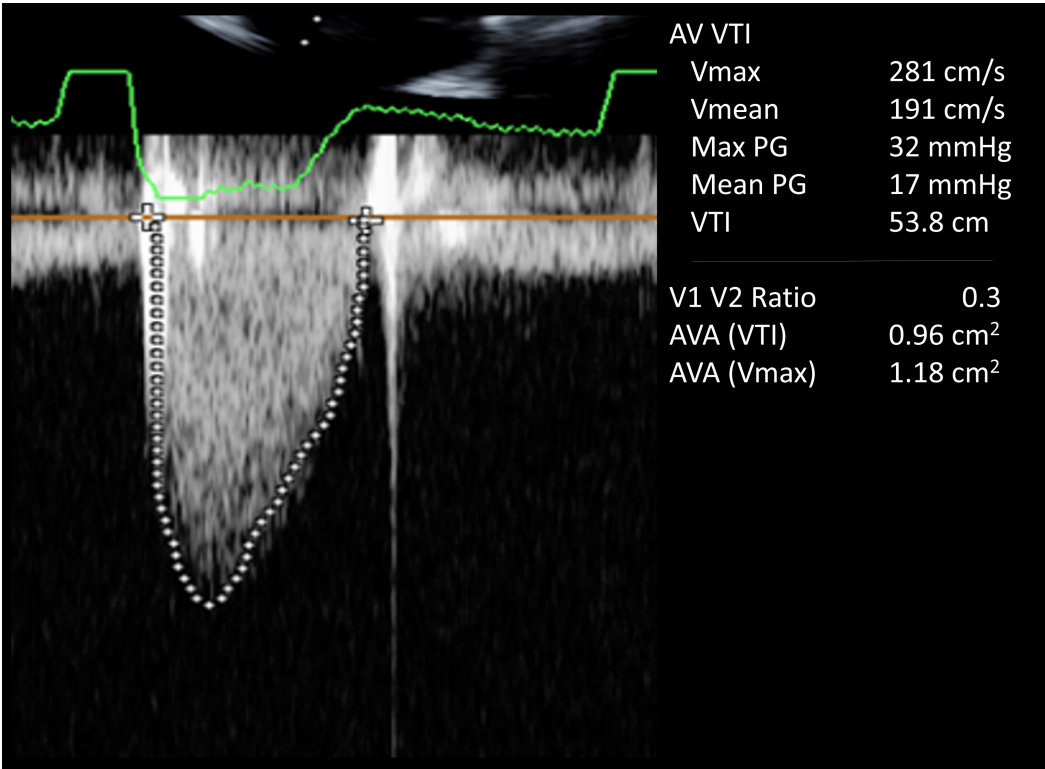
**FIGURE 3: Doppler echocardiogram showing improvement in peak and mean gradients at 32 mm Hg and 17 mm Hg**
