Flange Fracture and Dislocation: An Unusual Complication of Percutaneous Tracheostomy

Shnaydman I, Baum J, Barda L, et al. (June 29, 2022) Flange Fracture and Dislocation: An Unusual Complication of Percutaneous Tracheostomy. Cureus 14(6): e26426. DOI 10.7759/cureus.26426

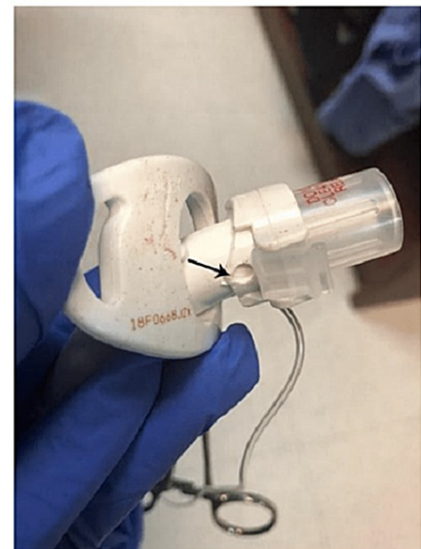
Figure: 1c

FIGURE 1: Flange dislocation of percutaneous tracheostomy (1a); another view of the flange dislocation, with an arrow indicating the proper flange pin position (1b); flange dislocation from the second case with an arrow demonstrating the proper flange pin position (1c)

A 74-year-old female whose orthotopic liver transplant was complicated by rejection developed respiratory failure due to disseminated aspergillosis. She underwent a bronchoscopic-guided PDT. Several hours later, the flange was noted to be separated from the cannula and was not able to be resealed. The decision was made to convert to open tracheostomy for placement under direct visualization to avoid any further complications. The patient was orotracheally intubated, taken to the operating room, and underwent an uneventful open tracheostomy.

in which the outer cannula separated from the flange within hours of performing PDT, leading to the impending loss of airway. Both procedures used new tubes placed by different operating teams. On examination, the tracheostomy tubes were cleanly separated at the plastic, pivoting joint between the silicone flange and the PVC outer cannula (Figures 2a-2c).
