# Elevated Electrode Impedances During Deep Brain Stimulation Surgery May Be Due to Peri-Electrode Air Collections

**Categories:** Neurology, Neurosurgery

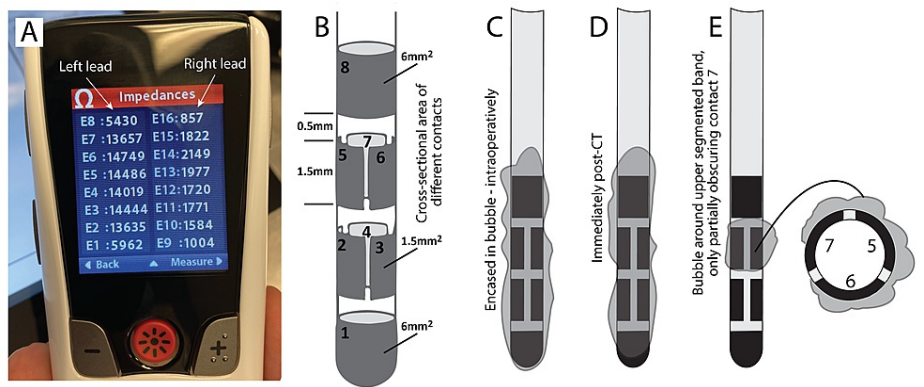
FIGURE 1: Example case 1

(A) Intraoperative impedance measurements from the patient remote, showing abnormally high values in the left lead compared to the right lead. (B) Schematic of implanted electrode segment geometry. (C-E) Cartoon simulations of the peri-lead air collection at the time of impedance testing intraoperatively (C), post-implantation head CT (D), and on postoperative day 1 as impedances began to improve (E).

segmented electrodes of roughly 1:1.5) (Table 1, Column A; Figure 1); and (9) the proximal end of the lead was tucked under the scalp for later attachment to its lead extension.

At this point, we hypothesized that a large bubble of air was surrounding all contacts increasing all impedances proportionally (Figure 1, Panel C). The lead was left in place, and the incisions were closed. We induced a brief Valsalva via the ventilator in an attempt to extrude the air; this resulted in a modest drop in impedances on the circumferential electrodes only (Table 1, Column D). The patient then went for postoperative CT that showed no apparent discontinuity of the connections but revealed a layer of air surrounding the left electrode (Figure 2). Impedances were remeasured after the CT and showed further normalization of the most ventral circumferential electrode impedance (Table 1, Column E), likely consistent with a reduction in the volume of the air bubble (Figure 2, Panel D). The patient went to recovery.

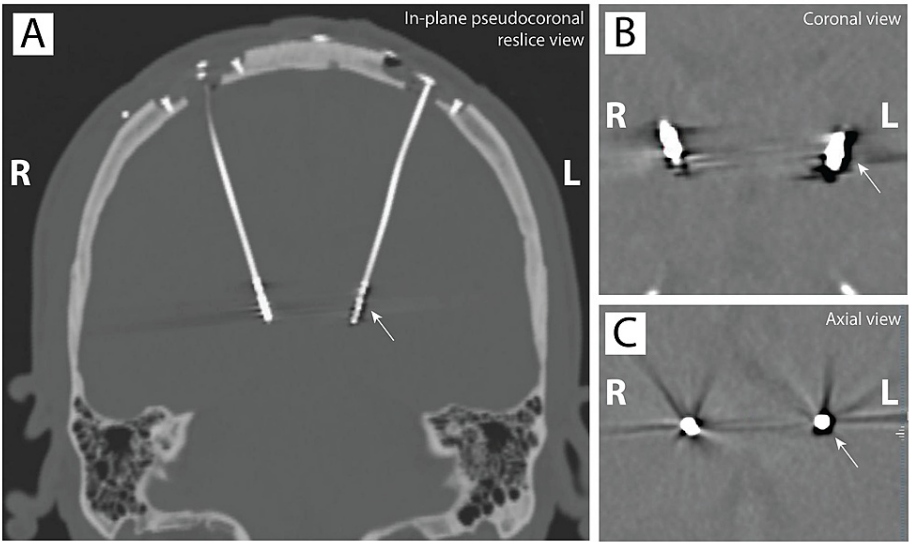
**FIGURE 2: Perioperative CT image from example case 1**

(A, B) Coronal (resliced along the plane of the left lead) and (C) axial (resliced orthogonal to the plane of the left lead) non-contrast head CT after ventral intermediate nucleus deep brain stimulation implantation showing air bubble surrounding the left electrode in example case 1.

The following day impedances had normalized except for those measured from the contacts of the dorsal-most segmented ring (Table 1, Column F) implying only a small amount of air remained (Figure 2, Panel E). By the first outpatient follow-up visit three weeks after surgery, all impedances were normal (Table 1, Column G).

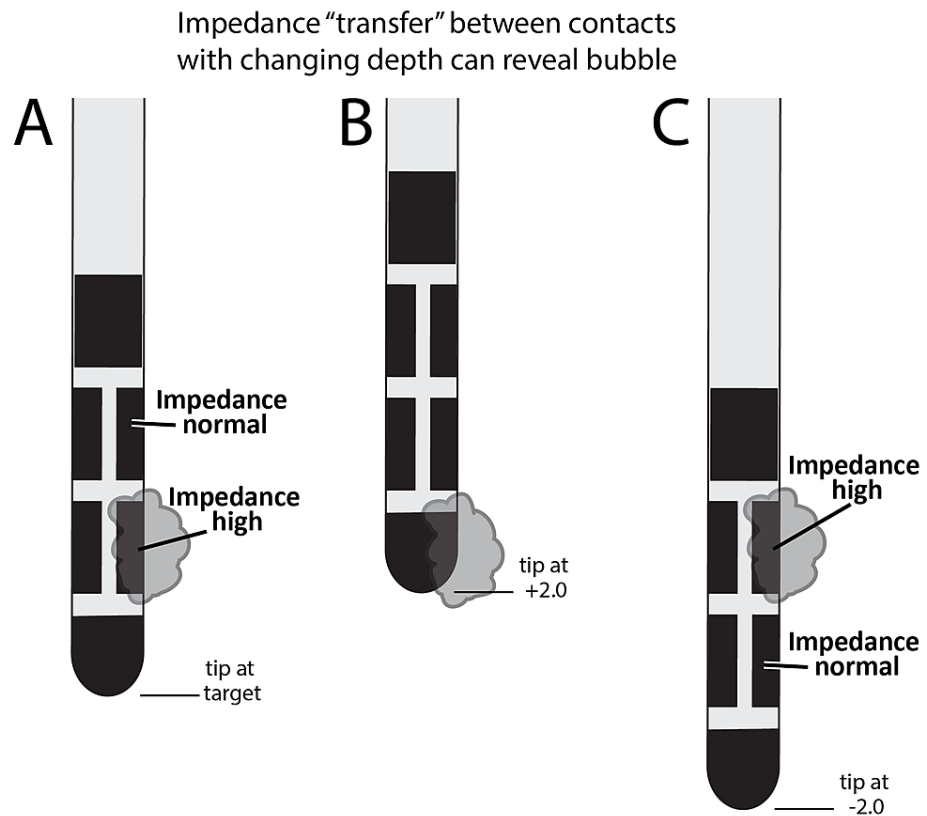
**FIGURE 3: Cartoon illustration describing the second clinical case**

(A) Air surrounding a single electrode segment with the lead at target, corresponding to elevated impedances in that electrode. (B) As the lead is withdrawn 2 mm above target, the air pocket is fixed, and the impedances normalized. (C) As the lead is inserted 2 mm beyond the target, the air collection remains fixed, corresponding to elevated impedances on the segment immediately superior to the one initially showing abnormal impedances.

impedances were again high on contact 3. We then withdrew the entire lead to 2 mm above target, and the impedances normalized (Table 2, Column B; Figure 3, Panel B). We advanced the lead to 2 mm below target, and the high impedances were now observed on electrode 6, the electrode immediately superior to contact 3 on the lead (Table 2, Column C; Figure 3, Panel C). As this testing confirmed that the high impedance was intrinsic to patient anatomy rather than intrinsic to the lead, we left the lead in place. During the first programming follow-up one month after surgery, all impedances were found to be within normal limits.

See Figure 3.
