An Entrapped Vacuum Drainage Tube Between the Surfaces of a Dual-Mobility Cup Following Total Hip Arthroplasty

Categories: Orthopedics

Keywords: dual-mobility total hip arthroplasty, total hip arthroplasty complication, early postoperative complication, vacuum drainage tube entrapment, total hip arthroplasty

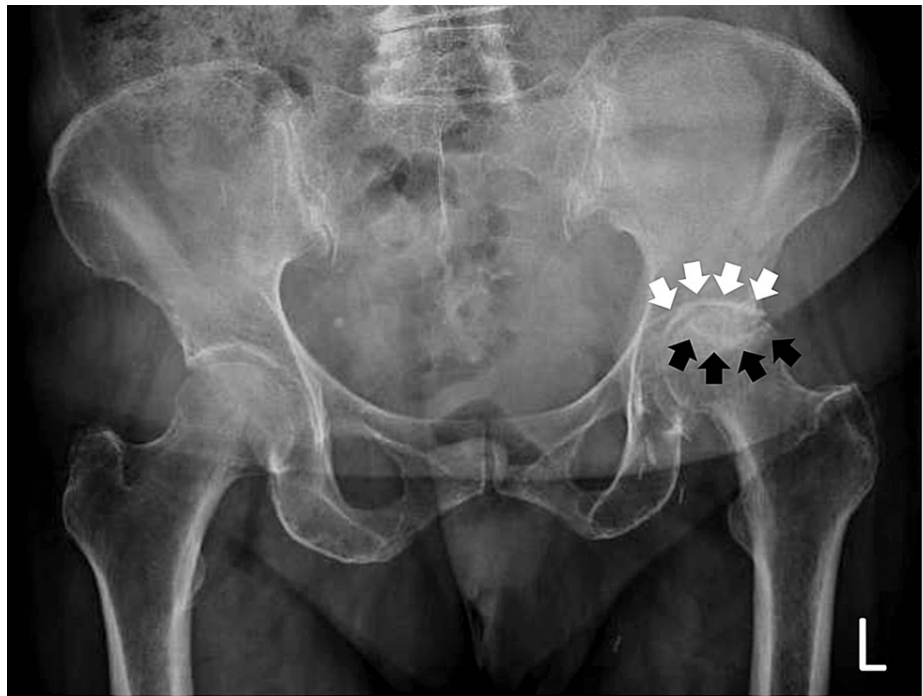
FIGURE 1: The preoperative radiograph of the patient.

Preoperative standard anteroposterior hip and pelvis radiograph depicting the Ficat [3] end-stage avascular necrosis of the left femoral head. Notice the crescent sign (depicted by black arrows) and the sclerotic osteoarthritic border of the acetabulum (depicted by white arrows).

Her symptoms (hip pain, difficulty walking, and restricted hip movements) started 18 months before her referral and gradually deteriorated. Upon her initial evaluation, all her hip movements were painful and she was using two crutches for walking, being ambulatory only within her household limits. Passive hip flexion was 60°, there was a lack of extension of approximately 10°, and internal and external rotation movements were not possible. A standard radiograph revealed the existence of a Ficat [3] end-stage idiopathic avascular necrosis of the left femoral head [4] (Figure 1).

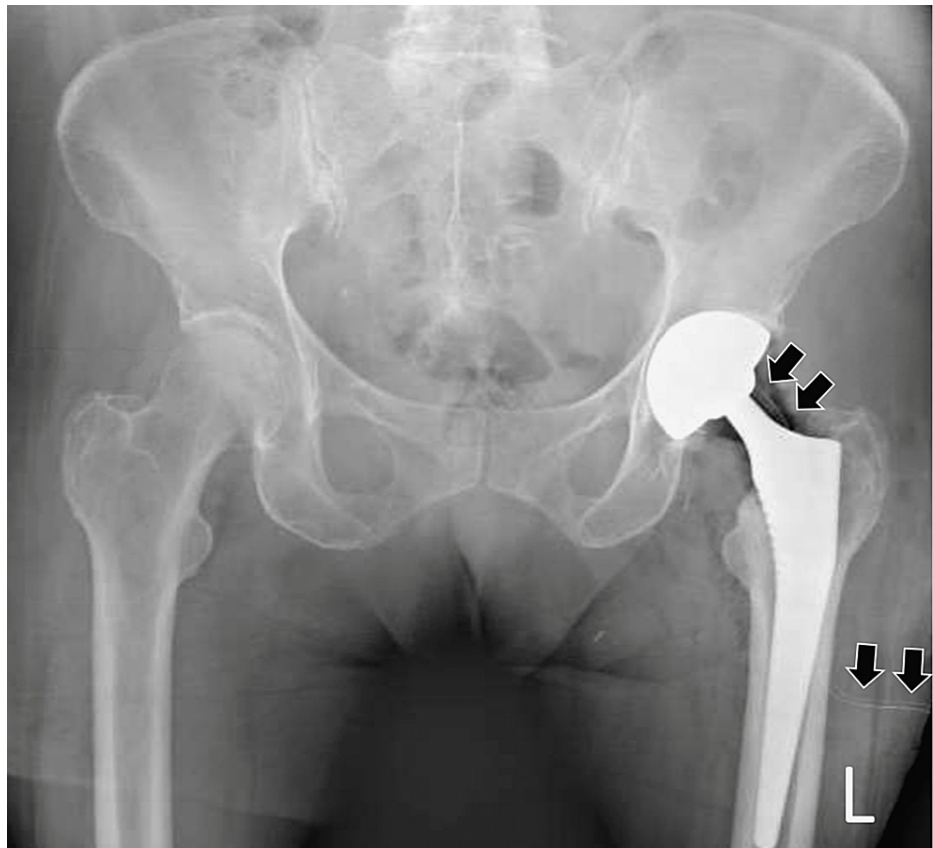
FIGURE 2: Immediate postoperative radiograph following total hip arthroplasty.

Standard anteroposterior hip and pelvis radiograph taken immediately postoperatively. Notice the position of the vacuum drainage tube (as depicted by black arrows) and its course toward the posterior-inferior aspect of the dual-mobility cup.

On the second postoperative day, the Redon canister was filled with 160 ccs of blood and it was decided to be removed. However, the attempt to remove it was unsuccessful. Consequently, the patient underwent urgent re-operation. The drain tube was found entrapped between the articulating surfaces of the posterior-inferior aspect of the dual-mobility cup. It was removed by gently yet firmly applying extraction force while the hip was slightly flexed, adducted, and internally rotated. The removed tube was checked and was found to be compressed at a distance of 4 mm from its tip, without any sign of a rupture. No evidence of a remaining part of the tube could be found, and full and unrestricted movements of the hip joint were confirmed. The wound was thoroughly irrigated with saline and sutured in layers. The standard perioperative antibiotic protocol for patients undergoing total hip arthroplasty (three doses of 2 g of cefazolin during 24 hours) was used for the re-operation. The patient was released with no further events and on schedule three days following her second operation. Upon her latest follow-up visit six months postoperatively, clinically, she was capable of full weight-bearing, she was able to walk without any assistance and/or aids, she reported no problem, and she was fully satisfied with the result of the operation. The radiograph taken on the same day confirmed the proper positioning of the prosthesis (Figure 3).

Despite thorough literature research, no data could be found regarding the incidence of vacuum drainage tube entrapment following total hip arthroplasty. This is certainly an infrequent and relatively “benign,” yet familiar to all surgeons, complication. The drainage tube is usually accidentally sutured during the closure procedure, which necessitates re-operating on the patient to be released. To the best of our knowledge, the entrapment of the drainage tube within the articulating surfaces of a dual-mobility total hip arthroplasty cup has never been reported in the literature. We postulate that this must have occurred either during the transfer of the patient from the operating table or during the immediate postoperative period and gradual mobilization because upon completion of the operation it was not evident. To prevent such complications, we recommend shortening the drain to keep it at a distance from the dual mobility to avoid entrapment during mobilization.

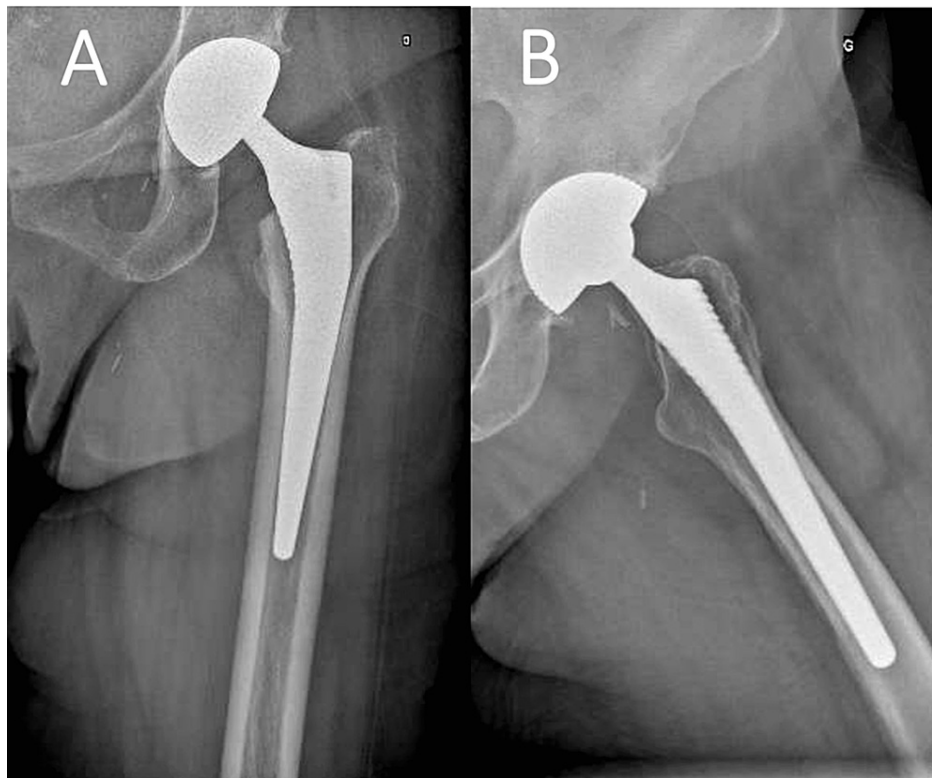
FIGURE 3: Radiograph obtained six months postoperatively.

Standard anteroposterior (A) and lateral (B) radiographs of the operated hip at six months postoperatively.
