Comparative Effect of No Finish Line, Heavy Chamfer, and Shoulder Marginal Designs on the Fracture Resistance of Zirconia (Cercon) Ceramic Restoration: An In Vitro Study

Gavara S, Jain S, Gupta H, et al. (May 14, 2023) Comparative Effect of No Finish Line, Heavy Chamfer, and Shoulder Marginal Designs on the Fracture Resistance of Zirconia (Cercon) Ceramic Restoration: An In Vitro Study. Cureus 15(5): e39009. DOI 10.7759/cureus.39009

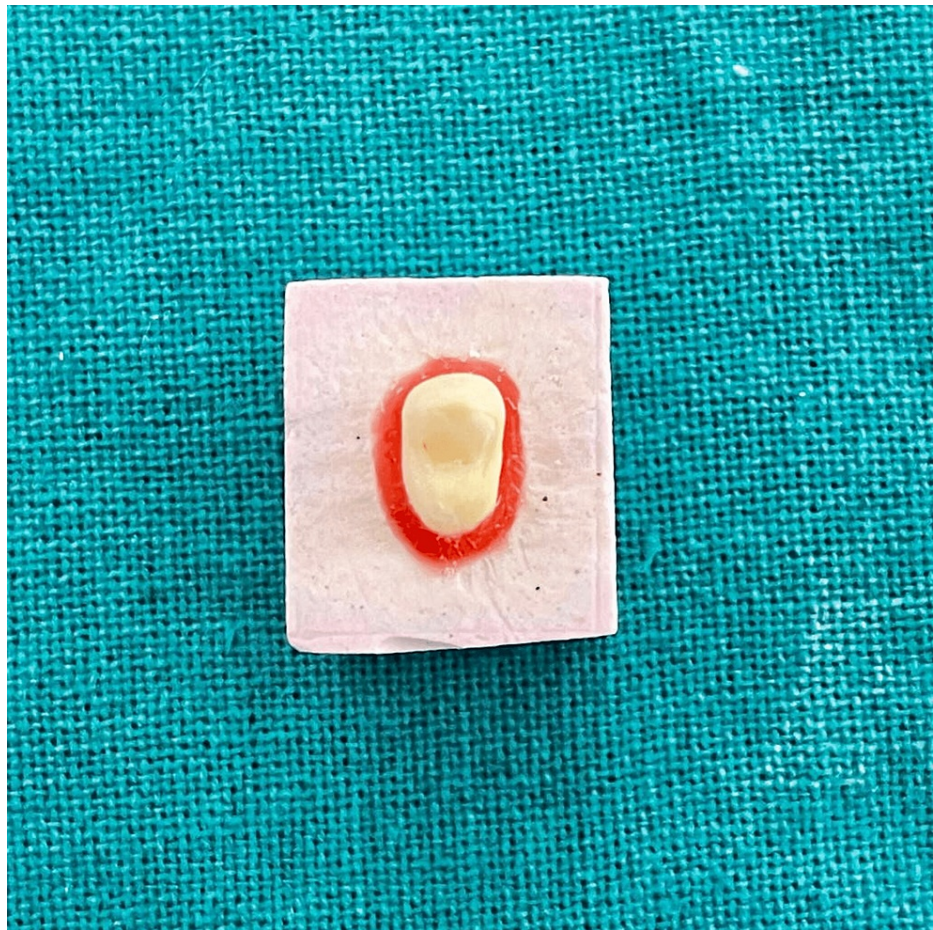
For the current investigation, 10 undamaged, caries-free, first maxillary premolars removed for orthodontic purposes were preserved in a 10% formaldehyde solution (Vinayak Manutrade, India) for two weeks. All teeth were prepared in BOPT 1 mm below the cemento-enamel junction with no finish line using an 862F-012 - 120 microns grit flame-shaped bur (Coltene, Switzerland) with a width of less than 0.3 mm. The occlusal surface was prepared with a cusp form for increased strength resistance (Figure 1). Chemically activated polymethyl methacrylate (Pyrax, India) was used to make 10 special trays, and a polyvinylsiloxane impression material was used to make 10 imprints (Affinis Coltene, Switzerland).

FIGURE 1: BOPT

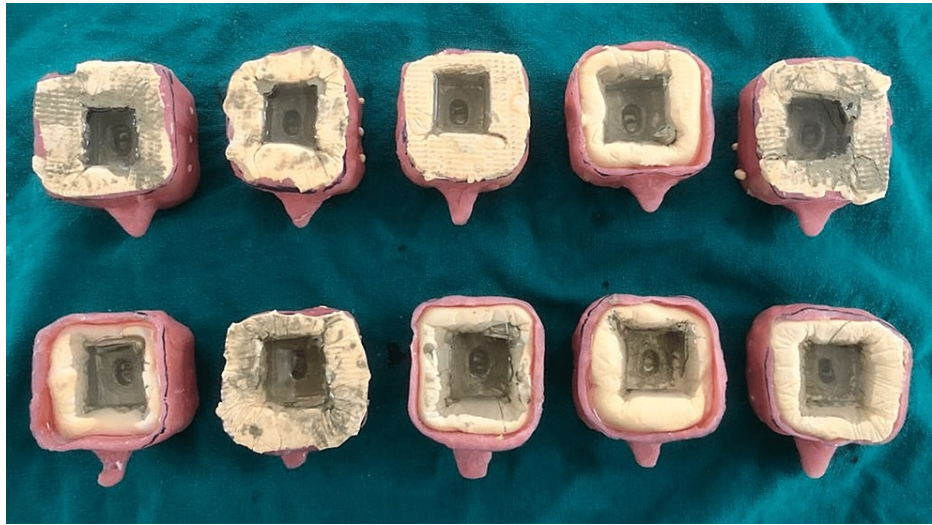
To manufacture 10 identical resin dies with BOPT finish line margin, all 10 impressions (Figure 2) were poured using an ultra-clear epoxy resin and hardener (Haksons, India). The teeth were then extracted, and the BOPT margin was transformed into a heavy chamfer (Figure 3) with an 879/0126-Torpedo diamond bur (Coltene, Switzerland) with a width of up to 0.3 mm. Ten polyvinylsiloxane imprints were generated, and 10 epoxy resin dies with thick chamfer finish lines were manufactured from these impressions. With the 837-012 - cylindrical diamond bur, the thick chamfer finish line margin was turned into a shoulder (Figure 4)

FIGURE 2: Ten Polyvinylsiloxane Impressions poured with Epoxy Resin and Hardener

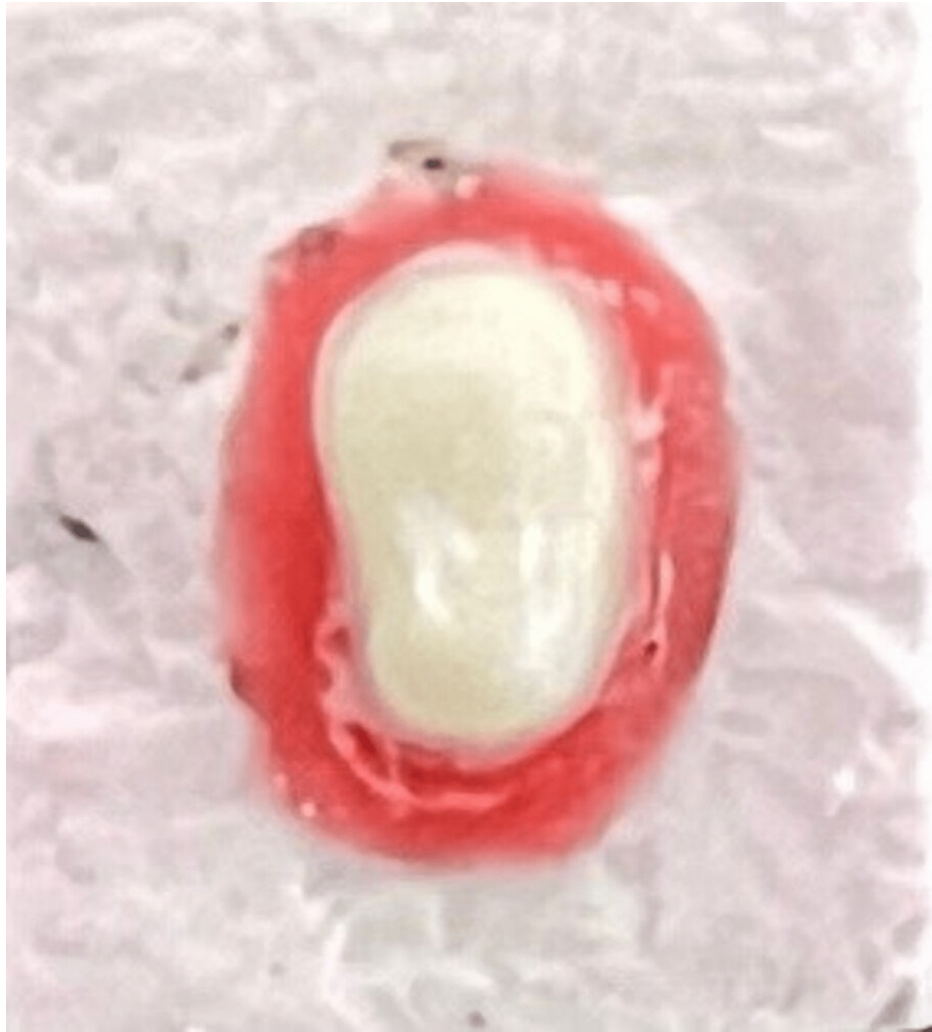
FIGURE 3: Heavy chamfer.

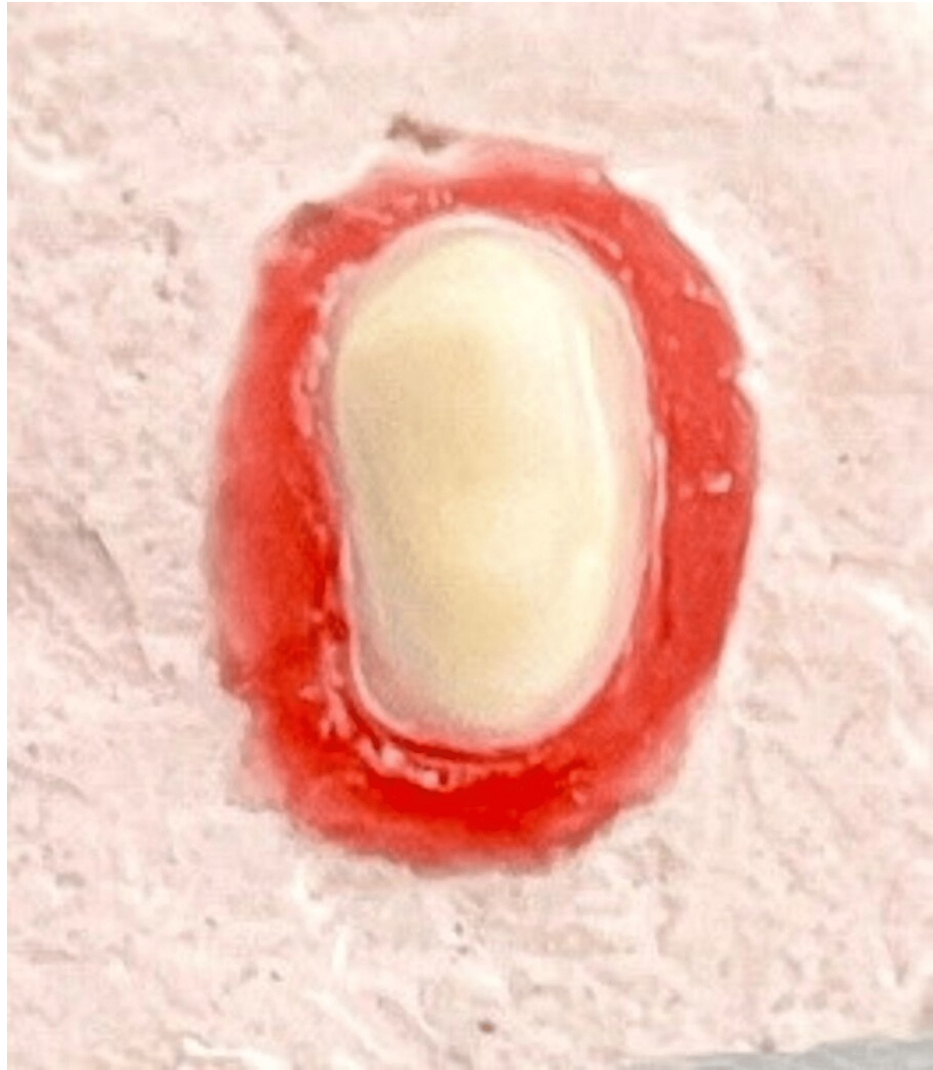
(Coltene, Switzerland) with a width greater than 0.3 mm. Ten polyvinylsiloxane impressions were obtained, which were then used to manufacture 10 epoxy resin dies.

FIGURE 4: Shoulder.

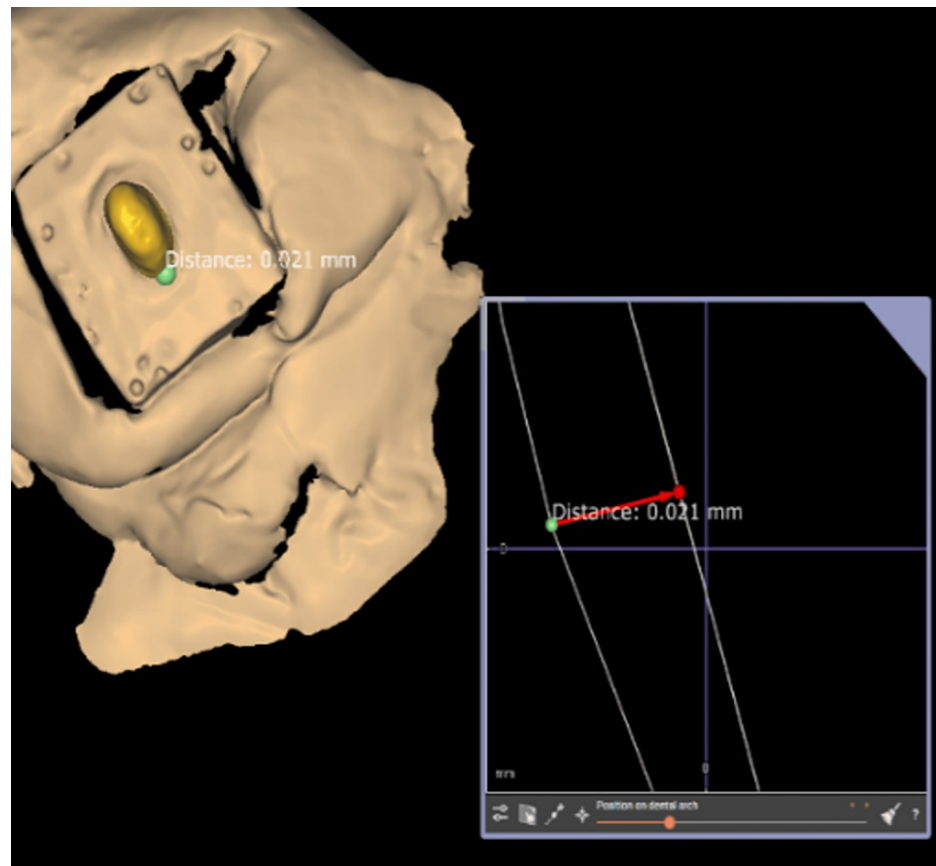
In total, 30 copings were manufactured in sintered ZrO_2 ceramic material utilizing Cercon HT disc CAD/CAM (Scan 24 P53, China) technology (Dentsply, India) by marking the finish lines in exo-cad software. Copings with 0.5 mm thicknesses and 35 μ m of cement space were milled from pre-sintered ZrO_2 , and the Cercon copings were heat sintered for six hours at 1,530°C following the sintering schedule. The copings were tested for minor differences on their respective epoxy resin dies using a three-dimensional (3D) scanner (Shining 3D EX Pro, China) (Figure 5). GIC luting cement was then used to bond each coping to its final die (Shofu, Japan).

FIGURE 5: Marginal discrepancies evaluated using a three-dimensional scanner.

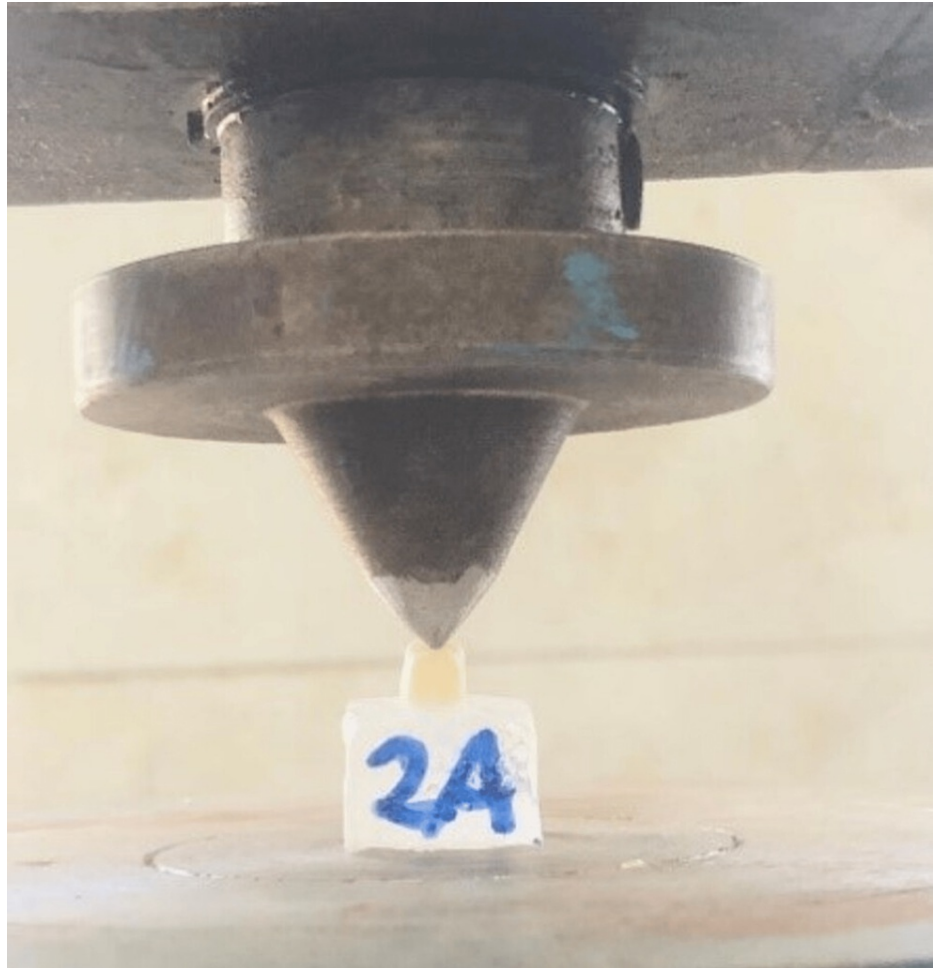
During the setting time, finger pressure was applied. The extra luting cement was eliminated. After cementation, the samples were kept at room temperature in a saline solution (Denis, India). Fracture resistance was done by using digital universal testing equipment (ETTL Groups, India) (ETTL Groups, India). Along the long axis, the load was applied at the center of the occlusal surface with a 1 mm/minute crosshead speed, a 5 mm diameter stainless steel tip, and a 5 N minimum load until fracture occurred (Figure 6). Load controller software was used to automatically record the fracture load data. The samples were examined from the standpoint of the failure's genesis. The data were examined using the Kruskal-Wallis test, and descriptive statistics of fracture resistance were calculated.

FIGURE 6: Fracture resistance performed using a digital universal testing machine.

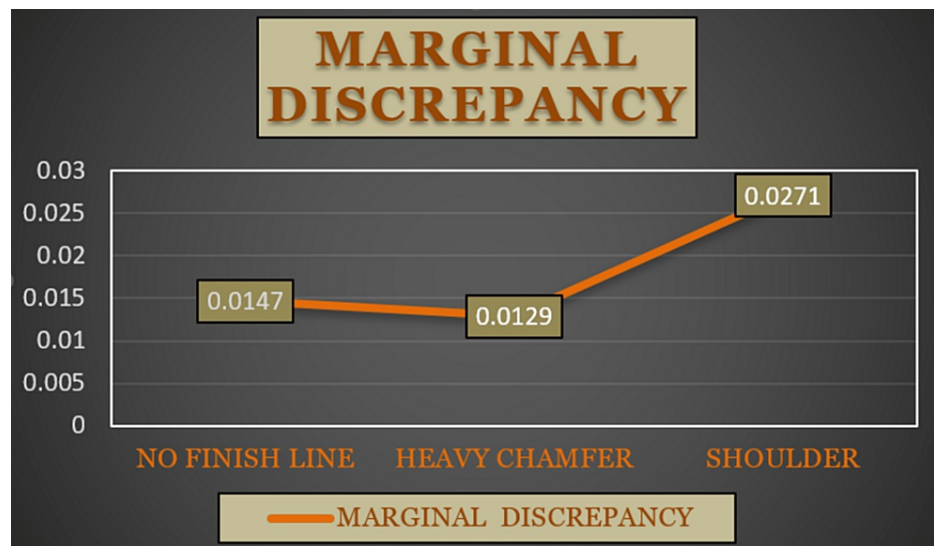
In this study, the BOPT finish line had a mean marginal discrepancy of 14.7 μm , the heavy chamfer finish line had a mean marginal discrepancy of 12.9 μm , and the shoulder finish line had a mean marginal discrepancy of 27.1 μm (Figure 7). BOPT finish line had a mean fracture resistance of 418.90 N, the heavy chamfer finish line had a mean fracture resistance of 451.00 N, and the shoulder finish line had a mean fracture resistance of 353.80 N (Figure 8).

FIGURE 7: Line diagram showing the mean marginal discrepancies of the no finish line, heavy chamfer, and shoulder marginal designs.

The CAD/CAM technology with zirconia has the best fracture strength of any all-ceramic material and has consistently permitted the most attractive, lifelike recreation of natural dentition [2]. To reduce marginal differences and maximize fracture resistance, CAD/CAM technology was employed in this study. Moreover, due to higher stress concentrations at the margins and/or internal surfaces, there have been poor marginal and/or internal adaptations which might impact the fracture strength of restorations [7]. According to the American Dental Association, the film thickness for type I cement should not exceed 25 μ m, and 40 μ m for type II cement. Models with BOPT finish lines had a mean marginal difference of 14.7 μ m, models with heavy chamfer finish lines had a mean marginal discrepancy of 12.9 μ m, and models with shoulder finish lines had a mean marginal disagreement of 27.1 μ m in this study.

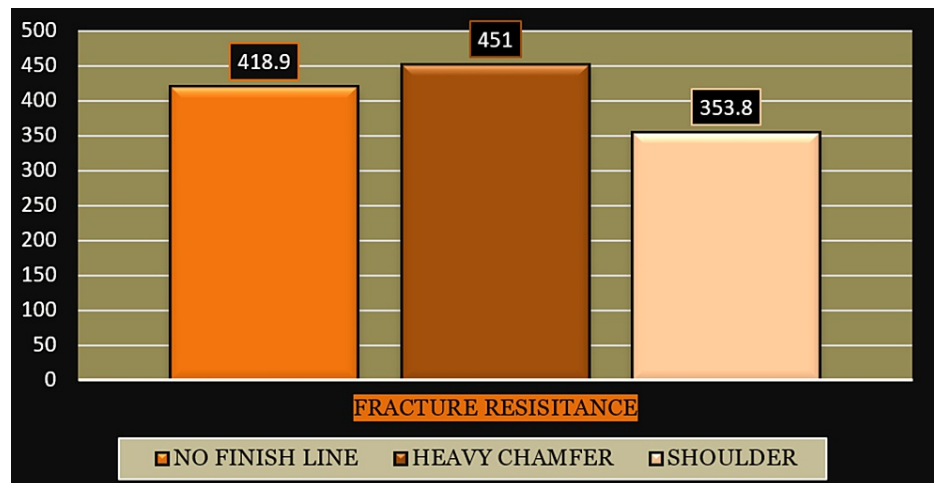
FIGURE 8: Bar diagram showing the mean fracture resistance of zirconia copings on the no finish line, heavy chamfer, and shoulder marginal designs.

In this study, we compared three finish lines, with the shoulder finish line and heavy chamfer being the most commonly employed for zirconia restorations. Nankali [8] investigated chewing in a group of people. The maximal masticatory power in some people can reach 350 N. In this study, the load was put on the long axis at the center of the occlusal surface with a 1 mm/minute crosshead speed, a 5 N minimum load, and a stainless steel tip with a 5 mm diameter on all 30 cemented copings on respective dies until a fracture occurred, and the fracture load information was captured automatically using load controller software. Copings with BOPT finish lines had a mean fracture resistance of 418.90 N, copings with heavy chamfer finish lines had a mean fracture resistance of 451.00 N, and copings with shoulder finish lines had a mean fracture resistance of 353.80 N.

higher mean fracture resistance than the shoulder margin. The Kruskal-Wallis test indicated that the mean fracture resistance among no finish line, heavy chamfer, and shoulder designs was higher in heavy chamfer (451.90.266), followed by no finish line (418.9088.275) and shoulder (353.8064.327). There was no discernible difference between no finish line and heavy chamfer. A substantial difference was noted between the heavy chamfer and shoulder finish lines, with a mean difference of about 97.200 and a p-value of 0.004.
