# Escherichia coli Cellular Activity and Frontal Trizonal Evaluation of Microspace Between Implants and Abutments Under Calibrated Cyclic Stress

**Aim:** To evaluate microspace and microleakage between implant and abutments subjected to pre- and post-calibrated cyclic stress.

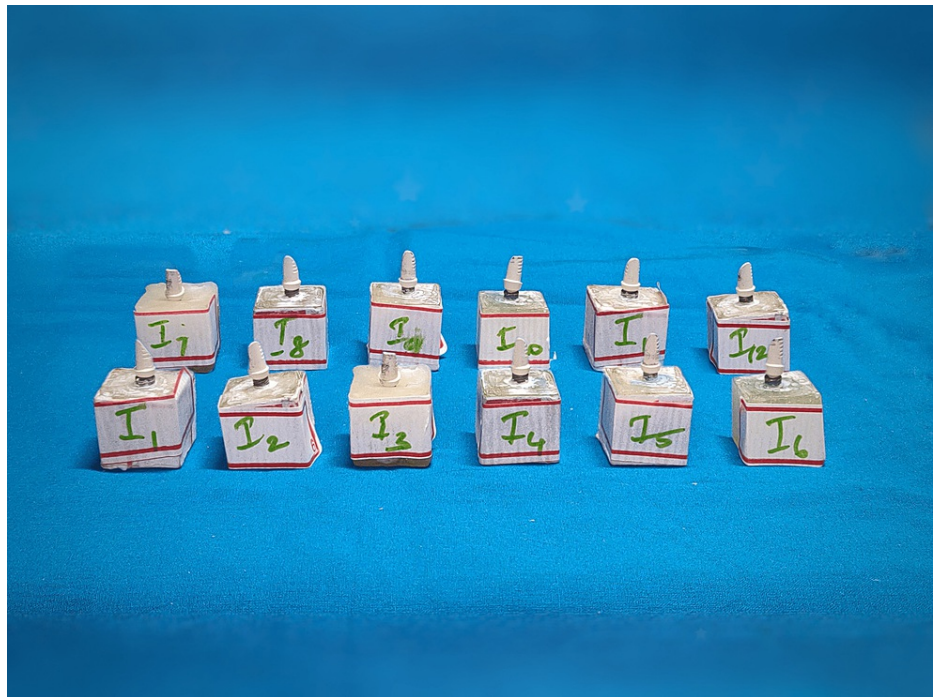
**FIGURE 1: Group I implants with abutments**

Twelve internal hexagon BioHPP PEEK abutments and 12 CAD/CAM milled zirconia abutments (DentGallop, Houston, TX, USA) were used in the current investigation. Based on the abutments used, the samples placed and enumerated were designated to two test groups. Group I test samples are composed of BioHPP PEEK abutments that were connected to their respective implants first and then loaded with screw Ni-Cr crowns (Figures 1, 2). Group II test samples composed of CAD/CAM milled zirconia abutments were connected to the implants.

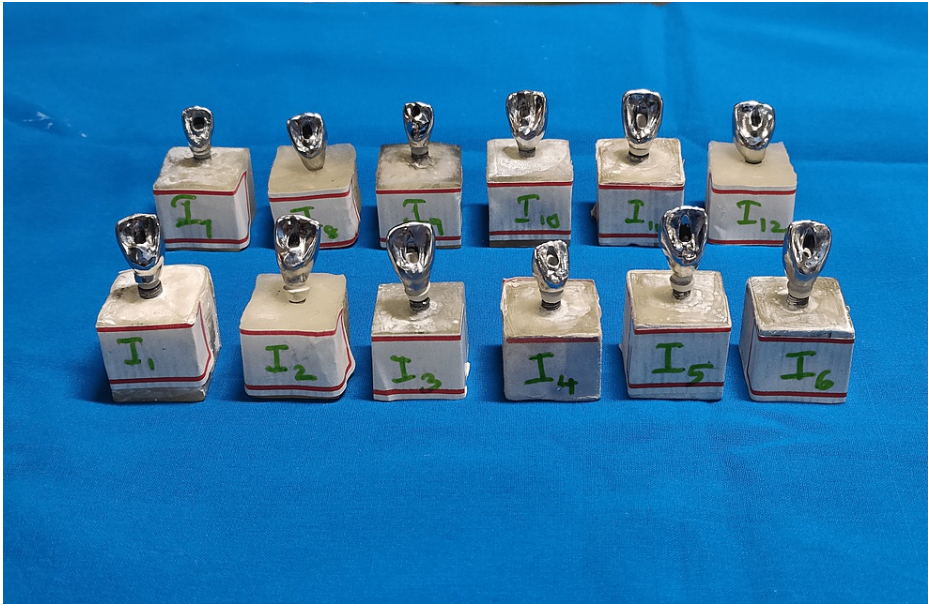
**FIGURE 2: Group I completed samples with crowns**

Twenty-four screw-retained cast nickel-chromium (Ni-Cr) crowns were obtained for each implant analog assembly using palatal screw access. Each Ni-Cr crown was chosen and fixed to its respective implant by manually torquing the prosthetic screw to 30N/cm. Crowns were thoroughly inspected for seating and marginal accuracy (Figures 3, 4).

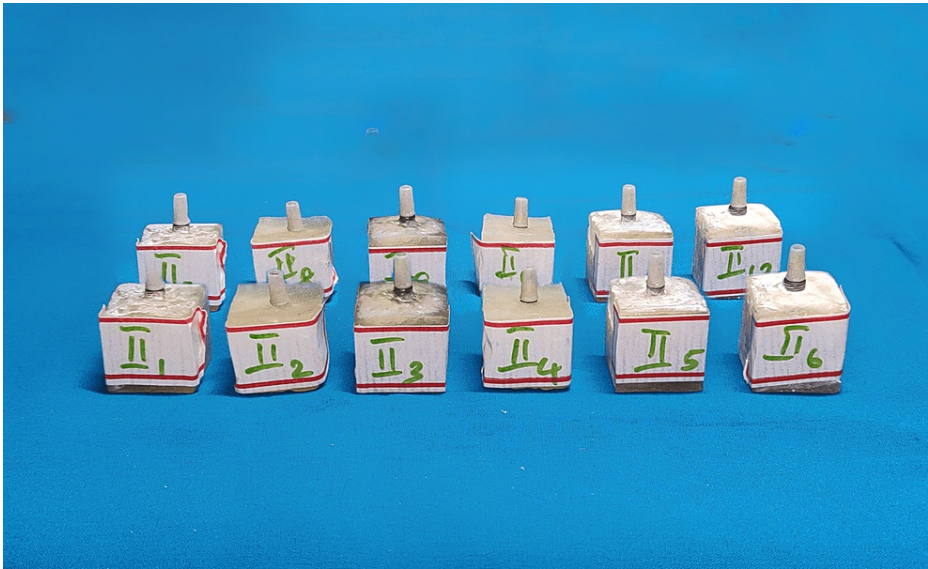
**FIGURE 3: Group II implants with abutments**

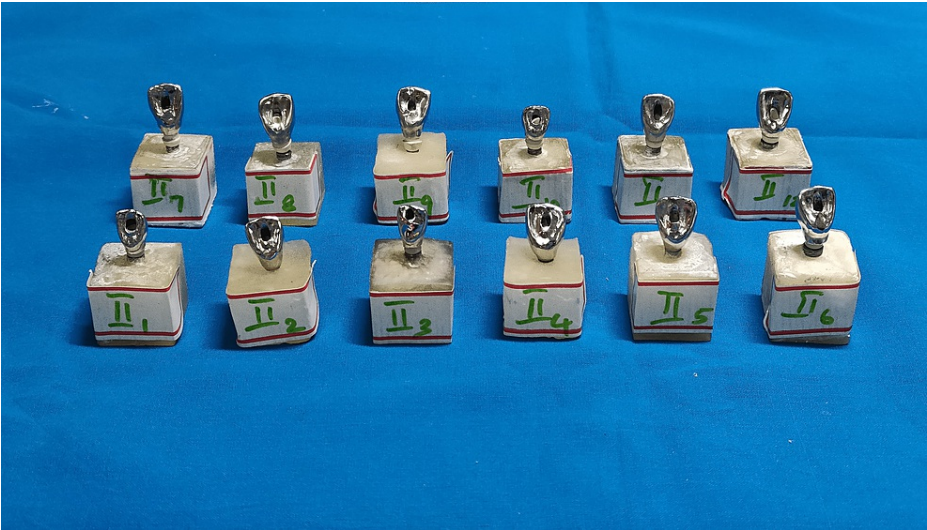
**FIGURE 4: Group II completed samples with crowns**

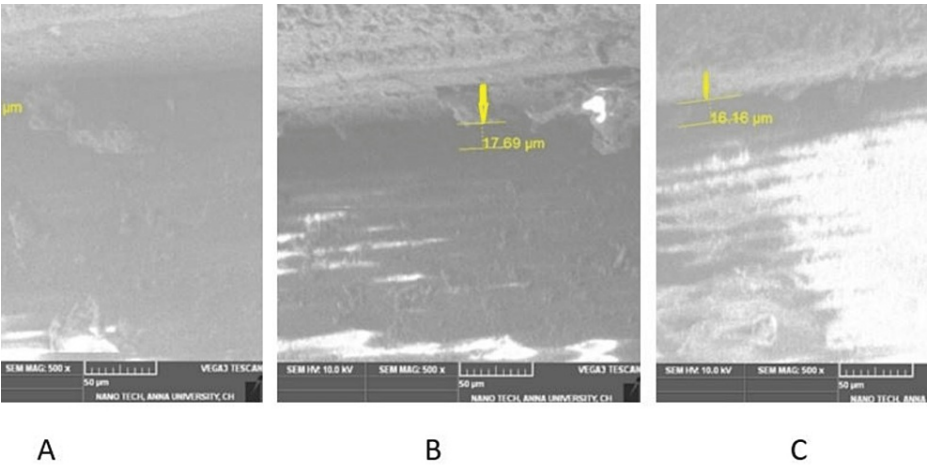
**FIGURE 5: Frontal trizonal images of Group I (A- front right, B- front left, C- center)**

The test samples were placed in an SEM source (TeScan, Brno, Czech Republic); the vertical microspace was measured at three different zones: left corners, center, and right corners using digital images (SEM TeScan's Essence software). In this study, all test samples were evaluated under 500x magnification. SEM images were transferred to this file. The vertical microgaps were measured for Group I and Group II test samples (Figures 5, 6).

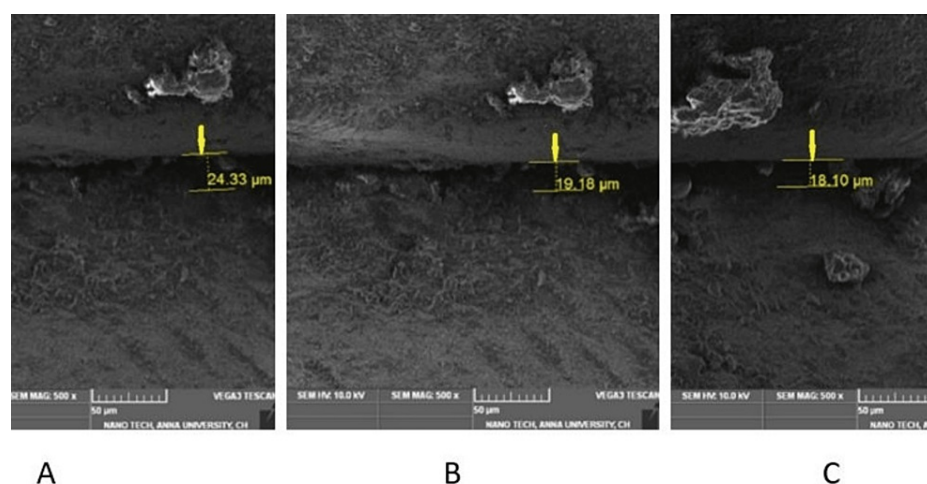
**FIGURE 6: Frontal trizonal images of Group II (A- front right, B- front left, C- center)**

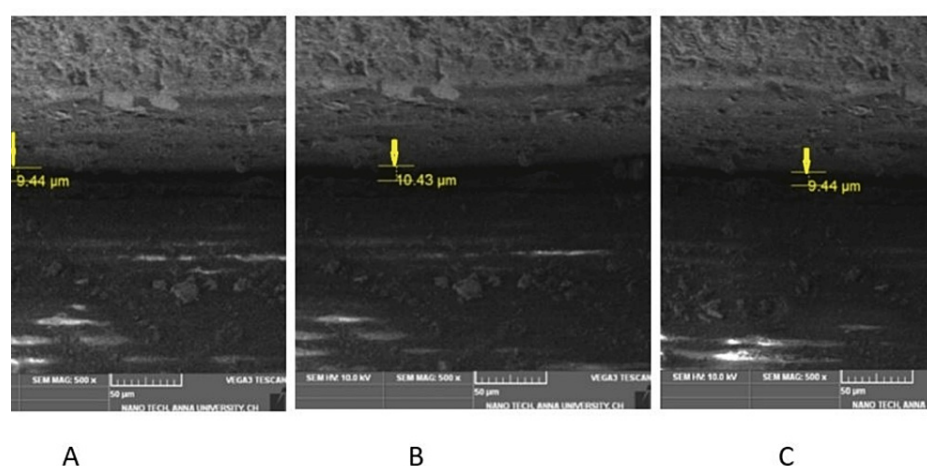
**FIGURE 7: Frontal trizonal images of Group IA (A- front right, B- front left, C- center)**

Calibrated cyclic stress delivery was performed for all test samples (Group I and Group II) using a cyclic stress delivery machine (Lokesh Industries, Chennai, India) simulating oral functions. Test samples with the prosthesis were positioned in the platform and secured at an angle of 30° for the anterior crown. The needle was oriented to contact the cingulum portion of the incisor crown. A cyclic stress delivery of 00 N was applied to each sample for 150,000 cycles, simulating six months of function. The cycle was continued for 24 hours with the discontinuance of one hour every 12 hours. After cyclic loading, existing groups were designated Group IA and Group IIB (Figures 7, 8).

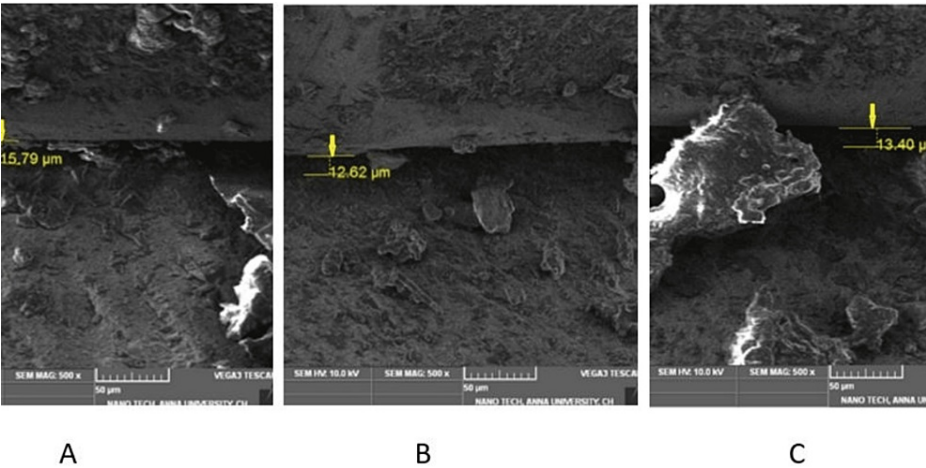
**FIGURE 8: Frontal trizonal images of Group IIB (A- front right, B- front left, C- center)**
