Fixation of Small Osteochondral Fragments in a Comminuted Distal Humerus Fracture with Magnesium Bioabsorbable Screws: A Case Report

Categories: Orthopedics, Trauma

Keywords: humerus fracture, bioabsorbable screw, internal fixation

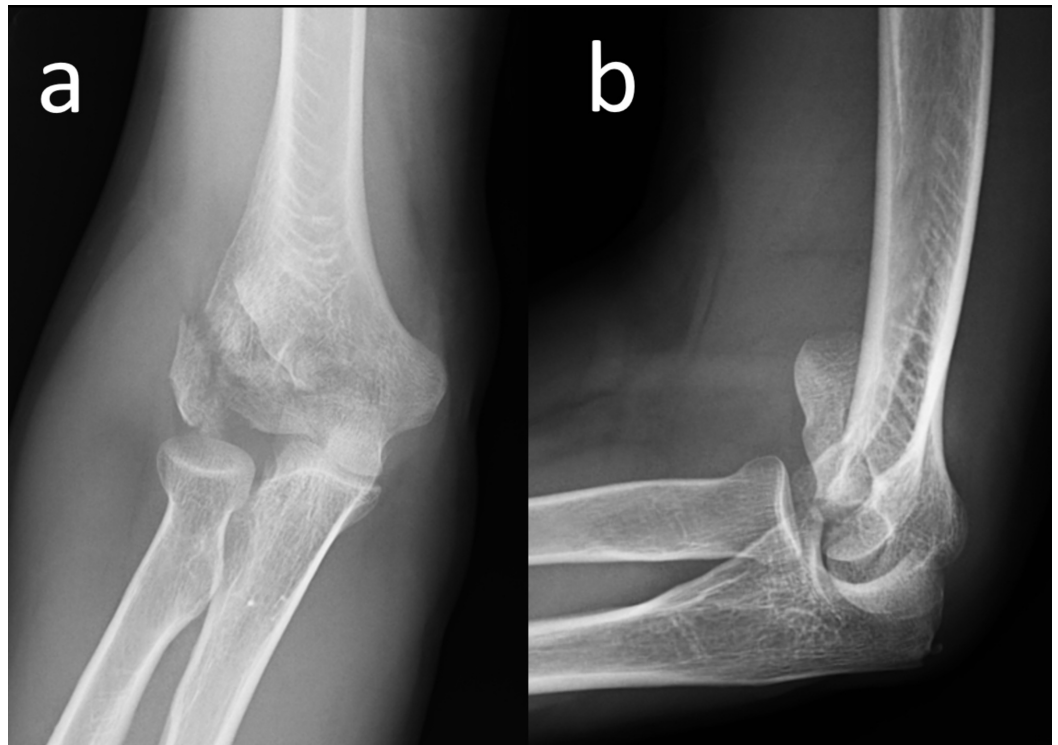
FIGURE 1: Preoperative elbow radiograph

Anteroposterior (a) and lateral (b) elbow radiographs of the patient at initial admission, showing comminuted distal humeral fractures with articular involvement.

We report a 50-year-old male patient who was admitted to our emergency department after falling from a height onto his elbow. On physical examination, his elbow was swollen and tender. The active and passive elbow range of motion was painful and limited. The neurovascular examination of the upper extremity was normal. Direct radiographic examination of the elbow showed a distal humeral fracture with comminution of the capitellum and lateral column (Figure 1).

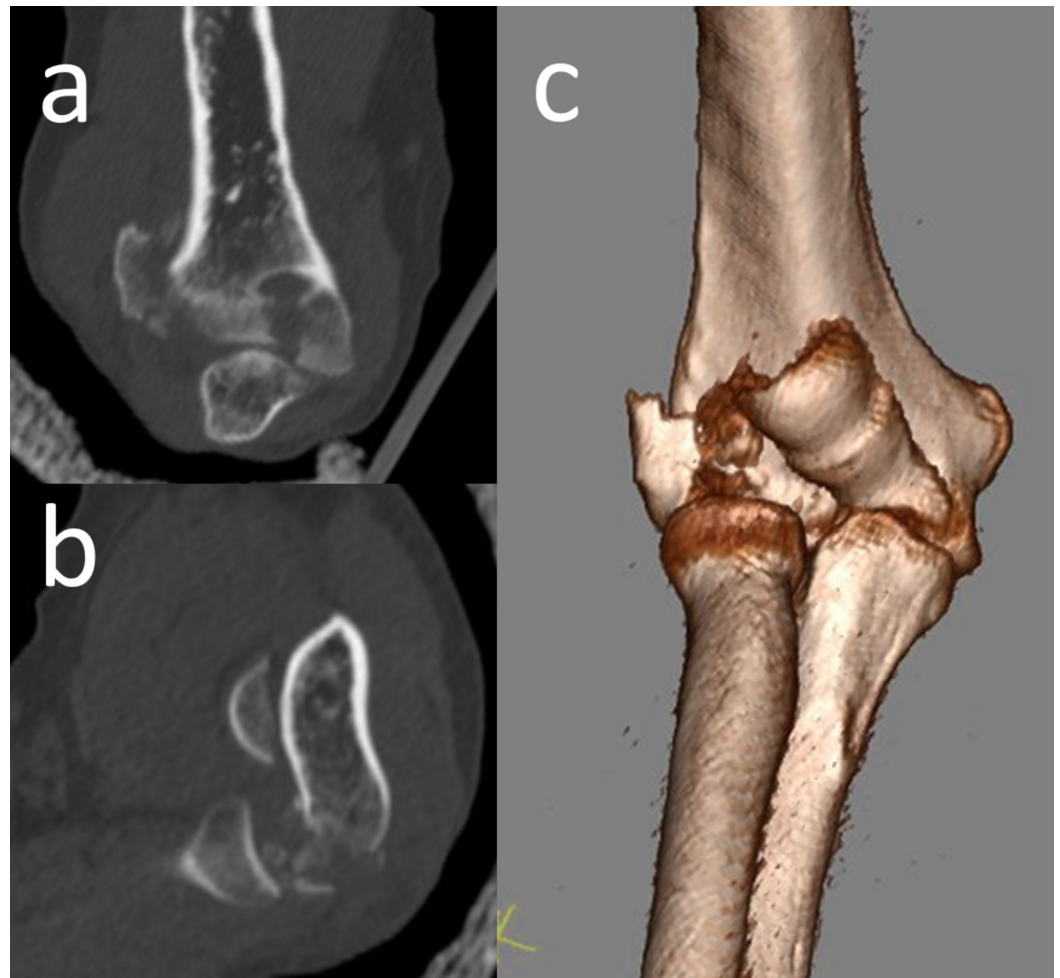
FIGURE 2: Computerized tomography of the elbow

Computerized tomography of the elbow. Coronal (a) and sagittal (b) sections demonstrated the free osteochondral fragments. 3D CT appearance (c) of the fracture.

In order to understand the extent of the comminution, computerized tomography (CT) imaging was performed. The CT examination showed fragmentation of the capitellum and a fracture extending to the lateral column (Figure 2).

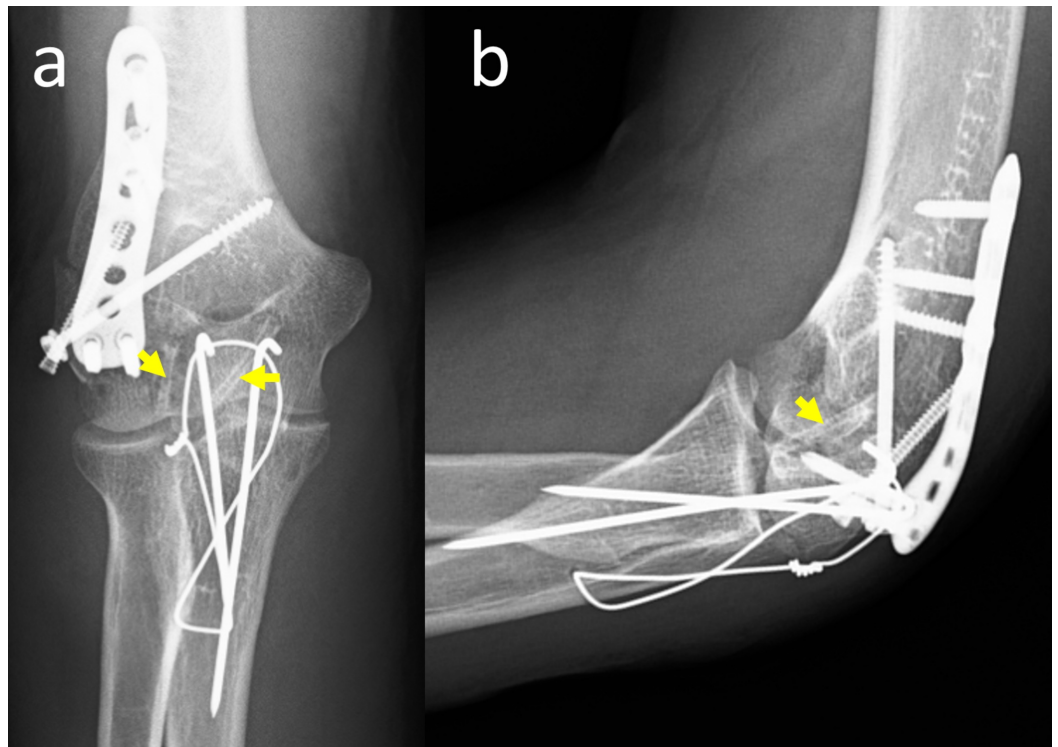
FIGURE 3: Postoperative radiographs

Anteroposterior (a) and lateral (b) elbow radiographs immediately after operation. Yellow arrows show the magnesium bioabsorbable screws.

Surgical fixation of the fracture was planned based on imaging findings. Under general anesthesia and tourniquet control, a posterior surgical approach with olecranon osteotomy was used for the exposure of the fracture. The articular surface was reduced and fixed with two 2.7 mm diameter magnesium bioabsorbable screws (MAGNEZIX® CS, Syntellix AG, Hanover, Germany). The lateral column was fixed with an anatomic lateral column plate. It has been paid attention that the two materials (titanium and magnesium) did not touch each other physically. The olecranon osteotomy was fixed with the tension band wiring technique (Figure 3).

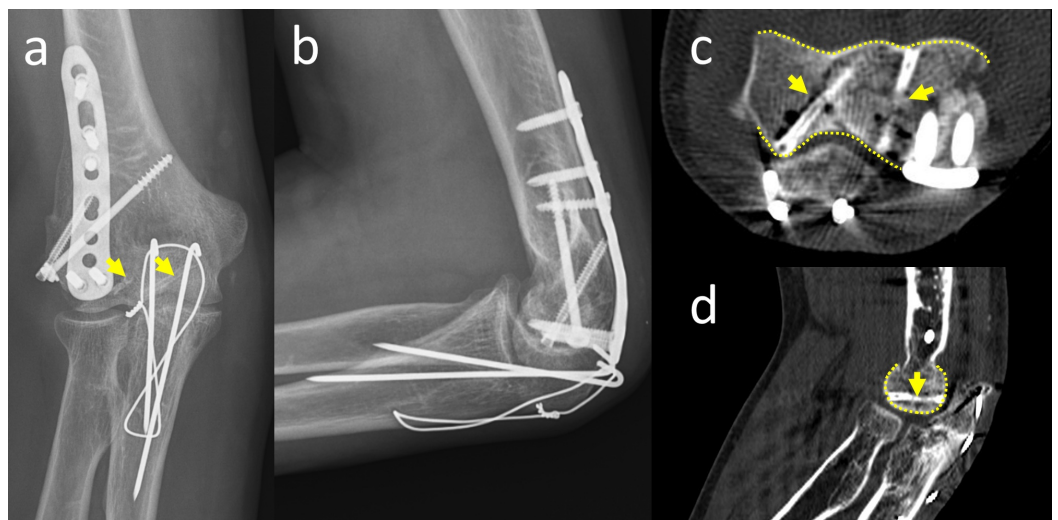
FIGURE 4: Final follow-up radiographs and CT

Anteroposterior (a) and lateral (b) elbow radiographs at the fourth-month follow-up. Axial (c) and sagittal (d) CT examination demonstrated the union of fracture and perfect articular surface (yellow dotted lines show the smooth articular surface and yellow arrows show the screws).

After the operation, the patient was immobilized in an above-elbow plaster cast for 10 days to facilitate the subsidence of edema around the elbow. Thereafter, the plaster cast was removed and the active elbow range of motion exercises was initiated. At the first month follow-up, the elbow range of motion was between 20 and 110 degrees. Supination and pronation of the forearm were in the normal range. At the fourth-month follow-up, the fracture was united and the elbow range of motion was nearly normal, between 5 degrees and 130 degrees (Figure 4). The Mayo elbow performance score was 100.

In the fourth month, no gas formation was observed around the screws on direct radiographs of the elbow in our patient. However, the CT examination showed a slight accumulation of gas around the screws, which was clinically insignificant. The quality of reduction of the joint surface was adequate and smooth without the protrusion of the screws. Union of the osteochondral fragments and degradation of the screws could be seen on axial and sagittal CT views.
