Plateau and Patella: A Framework for Ipsilateral Injury Fixation

Categories: Orthopedics, Trauma

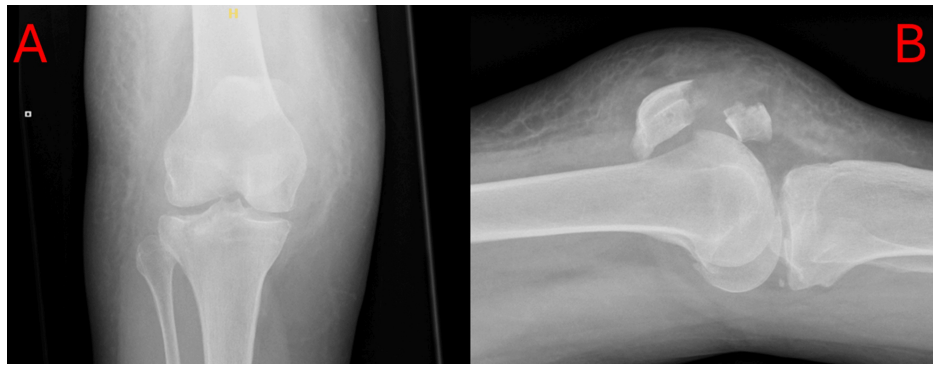
FIGURE 1: Preoperative anterior to posterior (a) and lateral (b) X-rays of the injury

A) Plain anterior to posterior radiograph of the patient's right knee. This image shows a Schatzker 2 [1] lateral condylar fracture; B) Plain lateral radiograph of the patient's right knee. This image shows a displaced, midbody patellar fracture with associated haematoma.

Given the severity of the injury, the patient was placed in a knee splint and admitted to the local Trauma and Orthopaedic service. A computerised tomography (CT) scan was undertaken to plan surgical intervention. This showed a Schatzker 2 [1] comminuted fracture of the right lateral tibial plateau, a depressed lateral condyle fracture involving the joint surface. There was a horizontal fracture through the right patella, with proximal displacement of the superior fragment (Figure 1). The CT scan subsequently demonstrated the small amount of comminution associated with this fracture.

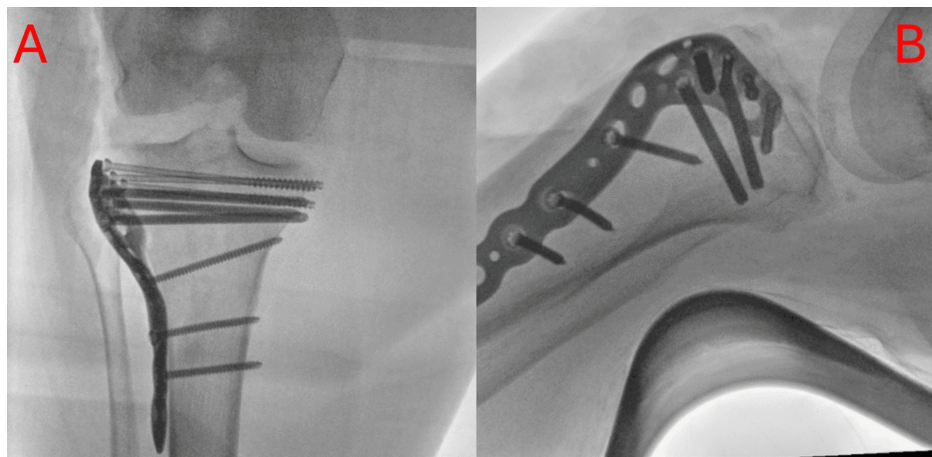
FIGURE 2: Intraoperative anterior to posterior (a) and lateral (b) X-rays of tibial plateau fixation

A) Plain intraoperative anterior to posterior radiograph of the patient's right knee. This image shows lateral plate and screw fixation of the tibial plateau fracture; B) Plain lateral intraoperative radiograph of the patient's right knee. This image shows the lateral plate, with screw fixation, of the tibial plateau fracture.

With the above in mind, the decision was made to proceed with a single midline incision to approach both injuries. After passing through the skin, and subcutaneous fat, the dissection proceeds along the lateral gutter, where the iliotibial band (ITB) was identified and split to visualise the split in the fracture tibial surface. The plateau was addressed primarily. The fracture was elevated through the split, supported with Kirschner wire, and filled with small autologous bone chips. Thereafter, with the use of cannulated screws and with a lateral proximal tibial plate, the fracture was lifted and supported, pictured below. A satisfactory hold was achieved with all the screws placed. The ITB was repaired, and following this, our attention focused on the patella fracture.

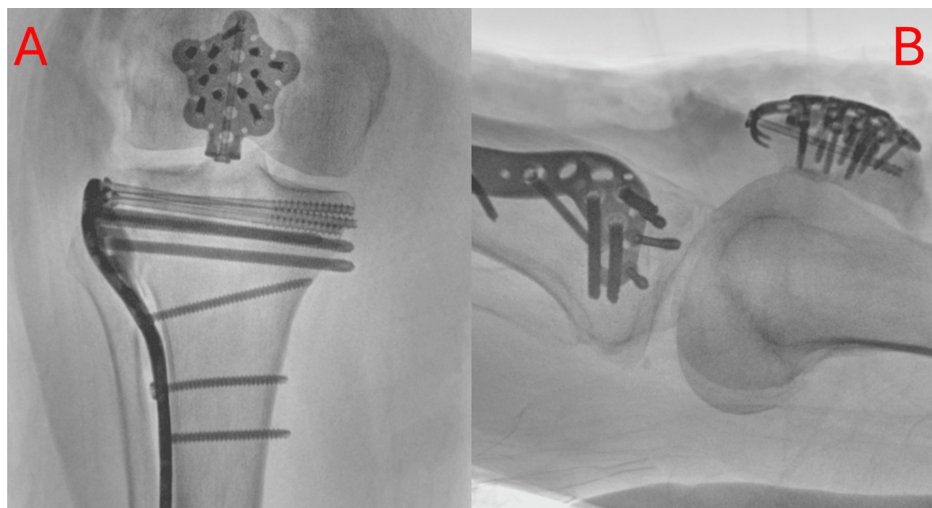
FIGURE 3: Intraoperative anterior to posterior (a) and lateral (b) X-rays of patellar fixation

A) Plain intraoperative anterior to posterior radiograph of the patient's right knee. This image shows the patellar fracture fixed with a plate and screws. It also shows the tibial plateau fracture fixation, seen in Figure 2; B) Plain lateral intraoperative radiograph of the patient's right knee. This image shows the patellar fracture fixed with plate and screws. It also shows the tibial plateau fracture fixation, seen in Figure 2.

To address the patella, using the same incision, we were able to clear the soft tissue and retinaculum superficial to the patella. As proven by the CT, the fractured patella was seen to be comminuted, distal, and more oblique than initially anticipated. Therefore, the decision was made to proceed with a patella plate (over a tension band technique). The fracture fragments were opposed and held with wires. Following this, the appropriately sized patella plate was utilised. An initial single partially threaded retrograde screw was inserted from the smaller (distal) fragment to the larger (proximal) fragment. The screw was partially threaded to reduce and apply compression at the fracture site. The patella plate, therefore, was used in neutralisation mode to reduce the tension across the fracture site. All screws utilised in securing the patella were locking screws and 2.7mm in diameter, as shown in Figure 3.

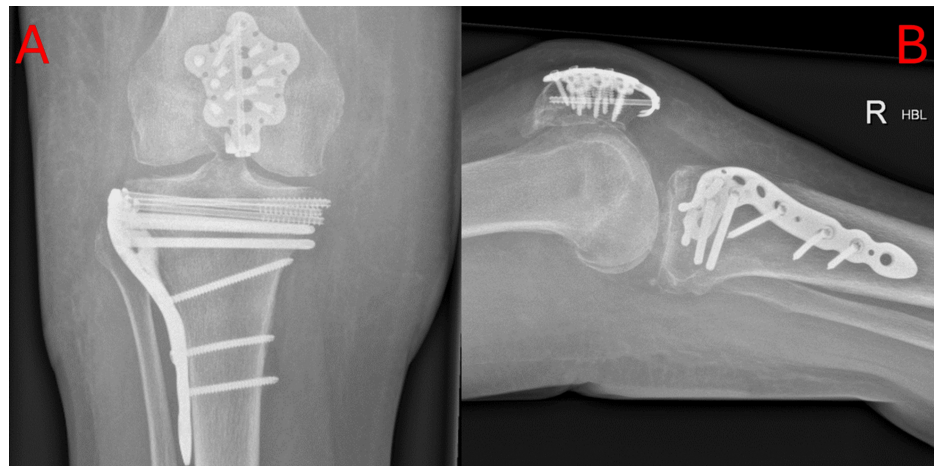
FIGURE 4: Anterior to posterior (a) and lateral (b) X-rays of right knee three months postoperatively.

A) Plain anterior to posterior radiograph of the patient's right knee. This image shows adequate fixation of both the patella and the tibial plateau fracture at three months after the operation; B) Plain lateral radiograph of the patient's right knee. This image shows adequate fixation of both the patella and the tibial plateau fracture at three months after the operation.

She was compliant with physiotherapy and discharged home with two weekly outpatient follow-ups. There have been no significant postoperative complications as of three months post-op. Her three-month x-rays, included below in Figure 4, show that the fracture remains well reduced and is healing. The fixation is stable with no migration of the hardware.

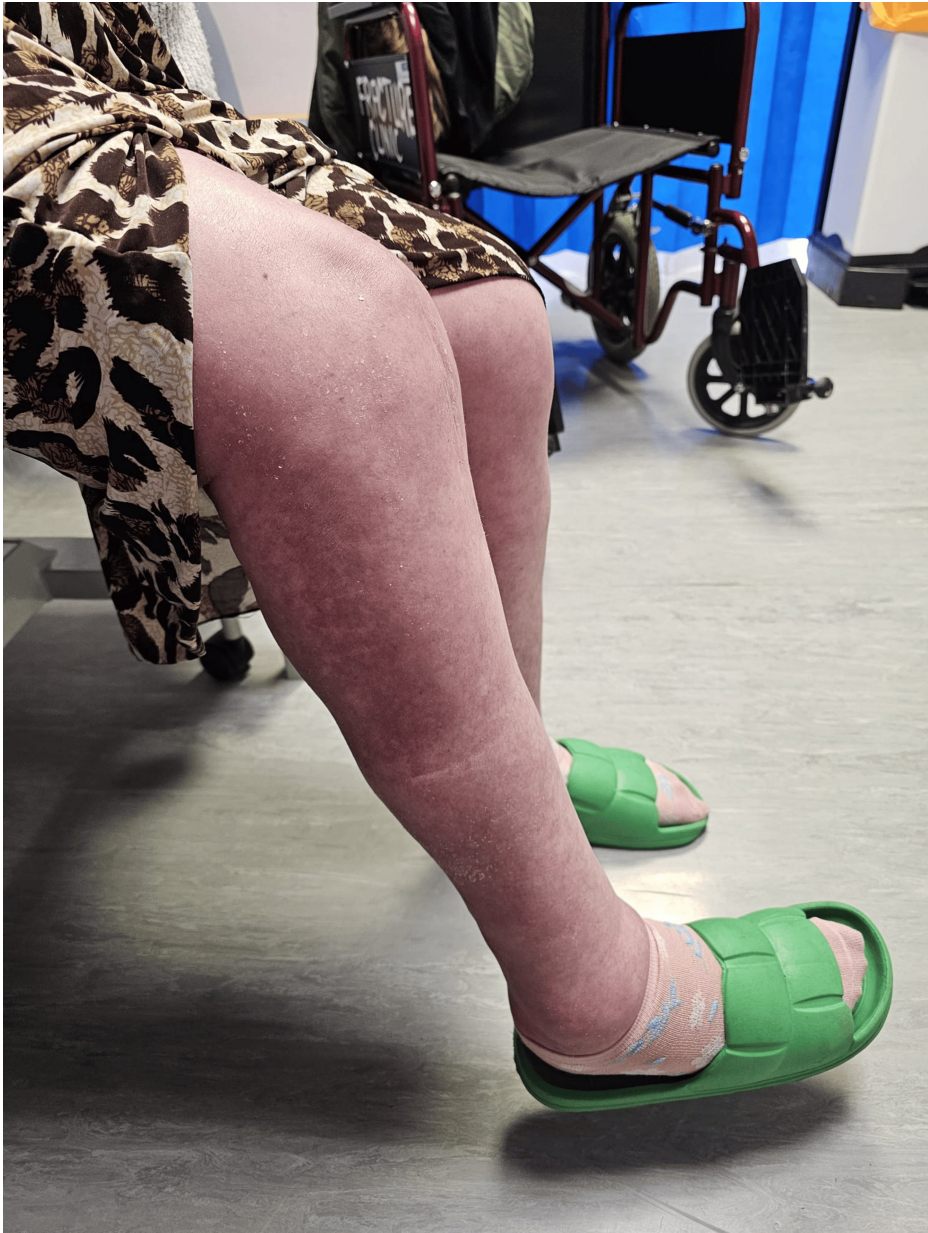
FIGURE 5: Patient's knee in flexion three months after the operation

Figures 5 and 6 show the patient's knee in flexion and extension at three months follow-up. There was a 10-degree extension deficit, and the patient could flex to 60 degrees.
