Cone Beam Computed Tomography-aided Endodontic Management of Second Maxillary Molar with Two Separate Palatal Roots: A Case Report

Purushotham M¹, Hrudi Sahoo¹

1. Conservative Dentistry and Endodontics, Sathyabama Dental College and Hospital, Chennai, IND

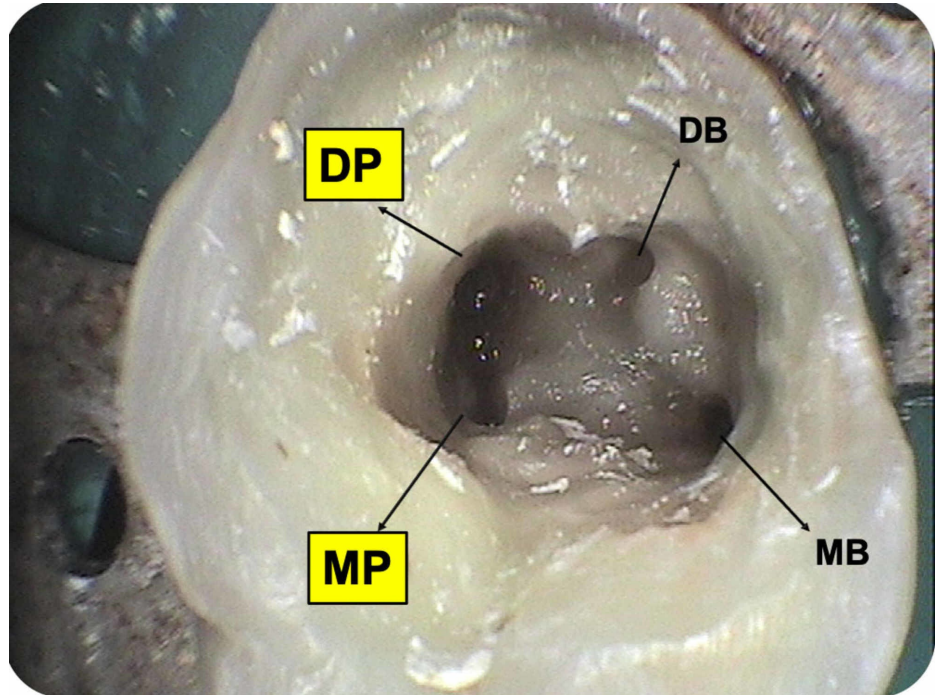
FIGURE 1: Access cavity of maxillary second molar (#27)

DP: distopalatal canal orifice; MP: mesiopalatal canal orifice; DB: distobuccal canal orifice; MB: mesiobuccal canal orifice

cavity, three root canal orifices were located, i.e mesiobuccal, distobuccal, and palatal root canals. Under a dental operating microscope with a 5X magnification (Seiler Medical, St. Louis, MO), the floor of the access cavity was examined using a DG-16 explorer (Hu-Friedy, Chicago, IL). Although the second mesiobuccal canal was not located, it was searched for by troughing along the line joining mesiobuccal and palatal orifices with low-speed burs and ultrasonic tips. The palatal canal unusually seemed to be distally positioned and a bleeding point was noticed mesial to the palatal canal orifice (Figure 1). A hand k-file (MANI, Inc., Shioya, Japan) (#10, 25 mm) was placed inside and an apex locator was used to confirm the presence of an extra palatal canal. A working length radiograph was taken (Figure 2). Pulp was completely extirpated and the access cavity was temporized with Cavit (3M Espe AG, Seefeld, Germany). To rule out the presence of further complexities inside the extra palatal canal, following the “as low as reasonably achievable” (ALARA) principles, a low-field-volume cone beam computed tomography (CBCT) scan was advised.

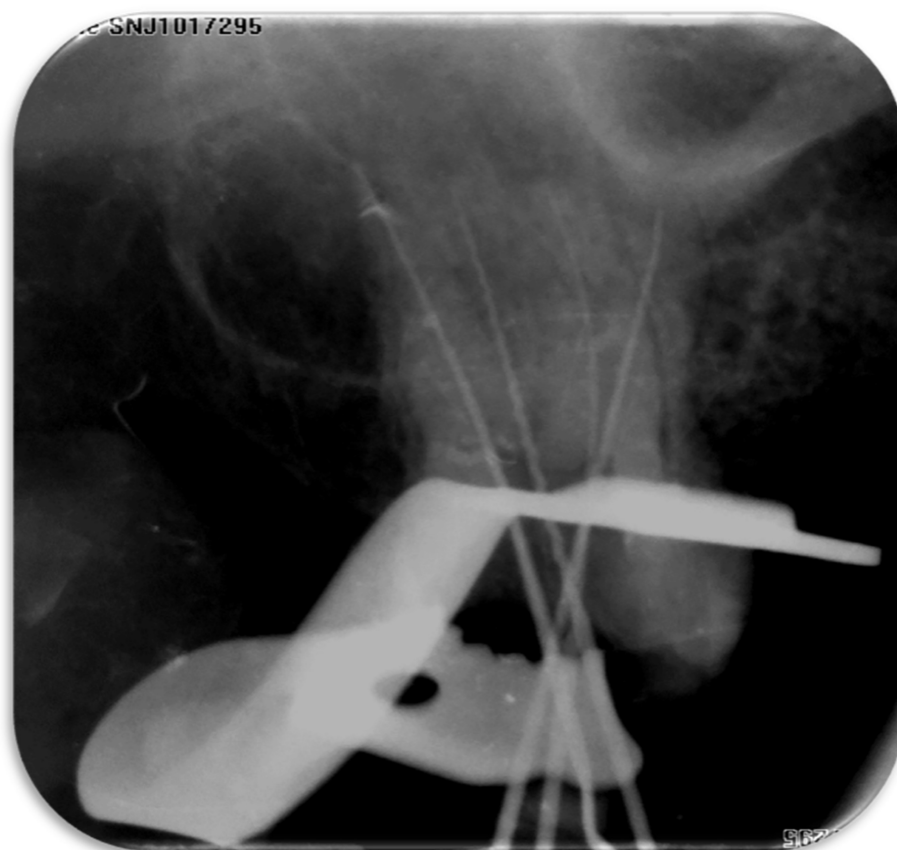
FIGURE 2: Radiographic working length determination (#27)

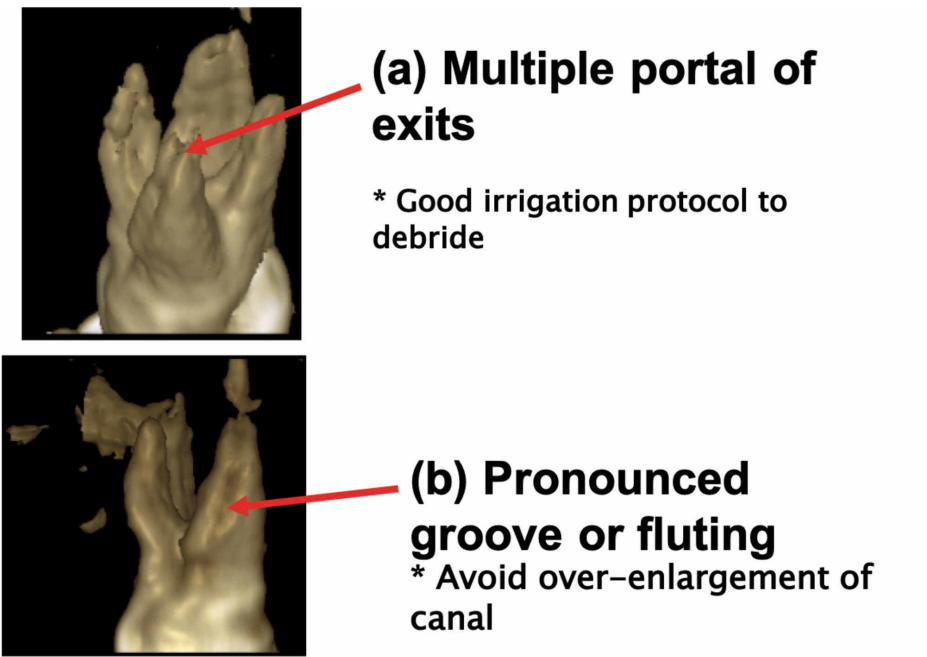
FIGURE 4: 3D reconstruction of #27 CBCT images

Further, to study the morphology of the mesiopalatal canal, the CBCT images were reconstructed using Horos Dicom visualization software. The images revealed multiple portals of exit at the apical third of the mesiopalatal canal and also a pronounced grooving or fluting on the mesial surface of the mesiopalatal root. These morphologic variations need to be kept in mind while preparing the root canal as excess root dentin removal during shaping procedures may be detrimental, and advanced irrigation devices such as EndoVac (Kerr, Brea, CA) should be used for improved debridement of such complex canal anatomy.

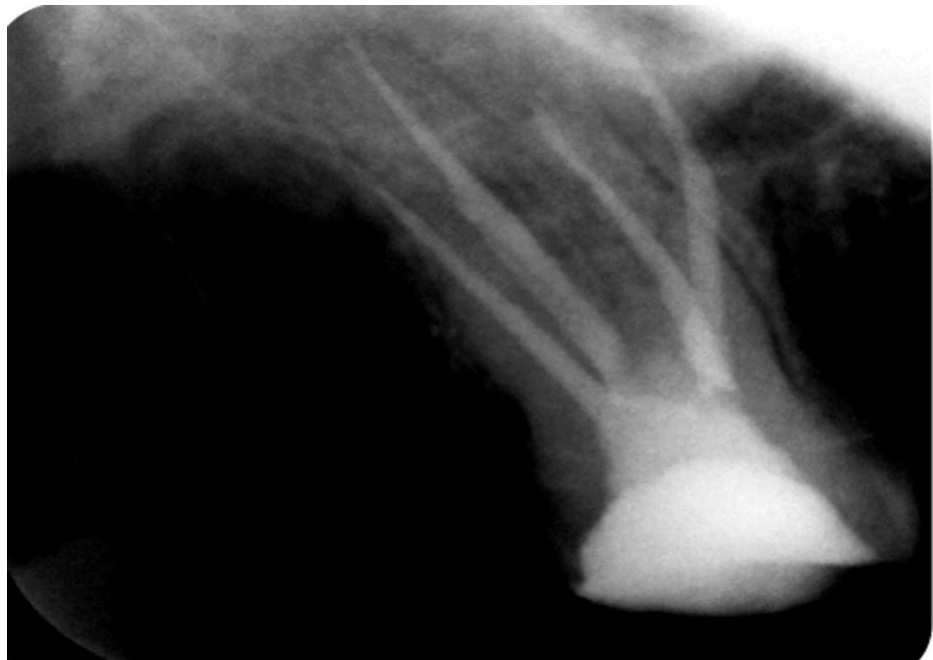
After a period of seven days, the patient was asymptomatic and the root canals were completely obturated using thermo-plasticized gutta-percha (Elements; VDW, Munich, Germany), and a postoperative intra-oral radiograph was taken (Figure 5). A six-month follow-up radiograph was also taken, which revealed a possible successful outcome of the treatment (Figure 6).

FIGURE 5: Obturation radiograph of #27

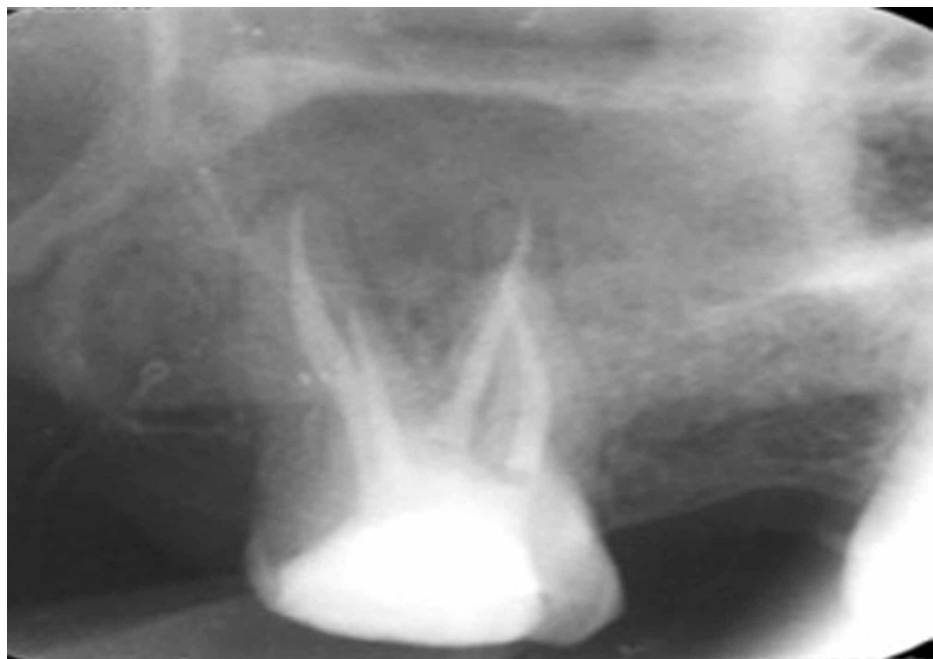
FIGURE 6: Follow-up radiograph of #27 after six months
