# Iatrogenic Axillary Artery Branch Injury Following Peripherally Inserted Central Catheter (PICC) Line Insertion Managed With Coil Embolization: A Case Report

DOI: 10.7759/cureus.84207

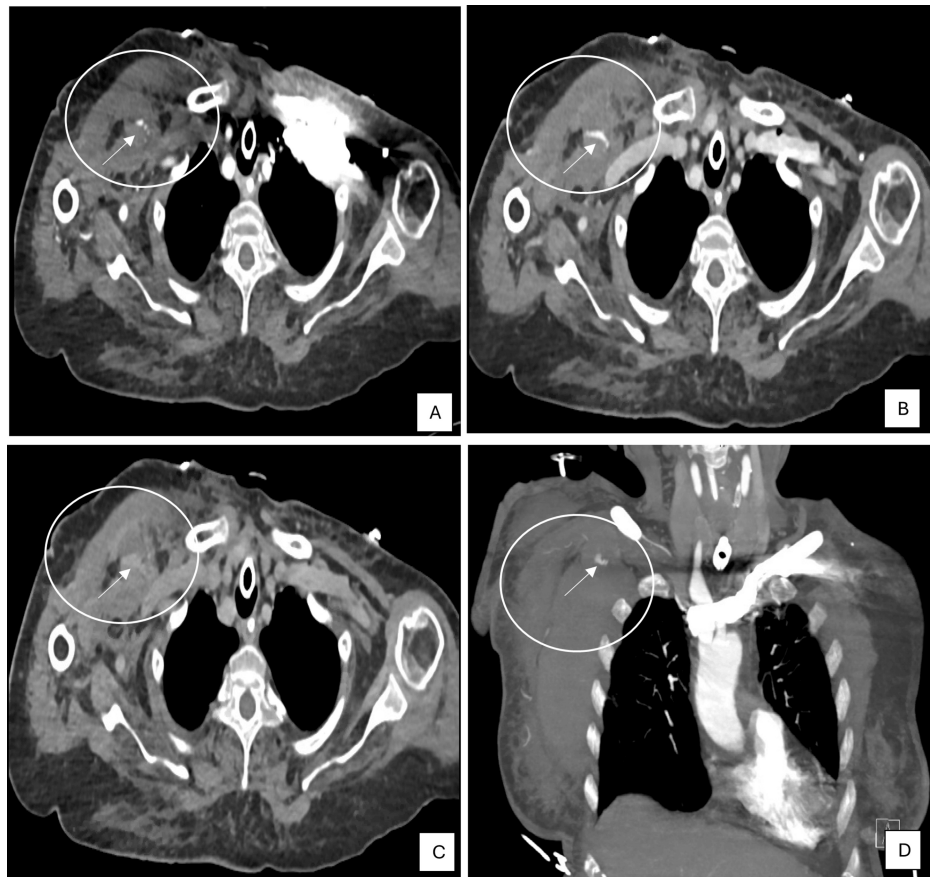
**FIGURE 1: Computed tomography: axial arterial phase (A), axial venous phase (B), axial delayed phase (C), and MIP coronal arterial phase (D)**

Computed tomography showing the focus of active arterial extravasation progressing on the venous and delayed phases in the vicinity of the right axillary artery (arrows) with large right muscular pectoral/subpectoral hematoma (white circle)

On postoperative day 3, the patient developed right chest swelling around the PICC line insertion site. Computed tomography angiography revealed a large right subpectoral hematoma (8×9×3.7 cm) with active arterial extravasation, suggestive of an axillary artery branch pseudoaneurysm (Figure 1).

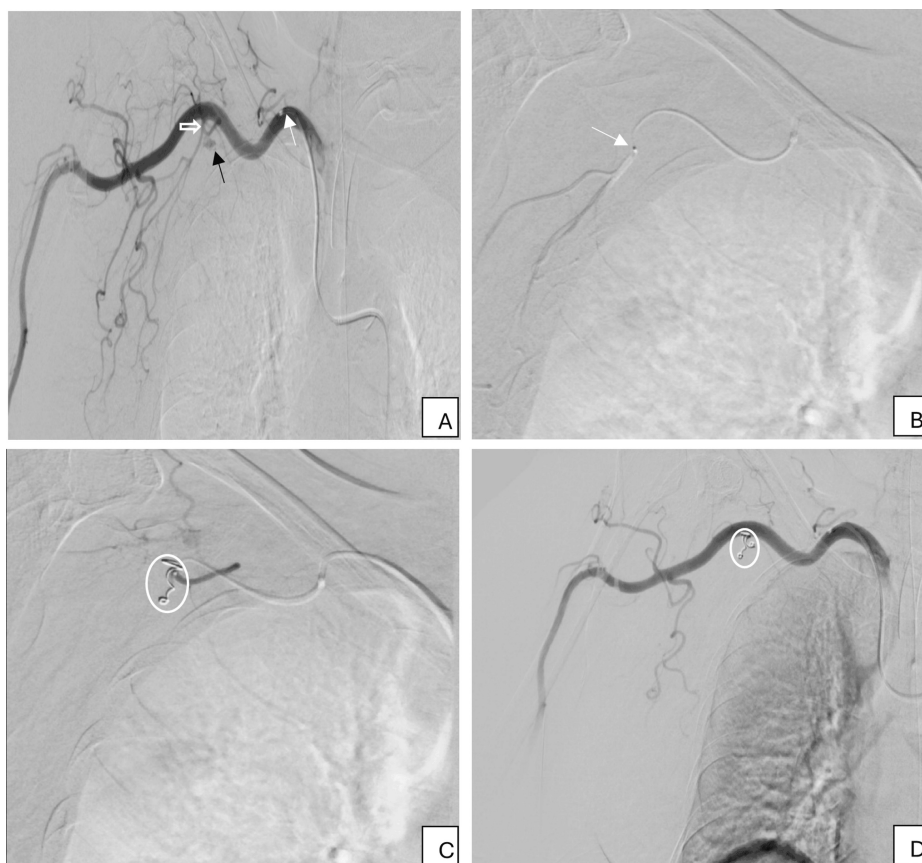
**FIGURE 2: DSA of the right upper limb**

DSA of the right upper limb with the tip of the angiographic catheter (white thin arrow) in the third part of the subclavian artery showing active arterial blush of extravasation (black thin arrow) from the first part of the axillary artery thoracoacromial branch arising from the common trunk (unfilled white arrow) of the lateral thoracic artery laterally and the thoracoacromial branch superomedially (A). DSA showing the microcatheter system superselectively engaging the common trunk of the lateral thoracic and thoracoacromial branches of the right axillary artery (B). Deployment of Tornado® pushable embolization coils (white circle) in the common trunk of the axillary artery branches (C). Last DSA run showing the successful satisfactory deployment of the coils with the resolution of the active arterial blush (white circle) (D)

Using a right common femoral artery approach, selective catheterization of the right subclavian artery was achieved with a 5F PIG angiographic catheter (Cordis, Hialeah, Florida, United States). A Direxion™ torqueable microcatheter (Boston Scientific, Marlborough, Massachusetts, United States) was utilized for superselective catheterization of the bleeding axillary artery branch. Embolization was performed with 5 mm×5 cm and 3 mm×2 cm Tornado® embolization microcoils (Cook, Bloomington, Indiana, United States), followed by balloon angioplasty using an 8 mm×4 cm Mustang™ balloon (Boston Scientific, Marlborough, Massachusetts, United States) for stabilization. Final angiography confirmed the complete cessation of bleeding with normal distal flow. Digital subtracted angiography (DSA) of the right upper limb is shown in Figure 2A-2D.
