# Long-Term Crestal Bone Stability Following Immediate Implant Placement in the Esthetic Zone: A Clinical Case Series Using Ritter RI-Quadro Spiral Implants

Manuel de la Rosa-Garza<sup>1</sup>, Gregori M. Kurtzman<sup>2</sup>

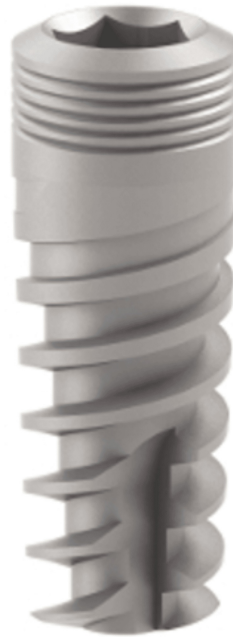
**FIGURE 1: Ritter RI-Quadro Spiral implant demonstrating the tapered body and progressive spiral thread design intended to enhance bone engagement and primary stability.**

The Ritter RI-Quadro Spiral implant (Ritter Implants, San Antonio, Texas) combines a tapered body with an aggressive spiral thread design, cervical microthreads, a moderately rough sandblasted large-grit acid-etched surface, and an internal conical restorative connection (Figure 1). These manufacturer-described features are designed to increase bone engagement at placement and provide a stable restorative interface; however, the present case series did not isolate or test the independent effect of any design feature. The clinical question, however, is not simply whether these design features are theoretically favorable, but whether the surrounding bone and soft tissues remain stable after years of function.

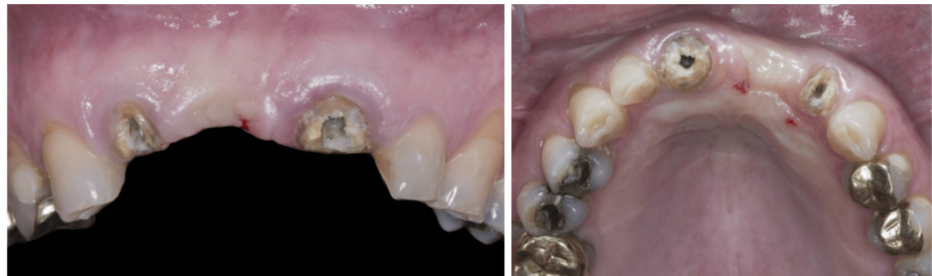
**FIGURE 2: Clinical appearance after removal of the failed anterior fixed prosthesis, demonstrating the previously endodontically treated teeth before extraction.**

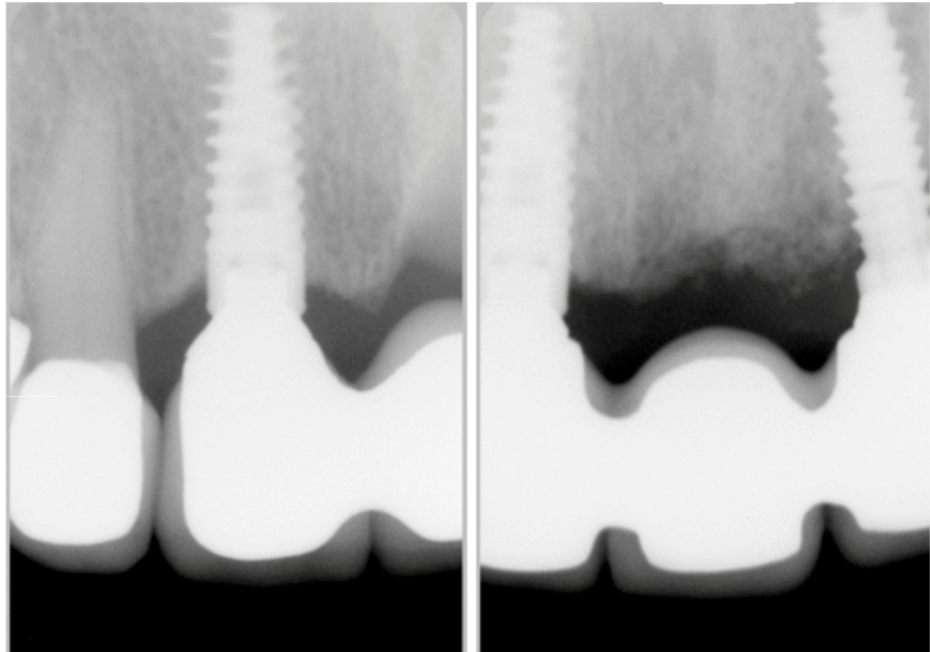
**FIGURE 3: Periapical radiograph at approximately 10 years demonstrating stable crestal bone around the implants.**

At approximately 10 years, both implants remained functional. The follow-up periapical radiograph demonstrated generally maintained crestal bone around the implants (Figure 3). Clinically, the peri-implant tissues remained stable, with slight recession at the lateral incisor site but no visible inflammation (Figure 4). At final follow-up, probing depths were 2–3 mm at the implant sites, bleeding on probing was within normal limits for clinically healthy implants, and percussion testing revealed no abnormal findings.

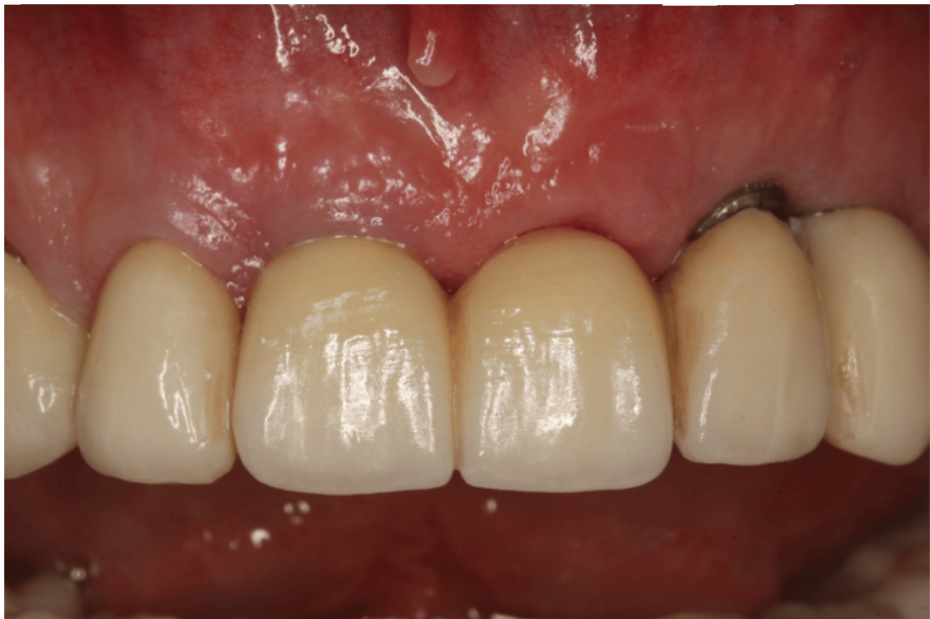
**FIGURE 4: Clinical appearance at approximately 10 years showing stable marginal tissue around the central incisor implant and slight recession at the lateral incisor implant without visible inflammation.**

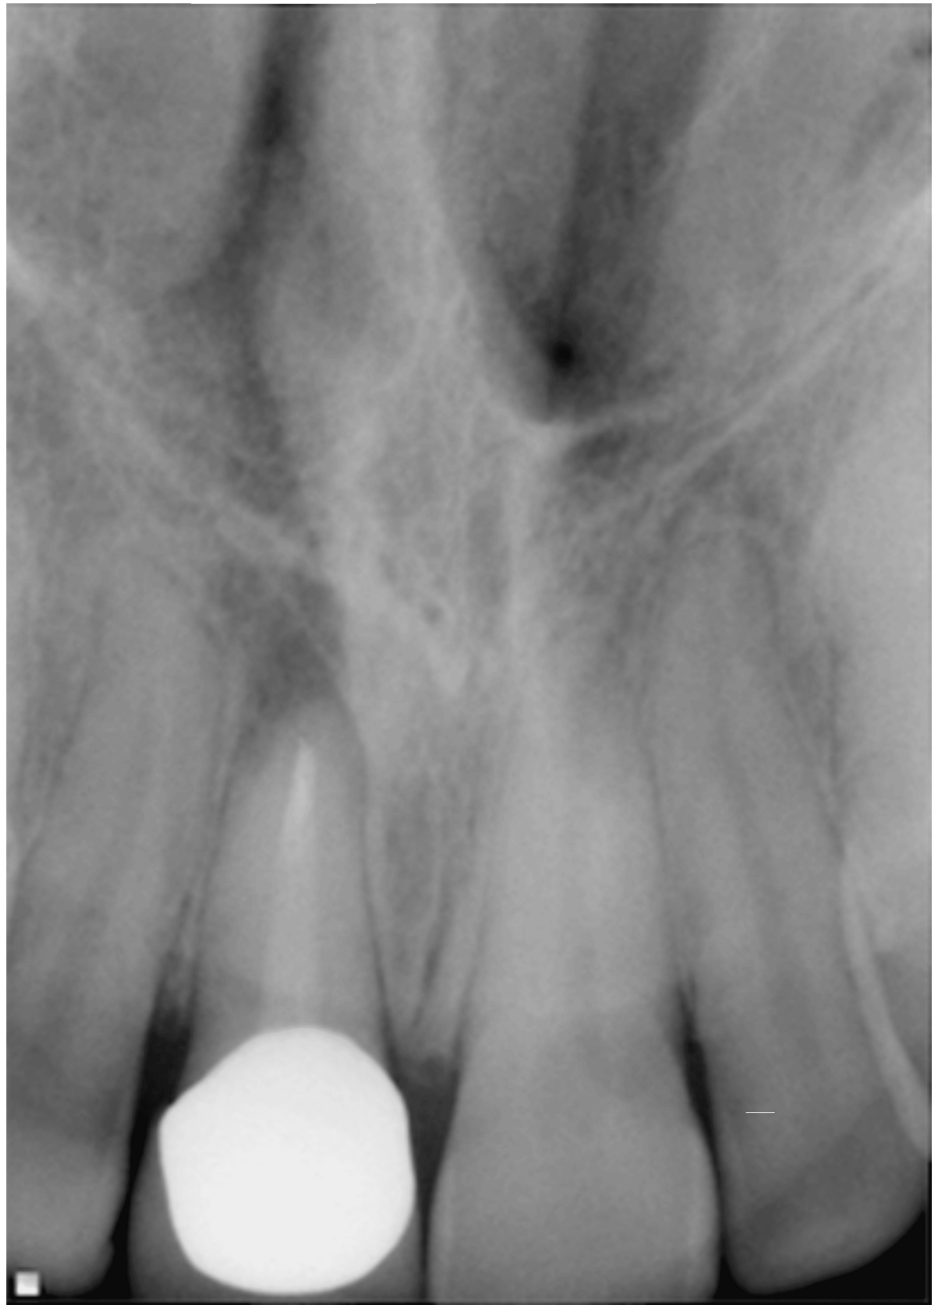
**FIGURE 5: Preoperative periapical radiograph demonstrating the failing endodontically treated maxillary central incisor with associated periapical pathology.**

The second patient was a 34-year-old woman who was a nonsmoker and systemically healthy with a healthy periodontal status. Tooth #8 was a failing endodontically treated maxillary central incisor with a relatively short root. The preoperative periapical radiograph demonstrated associated periapical pathology (Figure 5),

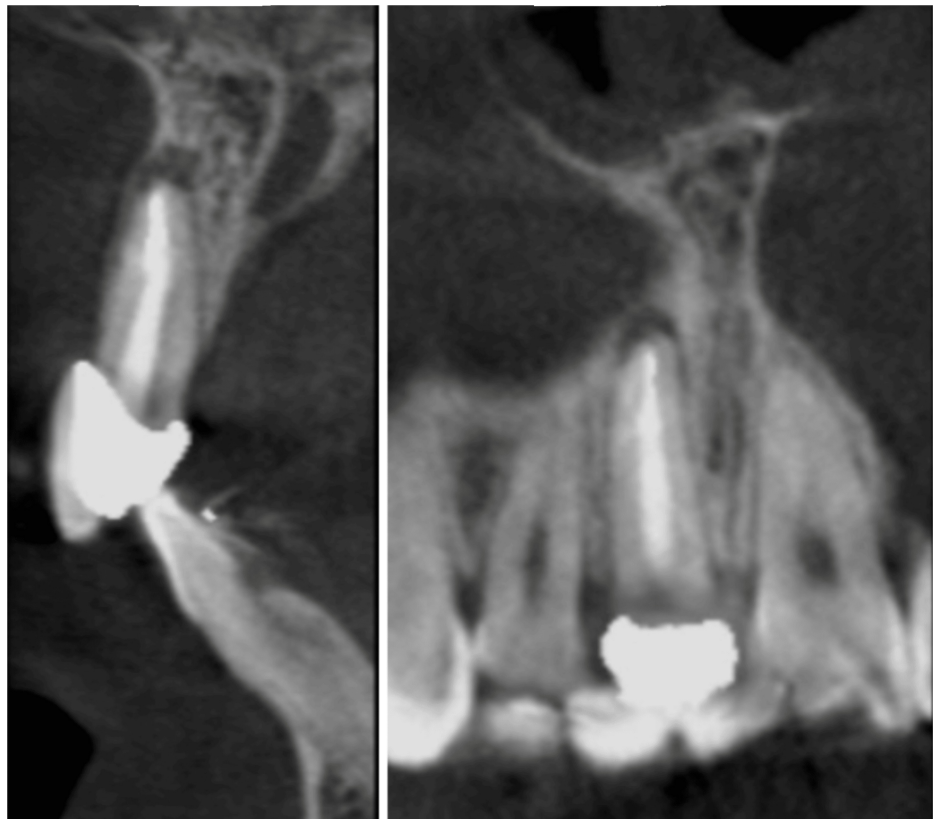
**FIGURE 6: Preoperative cone-beam computed tomography demonstrating absence of the facial plate at the failing maxillary central incisor.**

and cone-beam computed tomography showed loss of the facial plate (Figure 6). Because the extent of the endodontic lesion, limited remaining tooth structure expected after retreatment, and root dimensions resulted in a poor restorative prognosis, atraumatic extraction and immediate implant placement were selected. A surgical guide was used for osteotomy preparation, and a 4.2-mm Ritter RI-Quadro Spiral implant was placed immediately without flap elevation. The available records did not provide a standardized periodontal/peri-implant maintenance interval for this retrospective report.

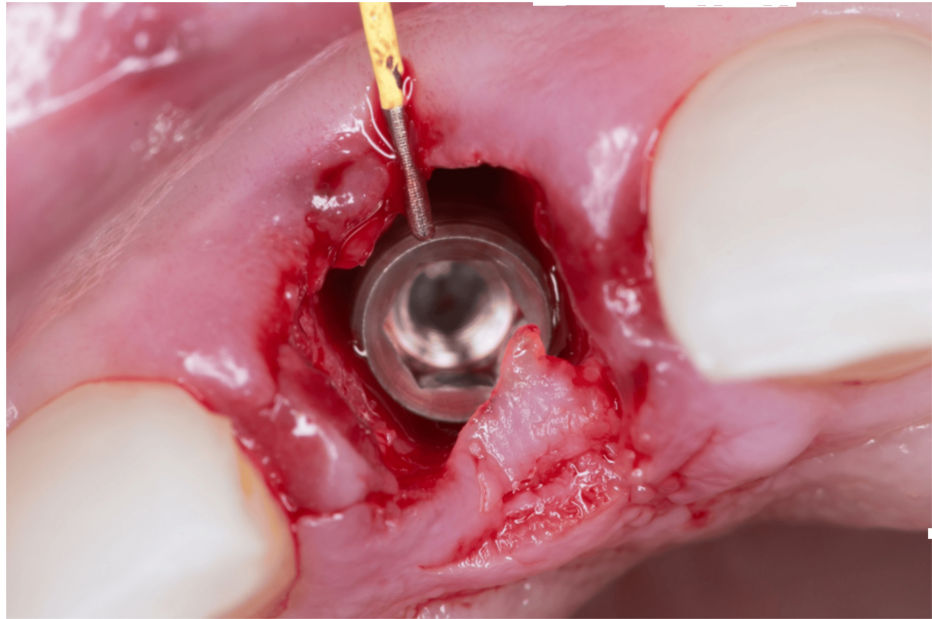
**FIGURE 7: Immediate implant placement in a palatal position after extraction, leaving a facial gap for grafting before flap closure.**

The implant was positioned palatally, leaving an approximately 2-mm facial gap that could be grafted before closure (Figure 7). The implant achieved approximately 45 N cm of insertion torque. Regeneration included particulate bovine xenograft (Bio-Oss; Geistlich Pharma AG, Wolhusen, Switzerland) combined with autogenous bone and platelet-rich fibrin. A connective tissue graft from the palate was added to reinforce the facial soft tissue volume.

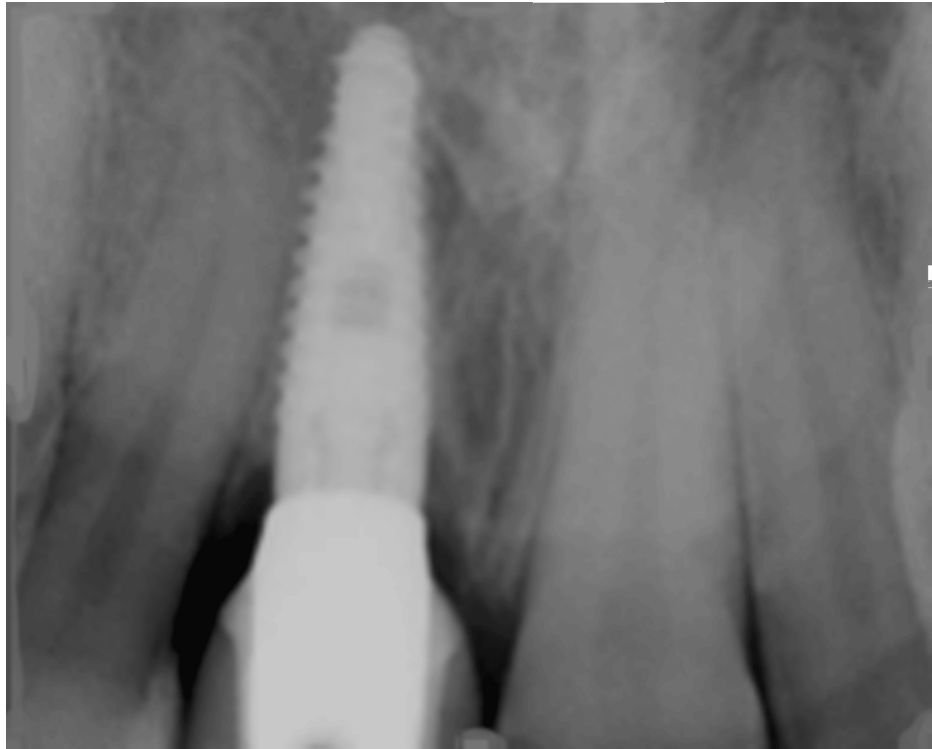
**FIGURE 9: Periapical radiograph obtained 15 weeks after implant placement.**

The implant position at placement is shown in Figure 8, and a radiograph obtained at 15 weeks documents healing (Figure 9). A resin-bonded Maryland-type provisional restoration was placed at surgery and left out of functional loading during healing. After five months, the implant was restored with a screw-retained definitive implant crown.

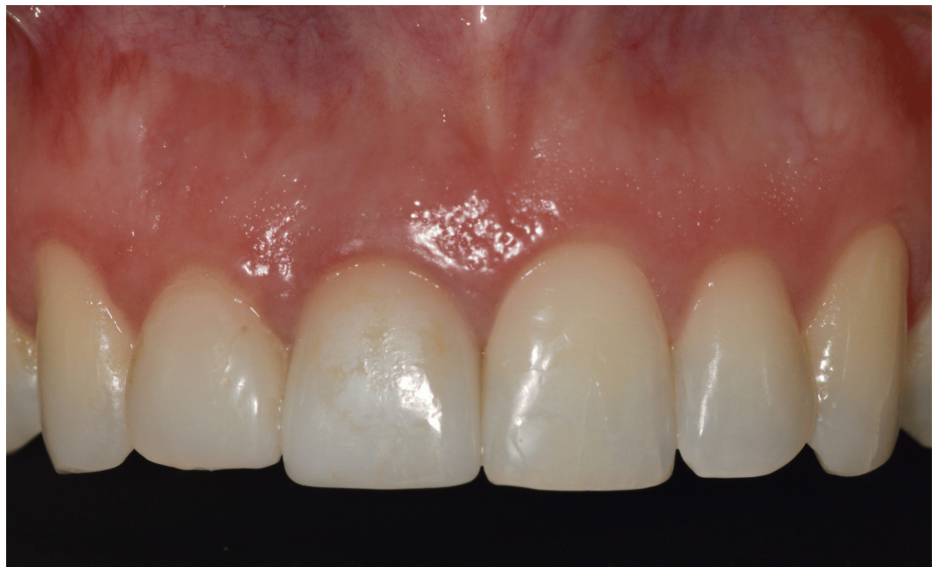
**FIGURE 10: Clinical appearance at approximately 10 years showing stable marginal gingiva without visible inflammation.**

At approximately 10 years, the restoration remained in function, and the marginal soft tissues appeared stable without visible inflammation (Figure 10). The long-term periapical radiograph showed preservation of crestal bone support without a generalized pattern of progressive radiographic bone loss or peri-implant radiolucency (Figure 11).

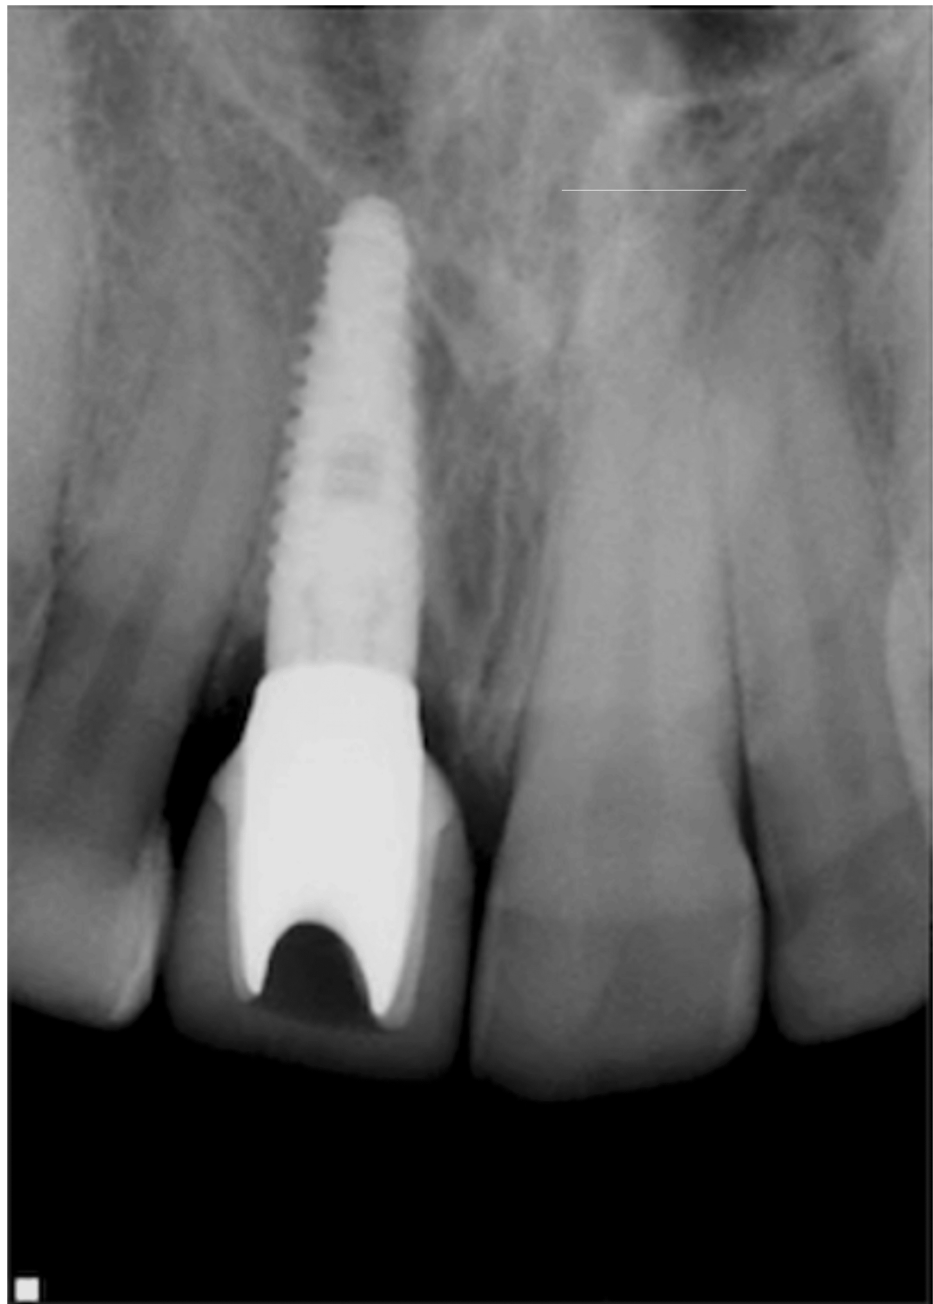
**FIGURE 11: Periapical radiograph at approximately 10 years demonstrating maintenance of crestal bone around the implant.**

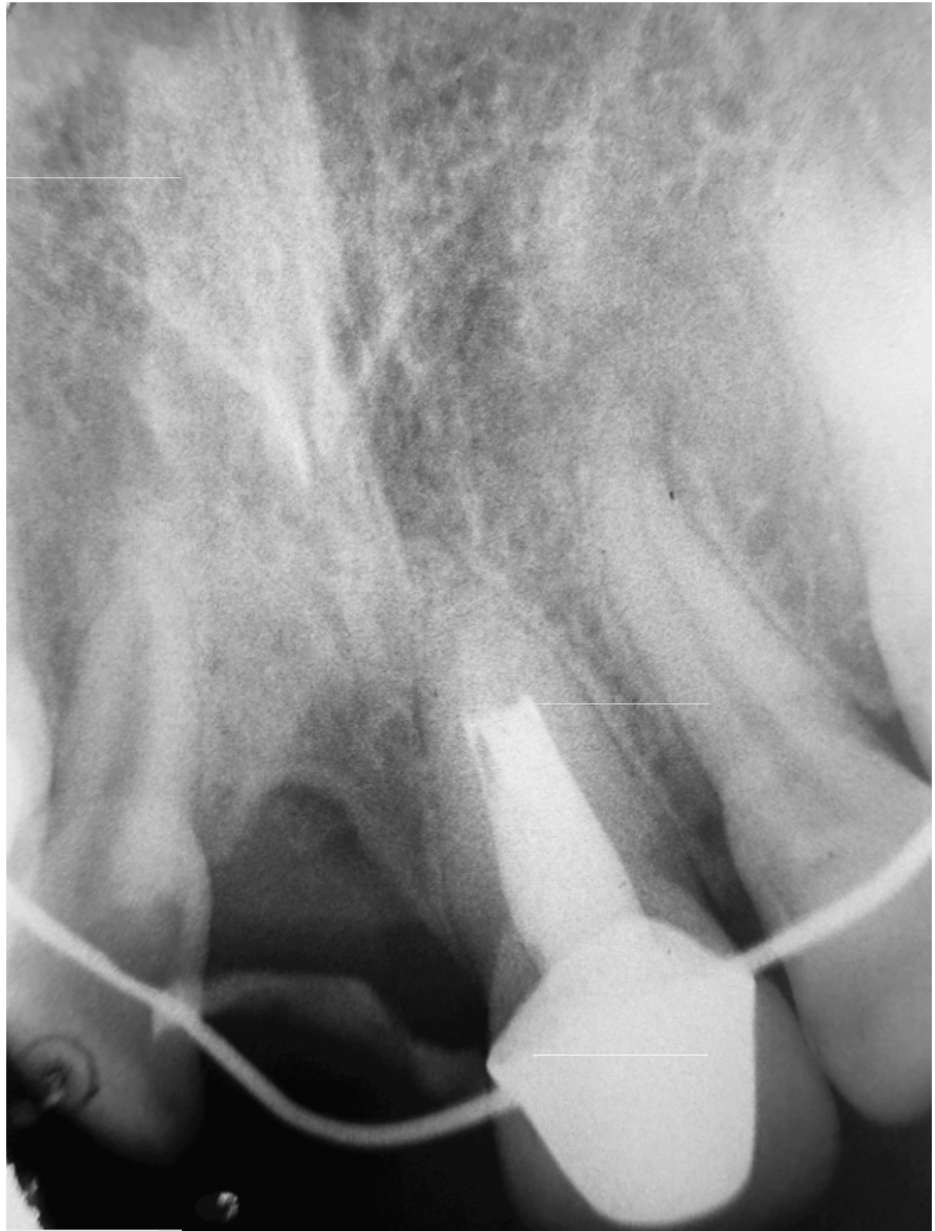
**FIGURE 12: Preoperative periapical radiograph demonstrating the failing endodontically treated maxillary central incisor before extraction and implant placement.**

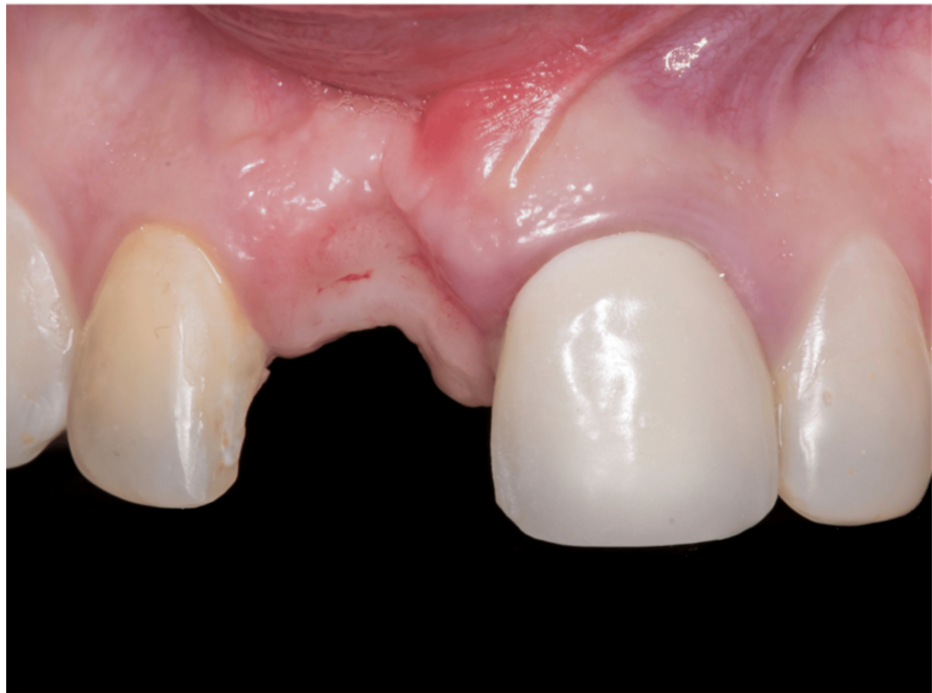
**FIGURE 13: Pre-treatment clinical appearance of the maxillary anterior site.**

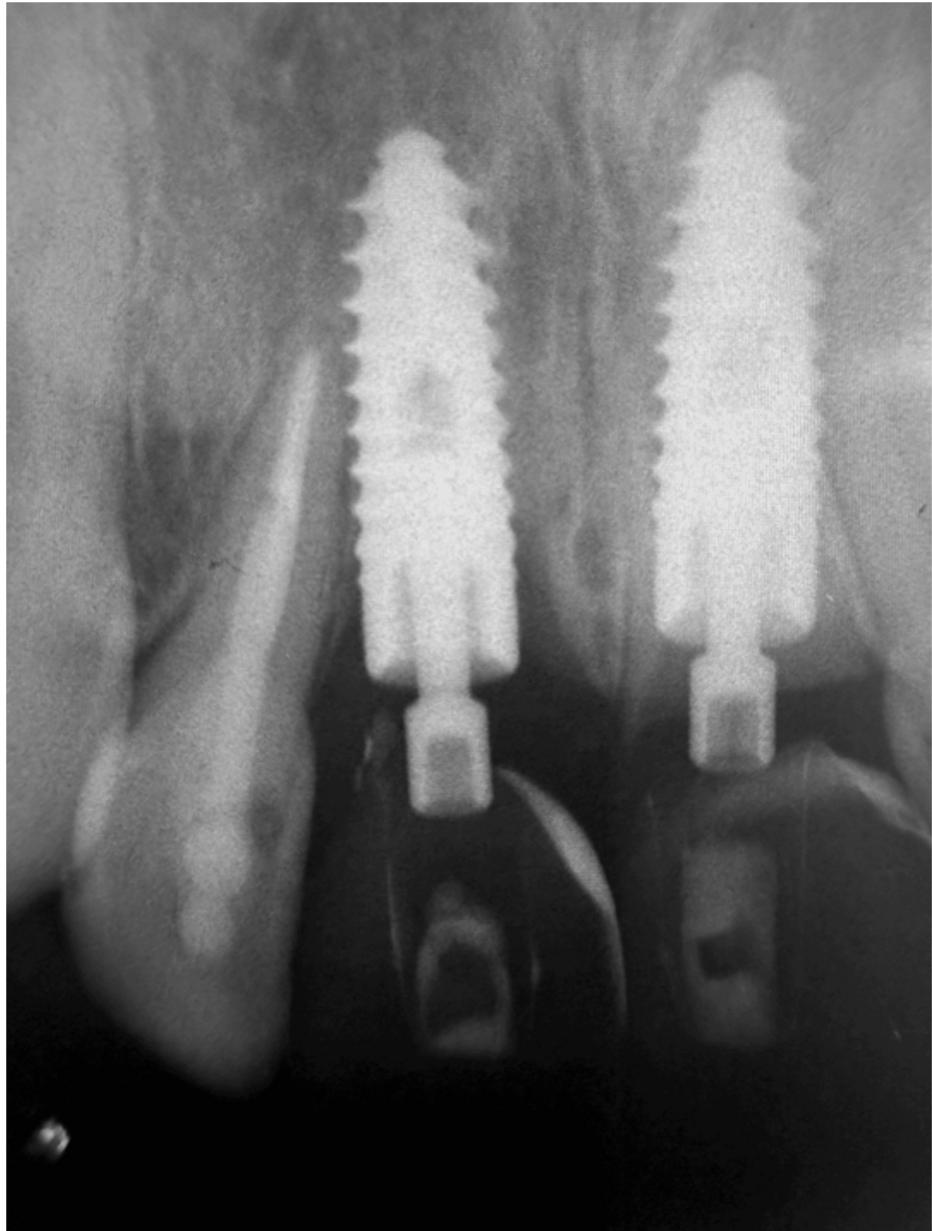
**FIGURE 15: Periapical radiograph at three months demonstrating maintenance of peri-implant crestal bone during early healing.**

Early radiographs at six weeks and three months demonstrated maintenance of the peri-implant crestal bone during healing (Figures 14, 15). A resin-bonded Maryland-type provisional restoration was used during healing.

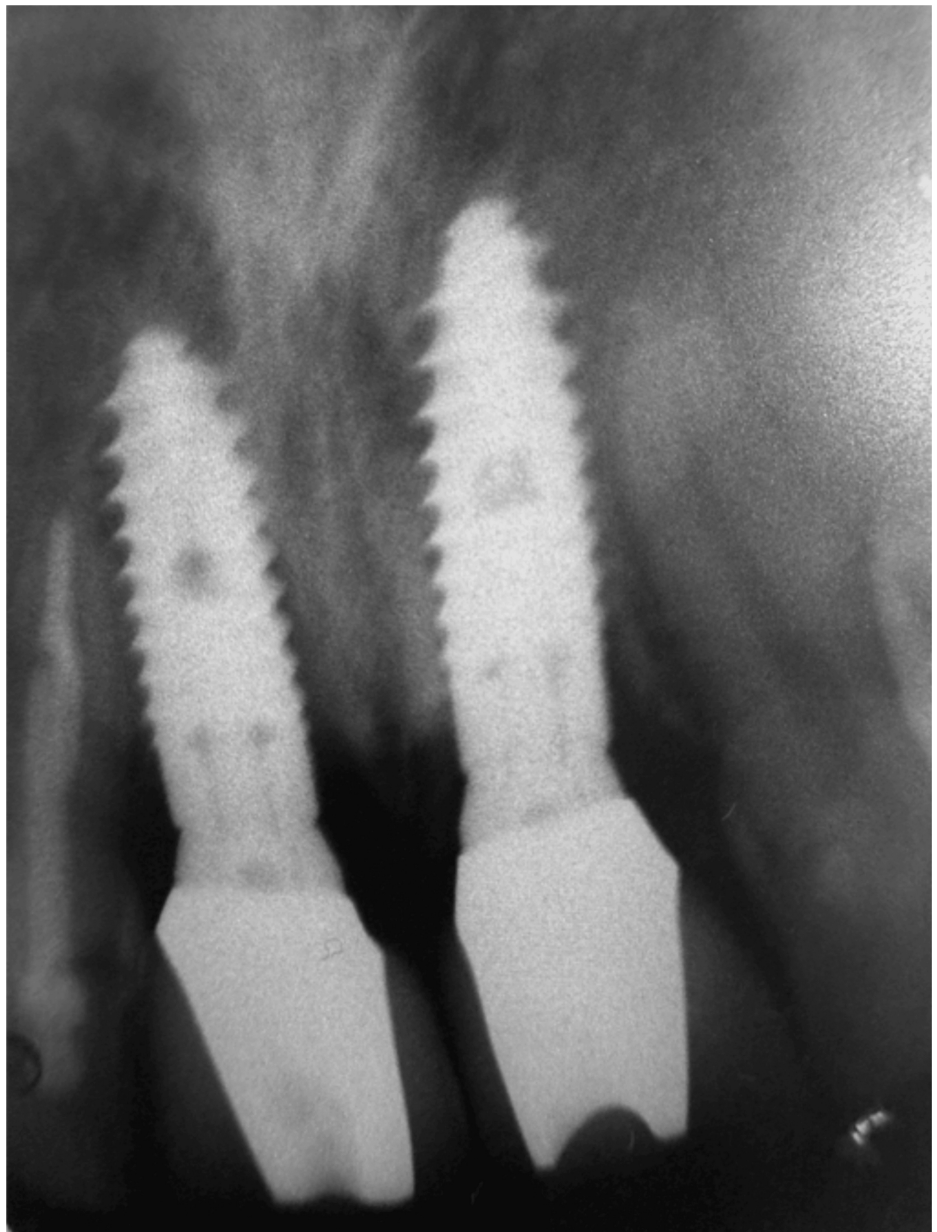
**FIGURE 16: Periapical radiograph at definitive restoration placement demonstrating maintained crestal bone around both implants.**

At six months, final impressions were made and screw-retained porcelain implant crowns were placed (Figure 16). At eight years, the marginal tissues remained clinically stable without visible inflammation (Figure 17), and the periapical radiograph continued to show generally maintained crestal architecture around both implants (Figure 18).

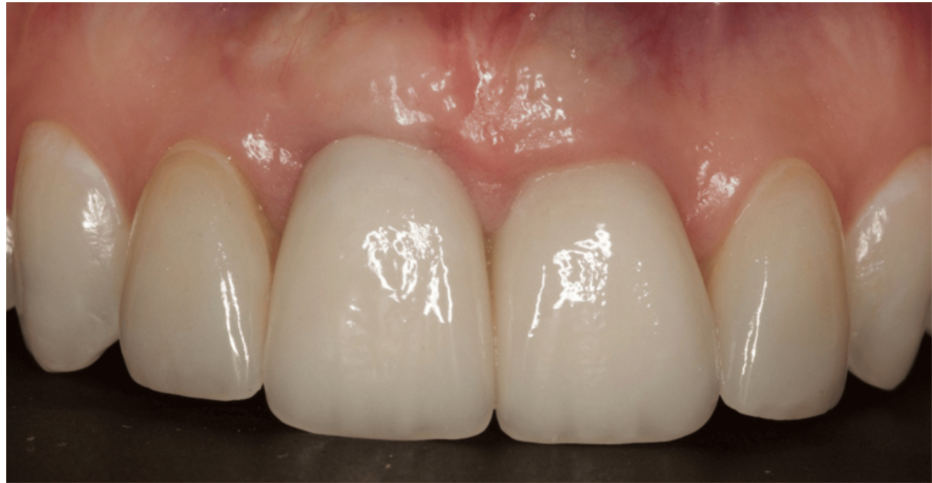
**FIGURE 17: Clinical appearance at eight years demonstrating stable marginal gingiva without visible inflammation.**

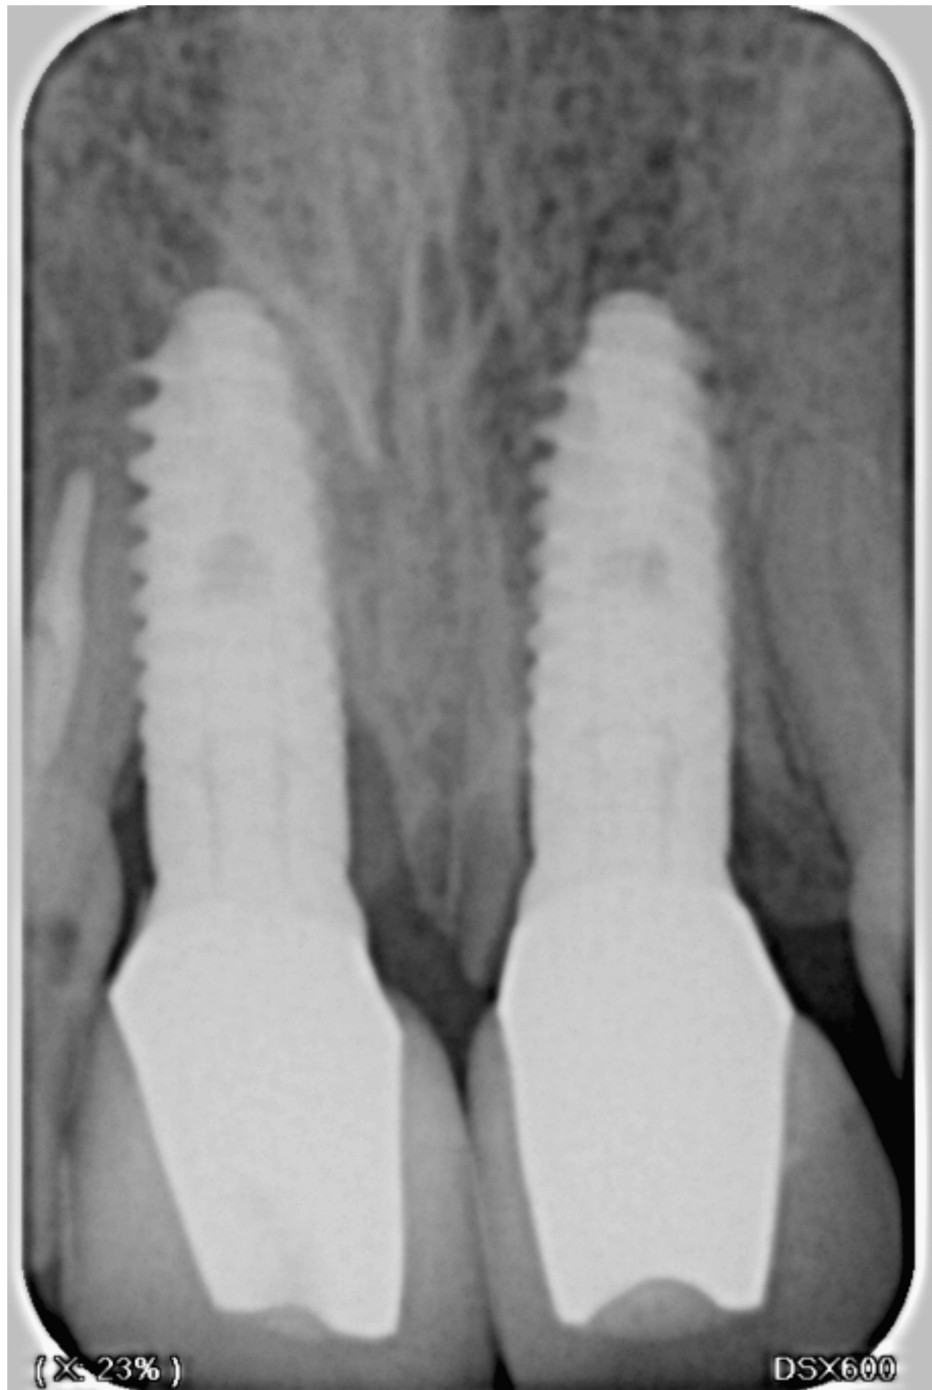
**FIGURE 18: Periapical radiograph at eight years demonstrating stable crestal bone around both implants.**

At implant #8, the long-term periapical radiograph shows an angular reduction of the mesial crestal bone level; the distal level appears comparatively similar. Because baseline and follow-up radiographs were not standardized or calibrated, the magnitude, timing, progression, and cause of this change cannot be determined reliably. It is therefore reported as a site-specific qualitative observation rather than attributed to implant design. At final follow-up, probing depths were 2-3 mm at both implant sites, bleeding on probing was within normal limits for clinically healthy implants, and percussion testing revealed no abnormal findings.
