Evaluation of Radicular Dentin Thickness in Maxillary and Mandibular Central Incisor, Canine, and Premolar Teeth

Anılı-Öztürk E, Büyükgöze-Dindar M (March 26, 2024) Evaluation of Radicular Dentin Thickness in Maxillary and Mandibular Central Incisor, Canine, and Premolar Teeth. Cureus 16(3): e56974. DOI 10.7759/cureus.56974

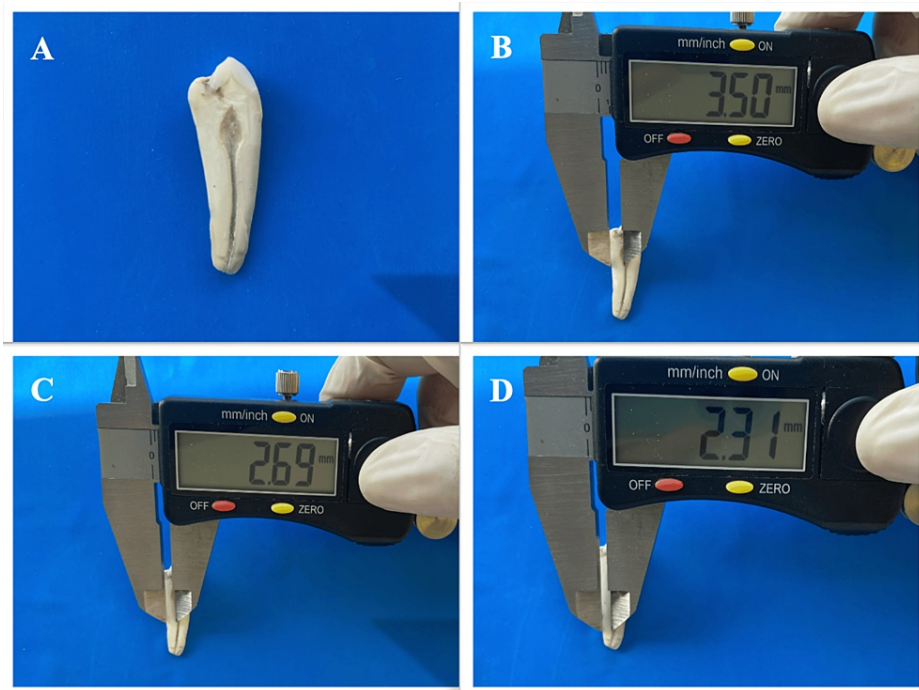
FIGURE 1: Illustration of buccolingually sectioned premolar teeth (A) and the measurement of lingual side dentin thickness using a precision mechanical caliper at the cemento-enamel junction (CEJ) (B), middle (C), and apical parts (D)

Initially, the teeth were sectioned buccolingually with a 0.2 mm thick ultra-thin silicon carbide separator disk, passing through the middle of the pulp chamber and forming the buccal and lingual portions. Afterward, the thickness of the buccal and lingual sides was measured using a precision mechanical caliper, from both parts of the root canal (Figure 1). Subsequently, both parts were sectioned again to obtain mesial and distal portions with a separator disk passing through the middle of the pulp chamber. After the mesial and distal dentin thickness measurements were made on the obtained sections, all measurements were repeated in apical, middle, and coronal portions for each tooth. All measurements were made by a single operator (MBD) for standardization. The obtained data were recorded, and statistical analysis was performed.
