Re-expansion of Osteoporotic Compression Fractures Using Bilateral SpineJack Implants: Early Clinical Experience and Biomechanical Considerations

Robert E. Jacobson¹, Anastas Nenov², Hoang D. Duong³

Technical Report

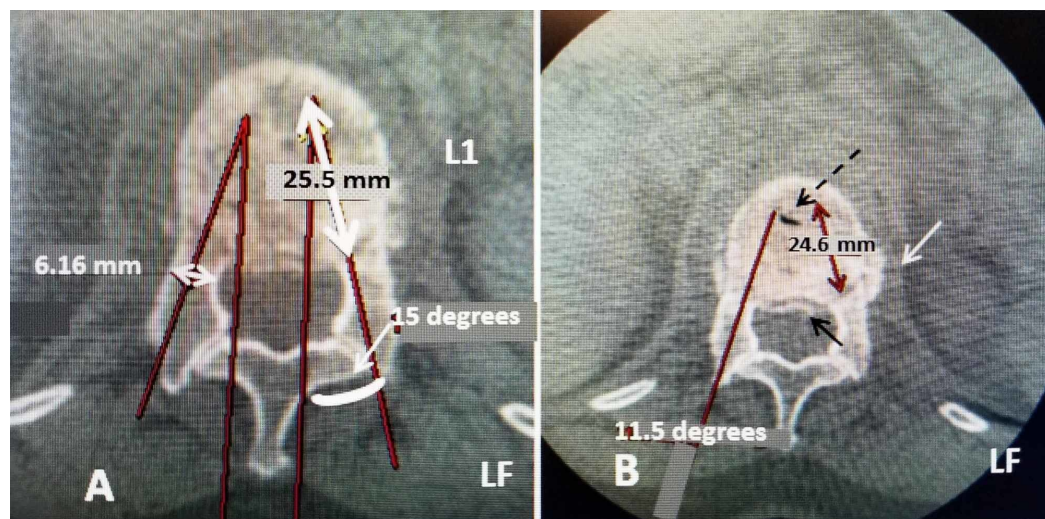
FIGURE 1: Measuring the fractured vertebral body to determine pedicle diameter and length to size correct implant to be inserted

A: Axial CT scan of L1 fracture. The red line through the pedicle shows the angle (15 degrees) and position for placement of the implant. The 25.5-mm measurement is the maximum length of the implant (double-headed white arrow) on left (LF). The pedicle diameter 6.16 mm is also marked (small double-headed arrow on right over pedicle) to get the width of the closed implant that can be inserted. The final implant size is determined by both pedicle diameter (between the side cortex) and length to properly center the implants under the fractured endplates. In this case, a 5.8 x 20-mm implant can be used.

B: Axial slice showing the angle (11.5 degrees) of insertion of the implant (solid red line). The fracture starts from the base of the L1 pedicle on the left side (LF) (solid white arrow). Minimal posterior displacement of the fracture into the spinal canal is seen (small solid black arrow). The length of the fractured endplate of 24.6 mm is measured (double-headed red arrow) which determines the maximum size implant that can be centered under the fracture. The slight lateral displacement of the fracture on the left can be seen (solid white arrow). A vertebral cleft is also identified in L1 in the anterior part of the fracture (dashed black arrow). The two SpineJack implants will be positioned anteriorly on each side of the cleft and cement will fill the cleft defect between the two implants.

The first step in using the implants is the measurement of the fractured vertebra for proper sizing and to make sure there is not extensive comminution of the pedicle or posterior vertebral wall [4,6-7]. Either computerized tomography (CT) or magnetic resonance imaging (MRI) films in sagittal, axial and coronal views are made to assess the integrity of the posterior vertebral wall, the pedicle and the depth of the anterior vertebra from the pedicle base and the diameter of the pedicle [10]. Precise measurements of the inner cortical pedicle size and the depth of the vertebra in a line projected from the anterior-medial to more posterior-lateral part of the vertebra will aid in planning where the implant will be positioned in line with the pedicle. This, in turn, allows exact sizing of the originally closed SJ so it can fit through the pedicle and is positioned properly to provide support along the maximum length of the fractured endplate and also centered underneath the fractured endplate (Figure 1).

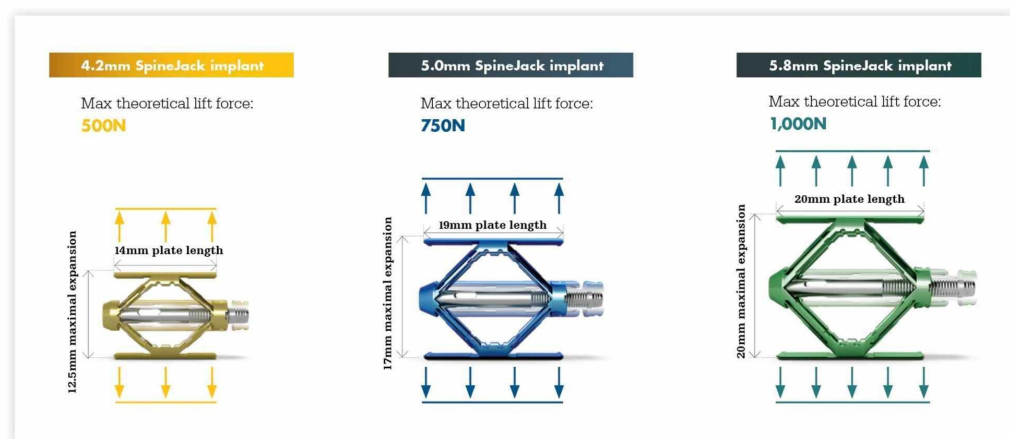
FIGURE 2: Dimensions of the different size SpineJack implants fully opened

The implants come in three sizes: 4.2, 5.0 and 5.8 mm closed. The diameter of the closed implant is critical in determining which size implant can be inserted through the pedicle. When fully deployed and locked in place, they provide different dimensions and Newtons of load support, basically doubling in strength (500-1000 Newtons) from 4.2 to 5.8-mm-sized implants. The opened length of the struts that support the fractured endplate is shown for each implant, which also has different sagittal heights as indicated. (Picture Courtesy: Stryker Corp, Kalamazoo, MI)

The implants come in three different diameters for insertion into the pedicle with sizes of 4.2, 5.0 and 5.8 mm using the internal cortical diameter of the pedicle as the determining factor for size. When fully opened, each device has different heights and lengths, varying from 12.5 x 14.0 mm to 20.0 x 20.0 mm. The lift forces have been calculated and are reflected as compression load strengths described as force in newtons [10,16]. It is important to note the change in lift force with implant size, increasing 50% from 4.2 to 5.0 mm and 100% from 4.2 to 5.8 mm, so it may be important to use the largest size that will be fit through the pedicle. The 4.2-mm implant has been placed in mid and upper thoracic levels (Figure 2) [10].

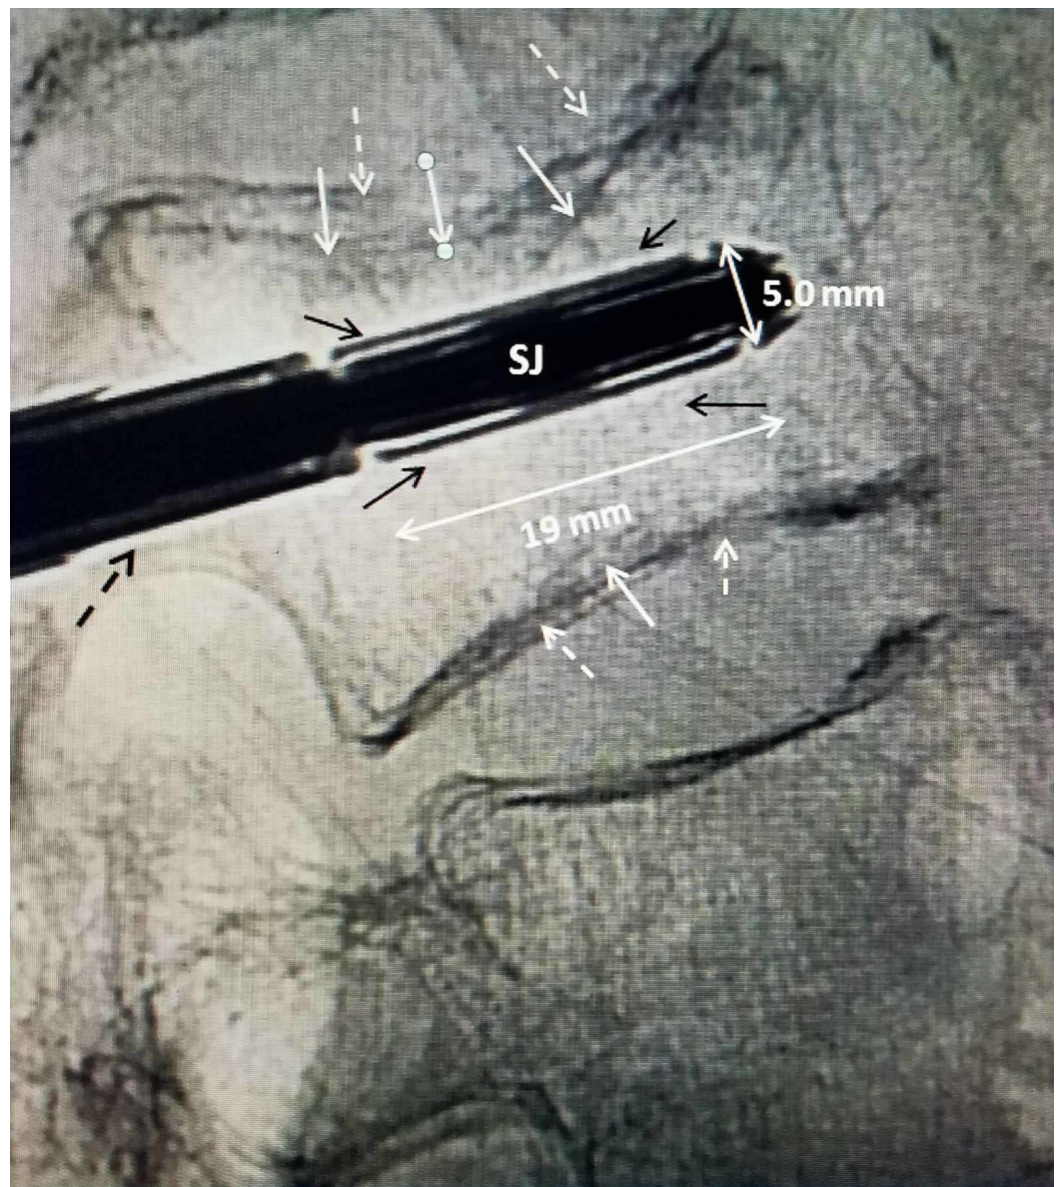
FIGURE 3: A closed 5.0-mm SpineJack implant aligned under superior endplate fracture

The closed implant is centered directly under the compressed superior endplate fracture. The dimension of the closed SJ is marked, 19.0-mm length and 5.0-mm diameter (double-headed white arrows). The 'struts' of the implant are seen in a closed position (solid black arrows) and make part of the diameter of the closed implant. The double shadow of the compressed superior and inferior endplates from each side are seen (solid white arrows and dashed white arrows). The insertion handle of the SJ is seen going through the pedicle (dashed black arrow).

Procedure: Under local anesthesia, similar to VA or BKP, with the patient placed in a prone position, after the fractured level is located, the device is inserted under local anesthesia. The fractured vertebra is localized and often if spinal hyper-extension is performed at this time, the collapsed vertebra can be seen to partially re-expand. This is found more commonly when CT or MRI reveals vacuum clefts within the fracture and is a sign of instability [3-4]. Next, two small 11-gauge vertebroplasty cannulas are used to access both pedicles but only up to the posterior margin of the vertebral body. A firm, 1.5-mm k-wire is then advanced to the anterior one-third of the vertebra on each side and the cannulas are removed. Next, a cannulated-sized reamer is used that matches the implant size selected. The reamer is passed over the k-wire and creates a path of the exact diameter as the closed implant for inserting the closed SJ device. The reamer also allows minor changes to correct angulation if needed. After both sides have been 'reamed', a sizer is used, that is exactly the same size as the closed implant so that the cavity can be properly positioned along the entire length of the fractured endplate. A lucent plastic marker with only a radio-opaque 5-mm tip is left in one side while the parallel opposite side is drilled so the two implants can be precisely aligned under fluoroscopic imaging (Figure 3).

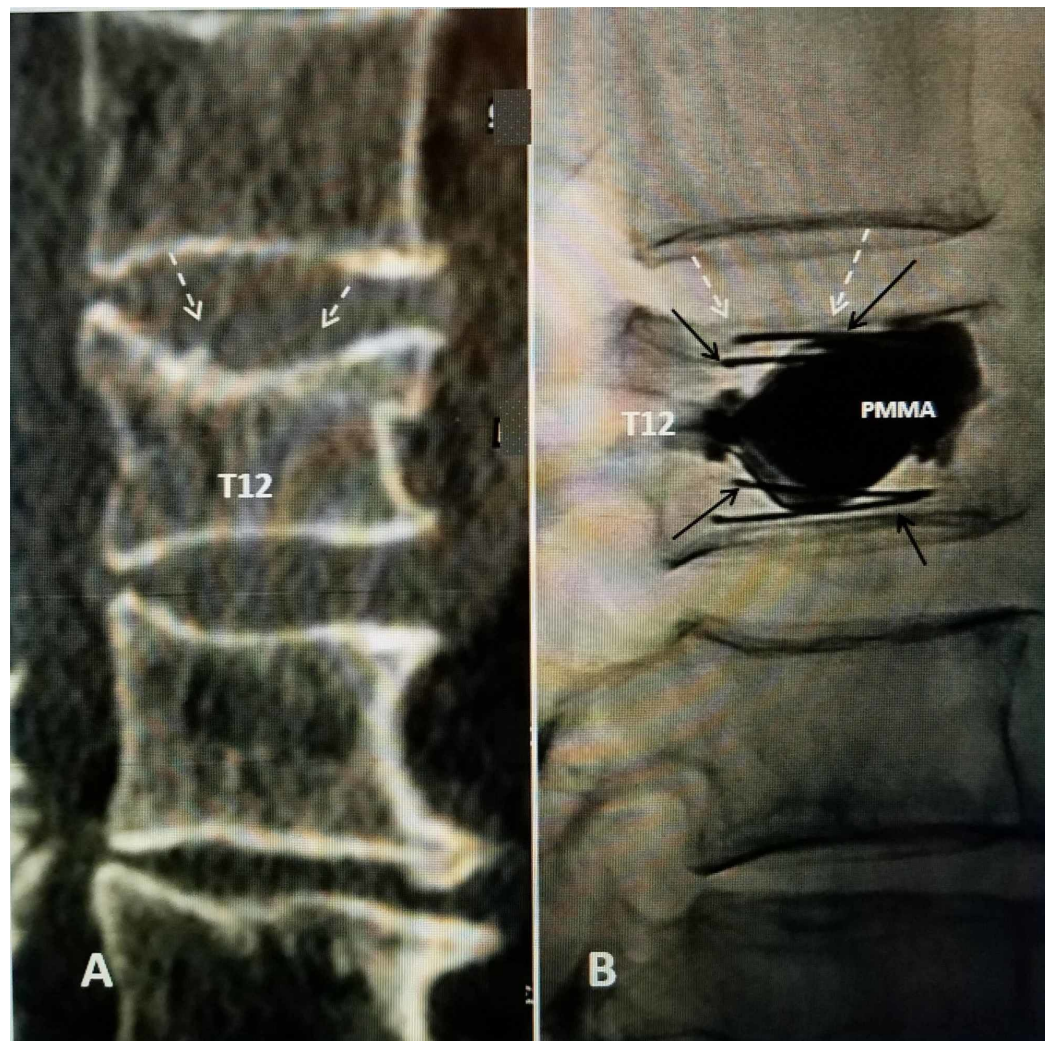
FIGURE 4: T12 fracture with two SpineJack implants placed in vertebral body with re-expansion of the superior endplate

A: Pre-operative sagittal CT scan showing compression fracture of the superior endplate of T12 (dashed white arrows).

B: Post-procedure digital fluoroscopic lateral image showing almost complete re-expansion of the superior endplate (dashed white arrows). The struts of the two parallel SpineJack 5.0-mm implants are clearly seen extending under the length of both superior and inferior endplates (solid black arrows). The cement is confined between the struts and the two implants (PMMA).

machined grooves. A simple mechanism locks the implant into the desired position as controlled by the physician. Once the desired expansion is obtained, the device is left in place inside the restored vertebra and polymethylmethacrylate (PMMA) bone cement is injected (Figure 4).

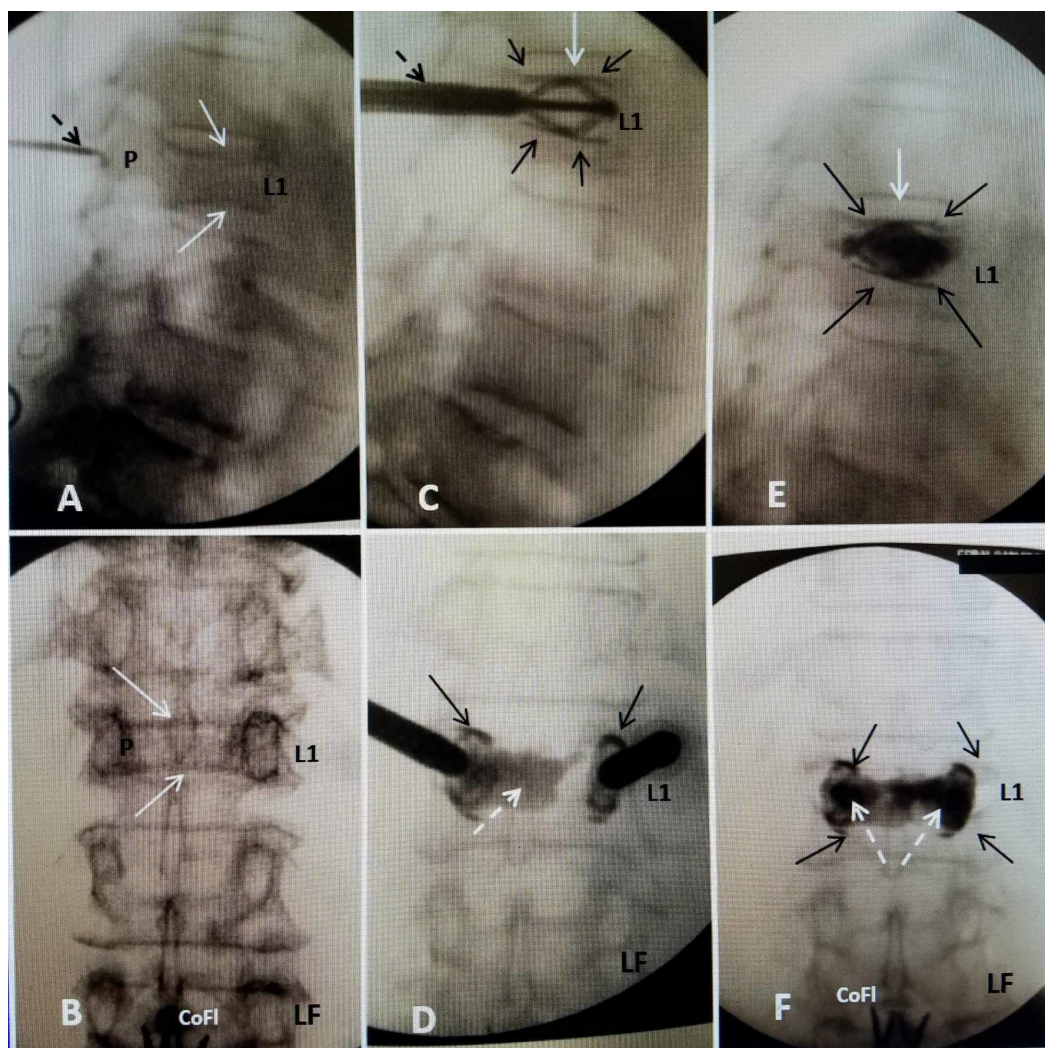
FIGURE 5: L1 acute compression fracture with sequential insertion of bilateral SpineJack implants followed by PMMA cement, demonstrating restoration of vertebral height

A: Lateral intra-operative fluoroscopy showing superior endplate fracture of L1 (solid white arrow). The introducer cannula (dashed black arrow) for the k-wire is placed in line with the pedicle (P).

B: Anterior-posterior (AP) film showing a biconcave collapse of both superior and inferior endplate of L1 (solid white arrows).

C: Lateral fluoroscopy showing the introducer cannula (dashed black arrow). The expanded 5.8-mm SJ is clearly seen before bone cement injected. The two SpineJacks are parallel and the struts pass along the length of the endplates restoring vertebral height especially in the middle of the superior endplate (solid white arrow).

D: Anterior-posterior (AP) intra-operative fluoroscopy showing the PMMA cement being injected unilaterally, on the right side, through the SJ implant (dashed white arrow). The struts are seen above and below the cement on both sides (solid black arrows). The cement is pooling around the

device and across the midline (dashed white arrow). The implant on the left (LF) is expanded but has not been injected with cement yet.

E: Lateral film after completed cement injection bilaterally. The superior and inferior struts (solid black arrows) appear to limit spread within and between the two implants. The fractured superior endplate has been restored to normal height (solid white arrow) with the struts supporting the superior endplate back to normal height.

F: AP film after PMMA cement injected in both implants. The superior struts and inferior struts (solid black arrows) are seen bilaterally. Bone cement is filling both devices and completely across the midline (dashed white arrows), compared to what is seen in 'D'.

inside the opened implant. This minimizes the possibility of posterior cement spread and the risk of leakage of cement into the spinal canal. The general surgical time to perform bilateral insertion of SJ implants with PMMA cement is similar to bilateral balloon kyphoplasty. The resultant vertebra not only has height restoration but broad anterior and lateral support by the devices with cement intermingled in the titanium struts and across the midline (Figure 5).

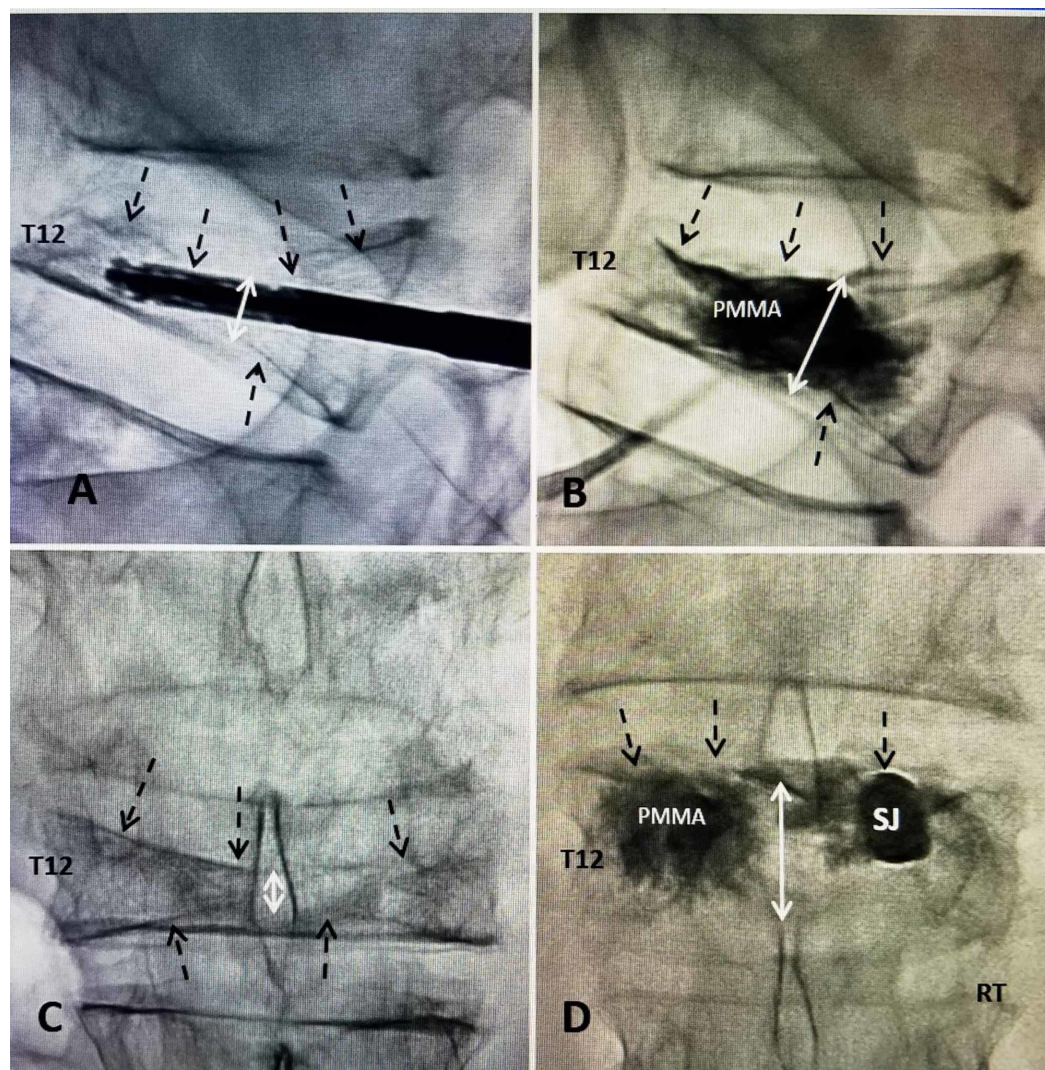
FIGURE 6: T12 acute compression fracture treated with 4.2-mm SpineJack

A: Initial lateral intra-operative film showing a 70% middle (double-headed white arrow) and anterior compression fracture of T12. The closed 4.2-mm SJ and attached handle are seen centered under the fracture. The bi-concave superior endplate fracture (four dashed black arrows) and lesser and more posterior inferior endplate fracture is seen (single dashed black arrow).

B: Lateral film after expansion of SJ in the center of T12 raising the middle part of the superior endplate fracture (three dashed black arrows). The 4.2-mm implant expands to 14.0 x 17.0 mm. It is filled with cement (PMMA). The middle T12 height has expanded three-fold (double-headed white arrow) and the inferior posterior endplate is also slightly expanded (single dashed black arrow). Note that the cement (PMMA) remains localized around the implant and none is tracking posteriorly toward the spinal canal.

C: Anterior-posterior (AP) film before insertion of SJ showing marked collapse in the center of T12 (double-headed white arrow). The central vertebral collapse is mostly from depression of the center superior endplate (3 dashed black arrows) compared to the inferior endplate (two dashed black arrows). Normally the posterior and lateral walls remain closer to normal height with high degree collapse because of the stronger superior and medial pedicle cortex that maintains the posterior vertebral wall.

D: AP fluoroscopy film after both SJ implants was inserted. Cement (PMMA) was injected in the left, before the right and is crossing the midline. The superior endplate is significantly elevated from the pre-implant film in 'C' and the midline height is restored (double-headed white arrow) especially in

the center of T12 (three dashed black arrows). The right SJ has not been injected with cement.

Biomechanical studies found that a more trabecular spread of cement distributes the load and stiffness throughout a wider area of the fractured vertebra [2,7]. This may be one of the reasons for less adjacent fractures with simple VA in distinction to BKP, where the cement is used in larger volumes and is placed in a more globular concentration [6,9,11]. Cement in the region of the endplate nearest the adjacent fractured vertebra is also critical to reducing the incidence of continued collapse. In a study of technical reasons for the recurrence of a fracture within the same vertebra, it was found that one of the main reasons for the continued collapse of a previously treated vertebra and the adjacent vertebra was non-filling or insufficient cement placement around the fractured area and a lack of cement specifically filling near the fractured endplate [7,11]. The SpineJack^R implant creates a symmetric broader load support directly under the osteoporotic collapsing superior cortex and endplate based on precise placement of bilateral 'struts' which are supplemented by PMMA cement. The force generated by the bilateral implants varies by implant size but ranges from 500 to 1000 Newtons of load support under the fractured endplate, as well as load from the spinal column. (A Newton is equivalent to 4.48 pounds (lbs) and so 500 Newtons is 112 pounds per implant for the 4.2 mm SJ to 1000 Newtons for the 5.8 mm SJ or 224 lbs per implant). The PMMA cement is incorporated within the cancellous bone inside, around and especially between the two implants, both laterally and anteriorly creating a broad supporting ring under the endplate. The mechanical center of each 'strut' is under the fracture, the extended wings spread the load and provide a broad large force strength along the length of the fracture, similar to skis 'floating' above the snow, as the skier is centered on long extended skis [17-18]. These implants are effective with high degrees of vertebral collapse and angulation which is more common at the thoracolumbar junction (Figure 6).
